Report Title	Response to Sussex Surveyor's Report
Project Number	1733
Site Address	Burgess Hill Park Centre RH15 8ET
Date	30/11/2022
Author	Brendan Haworth
Checked	Des McCall IStructE MICE
Status	Final
Revision

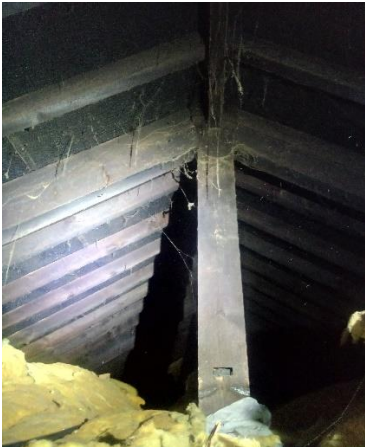
We gained access to the high-level hatch above the gymnasium floor and were satisfied that the roof timbers which were visible from that location are in good condition. See photograph opposite. It was not possible to gain access further into the roof space beyond standing in the hatch-opening. This was due to lack of head-space and excessive amounts of mineral wool at the opening.

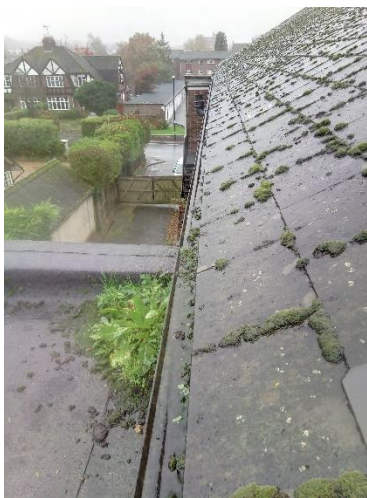
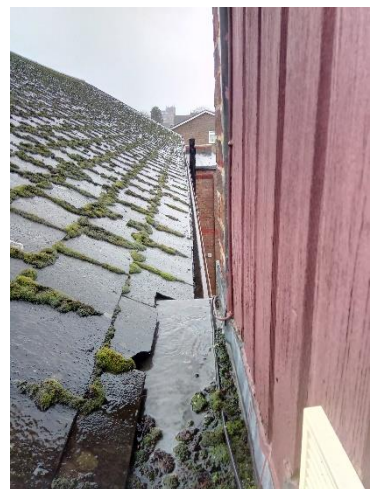
We also inspected both east and west roof slopes from outside on the flat roof at the rear of the main building. We did not measure the alignment of the roof but, we could not detect the undulations referred to in Sussex Surveyor's report. See photographs of East and West roof slopes viewed from the rear of the building towards the front of the building. East on the left, West on the right.

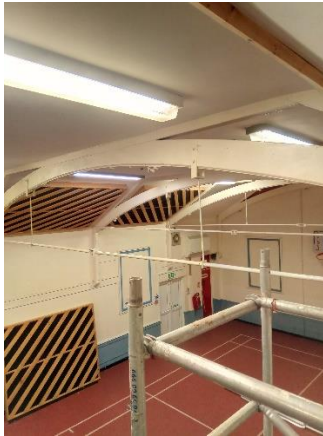
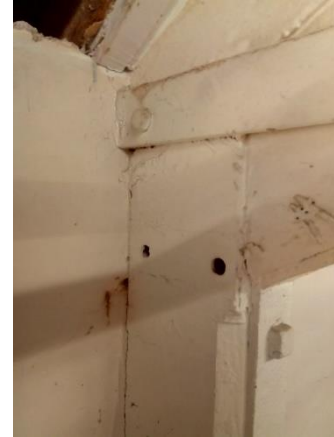
The main roof structure is a series of king post, curved collar-beam trusses with wall-posts on corbels. Each truss has an eaves-level horizontal metal tie-bar with vertical steel hangers from the curved collar beam – see photograph on the left. The trusses support purlins which in turn support rafters. It is likely that the shallow curve of the collar-beam necessitates the horizontal metal tie-bar. All the visible trusses, apart from

the one at the very rear of the gymnasium (opposite end to the stage) appear to have been fitted with replacement tie-bars, vertical hangers, connection straps, fixing bolts and tensioning nuts. The component parts are from what look like recent fabrications and current hollow section. Replacement tie-bars have been fitted approximately 125mm above their original position. See photograph above that indicates the original tie-bar mounting holes. There is what appears to be the original tie-bar fitted to the king post truss at the rear of the gymnasium (opposite end to the stage). Although it was only inspected from floor level, its fittings seem to be in good condition. It is therefore not clear why replacement tie-bars were installed to the other trusses or why they were fitted at a slightly higher level. It is possible that new tie-bars were fitted prior to removing the original ones.

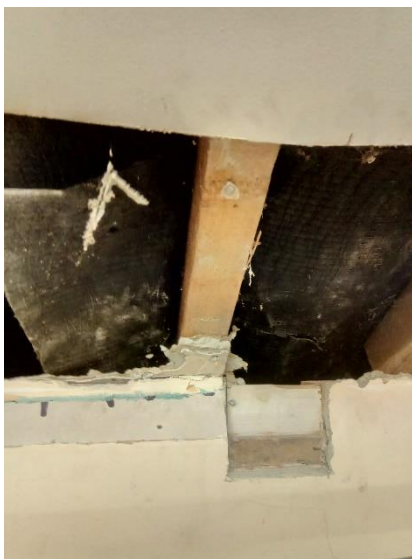
An opening was cut in the plasterboard to inspect the roof timbers at eaves level at a point mid-way along the gymnasium on the west elevation. All timbers appeared to be in good condition with rafters at that location from sawn timber that is probably less than 20 years old. See photograph opposite.

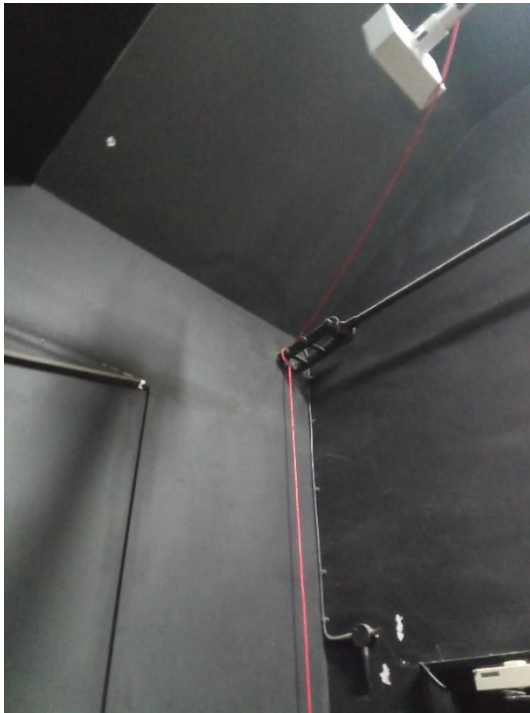
Spacing of the king post trusses indicated that there should be a truss located near the front of the stage. However there did not appear to be a truss at this location as the horizontal tie-beam, wall-posts corbels and curved collar beam were missing. This is the location where Sussex Surveyors identified the displacement of masonry at high level on the west elevation.

At the next anticipated truss position (at the back of the stage) only the horizontal tie-bar was visible. This matched what we believe is an original tie-bar at the opposite end of the gymnasium mentioned previously.

The photograph opposite shows the tie-bar at the rear of the stage area. The curved collar-beam, wall posts and corbels were missing at this location.

The important structural issue is the effect that removing two king-post roof trusses above the gymnasium has had on the stability of the roof and the main supporting masonry walls. It is clear that some movement has occurred in the masonry where one truss has been removed but it is not clear if that happened at the time of the truss's removal or is in fact on-going. It was not possible during the site visit to establish what structure, if any, has been put in place to replace the support originally provided by the two trusses which have been removed.

1. We recommend that more opening-up to allow a thorough and detailed examination of the rear portion of the roof above the stage area is commissioned. This should be done as soon as practically possible, and any structural interventions and repairs completed before the building comes back into use.

5. An exclusion zone below the displaced masonry on both sides of the building should be erected to prevent anyone entering the area where falling masonry might land.

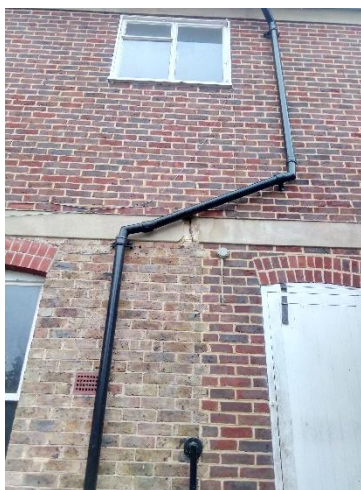
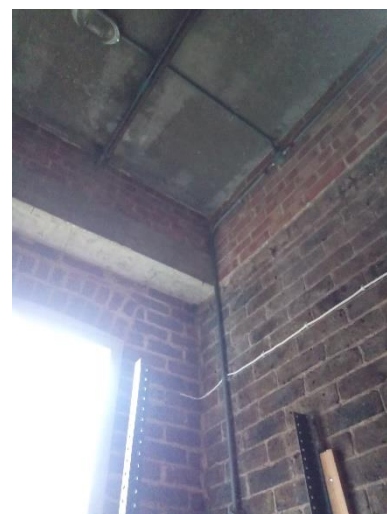
The render was hacked off to reveal a joint between original and more recent construction. There is a concrete beam behind the render band (photo on the right) and the crack coincided with the end of the beam. Ceiling tiles were removed at first floor level; access was limited but nothing structurally significant was noted. The crack does not indicate anything structurally significant and is likely to be

reflective cracking resulting from a joint between recent and original construction. No further action required except to repair the render band incorporating a movement joint.

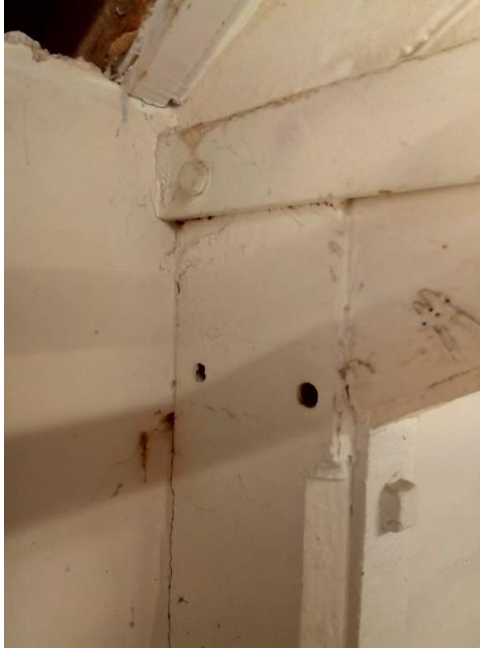
It is not clear why all but one of the tie-bars has been replaced and set at a slightly higher level. In the photograph opposite, the pair of holes below the horizontal steel bracket are we believe the original tie-bar bracket bolt-holes.

It is not clear why two trusses above the stage area were removed and it was not possible to determine what structure, if any, has been installed to replace those trusses.

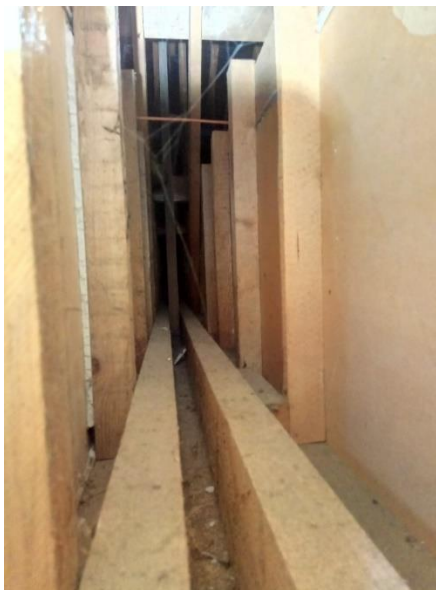
Above the stage area there are two horizontal down-stands projecting approximately 500mm from ceiling level.

Opening-up through the plasterboard to inspect one down-stand, revealed a pair of timbers 50x150 (estimated) spanning across the gymnasium, with a single 50x100 (estimated) vertical timber hanger at mid span which, extended up to the apex of the main roof. The side walls of each down-stand were formed from 50x50 timber battens and plasterboard. See photograph opposite.

It is not clear what the pair of down stands were intended for. However, scaffold tubes pass through the side walls of both down-stands and attached to the scaffold tubes are several stage lights. The scaffold tubes appear to be bearing onto the plasterboard which is an unsatisfactory means of support.

2. The scaffold tubes above the stage that carry lights should be taken down and if required, a more robust and appropriate means of mounting and supporting stage lights should be installed.
