BUILDING INSPECTION REPORT

BURGESS HILL PARK CENTRE

60 PARK ROAD

AUGUST 2022

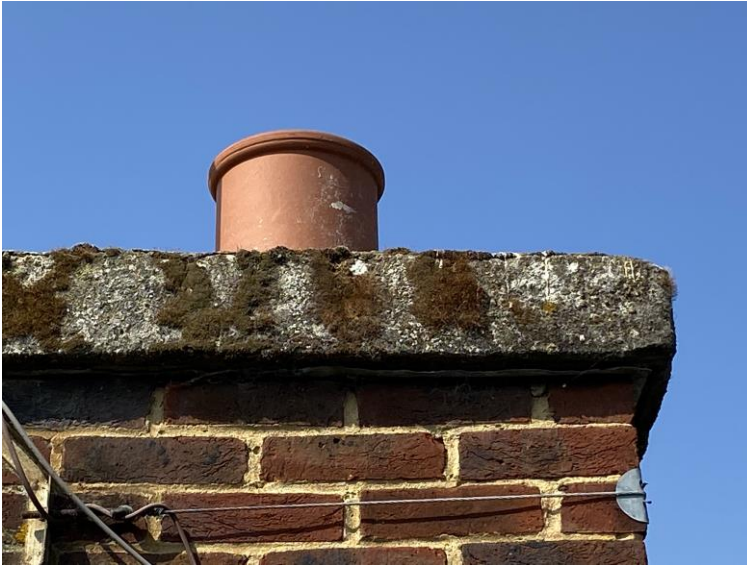
1.

Cracked concrete coping to northwest chimney stack.

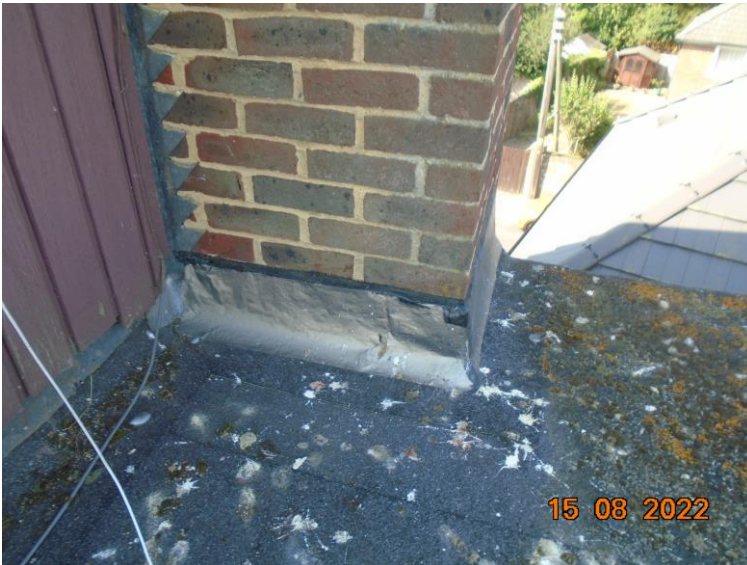
2.

Low quality flashband to northwest chimney stack.

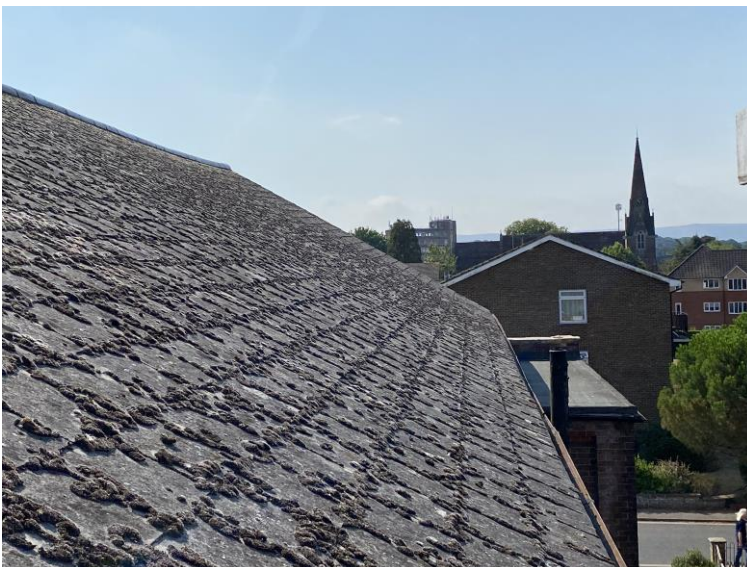
3.

Undulations to west roof pitch.

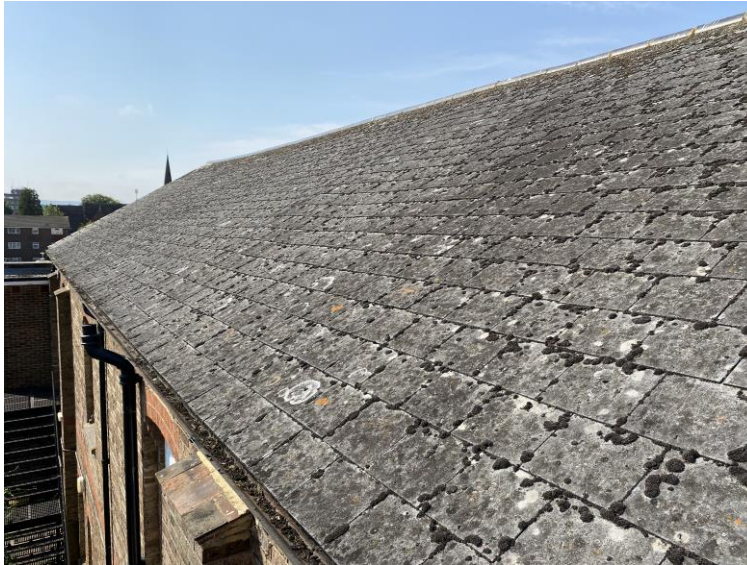
4.

Undulations to east roof pitch.

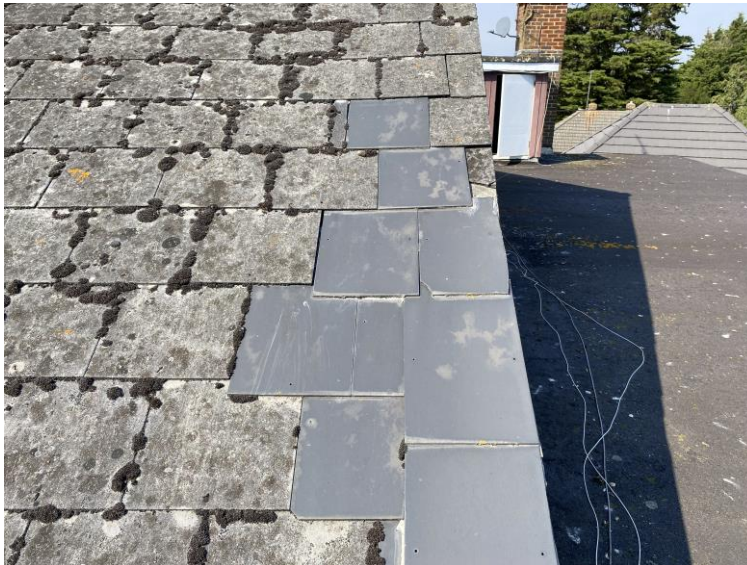
5.

Broken asbestos fibre cement slates, and replacement slates to rear east verge.

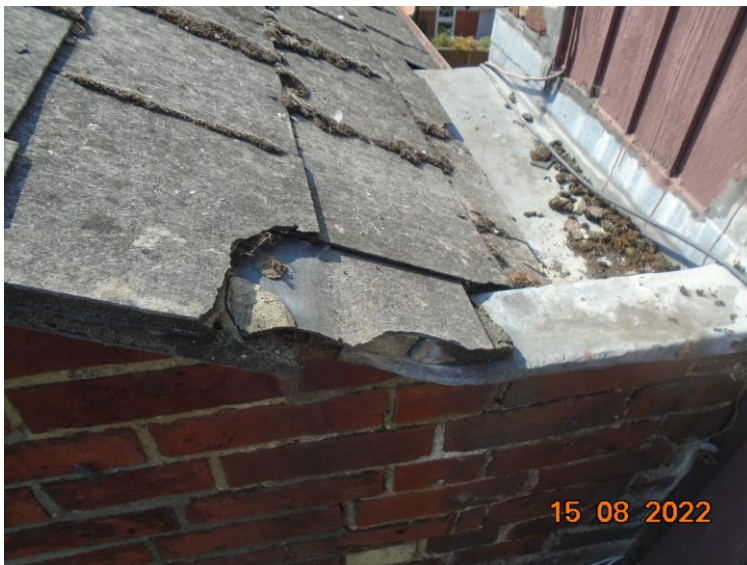
6.

Broken slates to rear west verge.

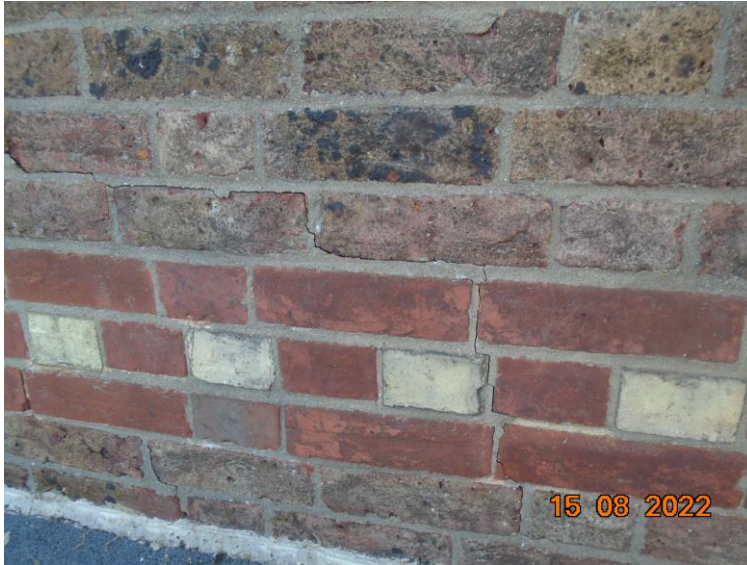
7.

Stepped cracking to rear gable wall.

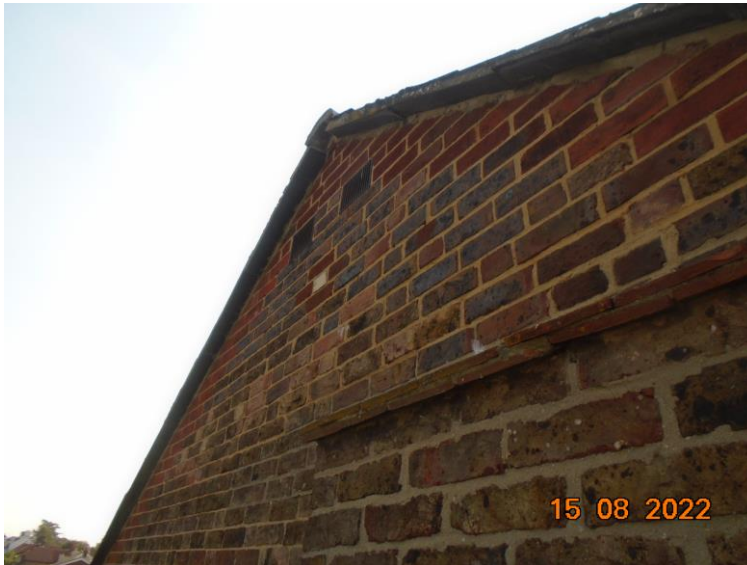
8.

Top section of rear gable wall rebuilt in the past.

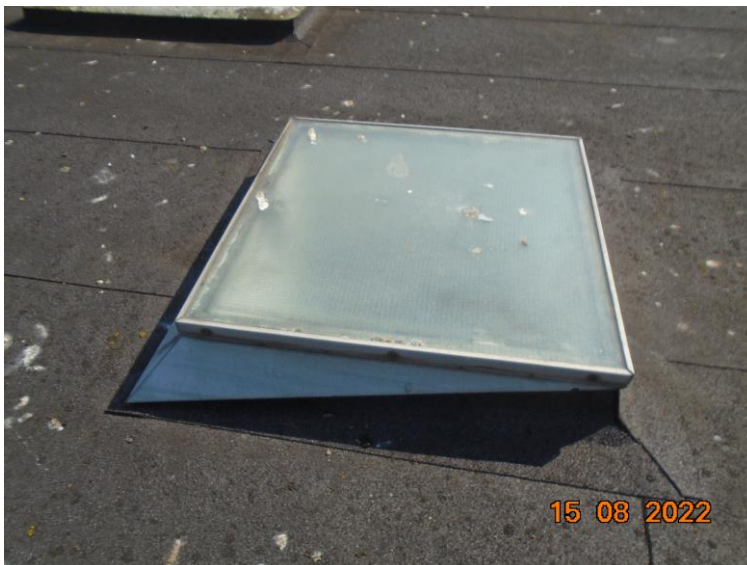
9.

Aged and deteriorated rear extension roof light.

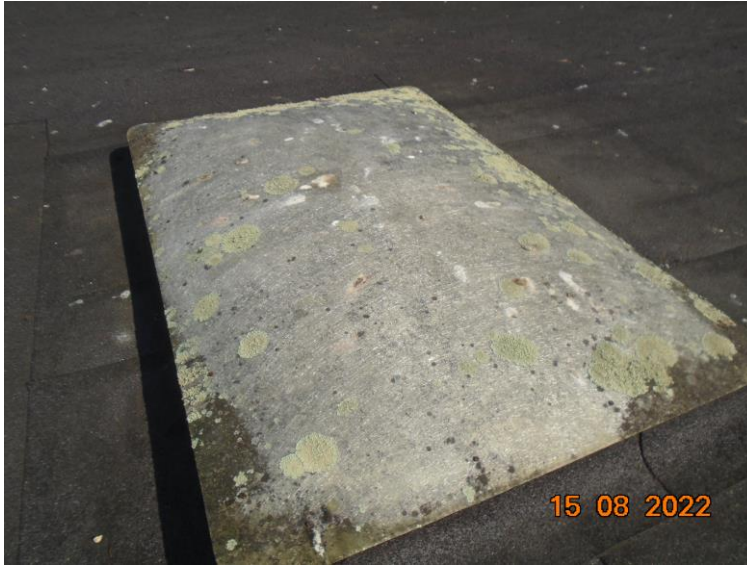
10.

Aged and deteriorated rear extension roof light.

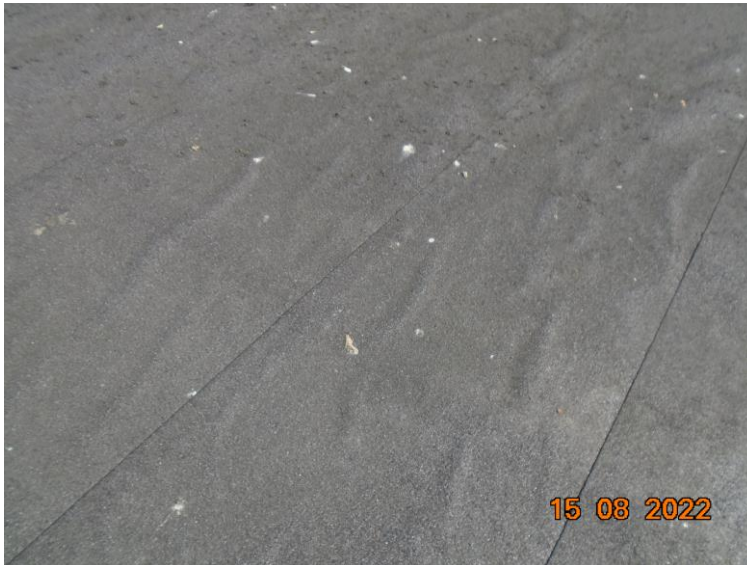
11.

Rippled and blistered felt over rear extension flat roof.

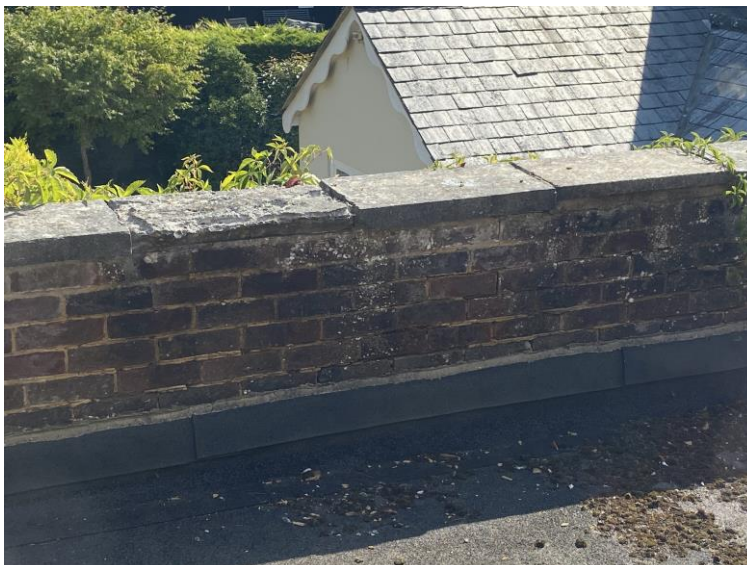
12.

Eroded coping stones and deteriorated masonry to parapet above recreation roof 3.

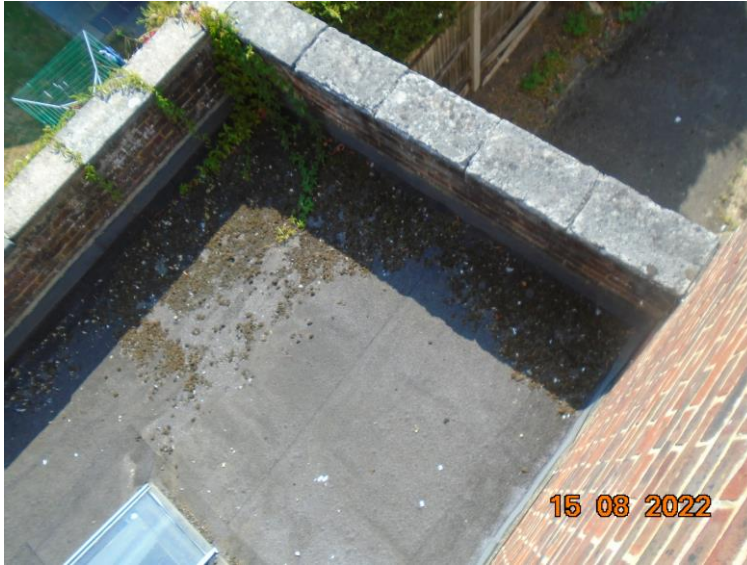
13.

Worn felt and deteriorated parapet walls to recreation room 3 front projection.

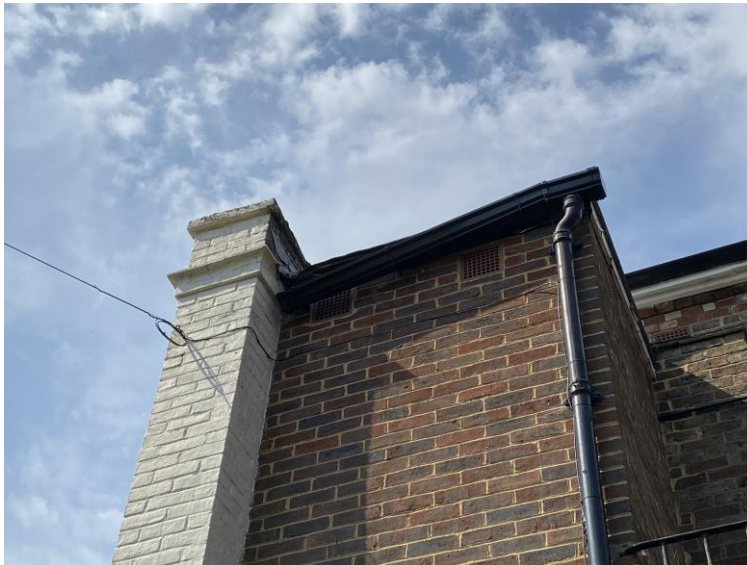
14.

Disconnected gutter from southeast extension roof.

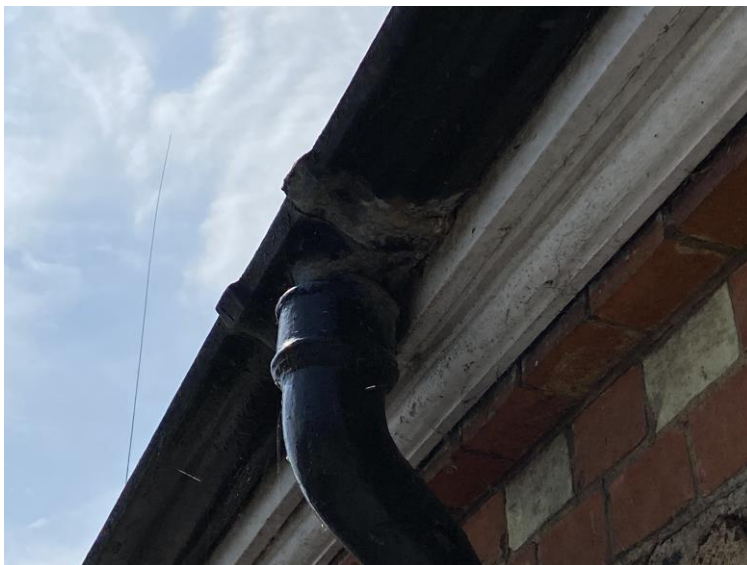
15.

Corrosion to cast-iron gutter joints on original building evidencing leaks.

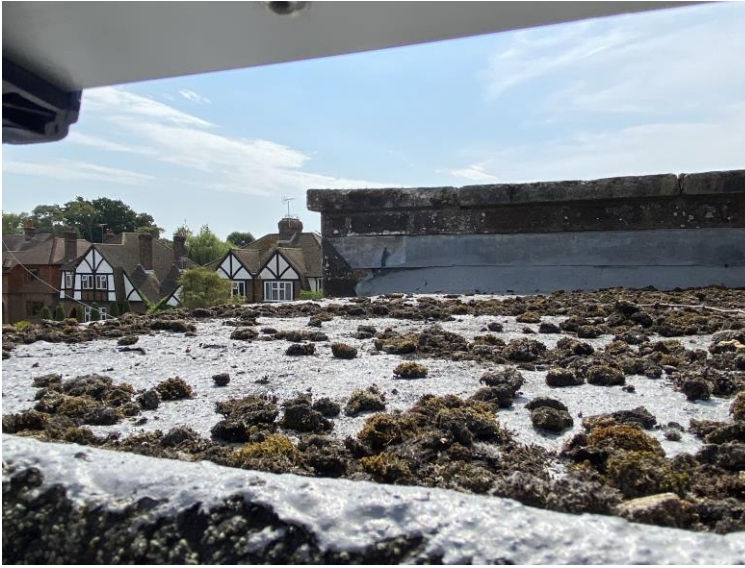
16.

Deteriorated felt flat roof covering and parapet wall to southeast extension.

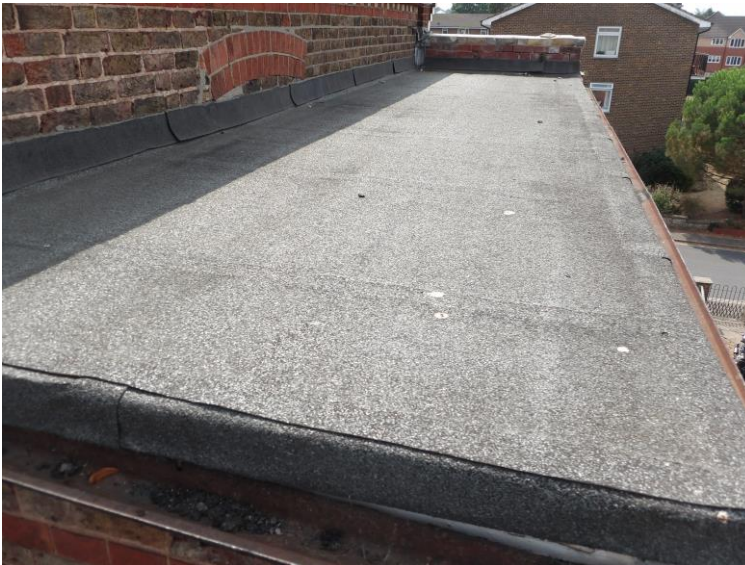
17.

Mineral felt covered flat roof over southwest extension in satisfactory condition.

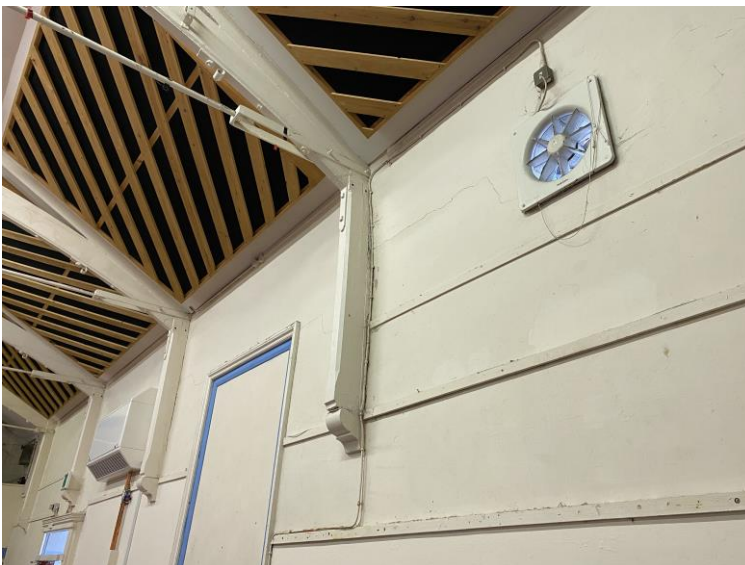
18.

Bulging to west wall of gym.

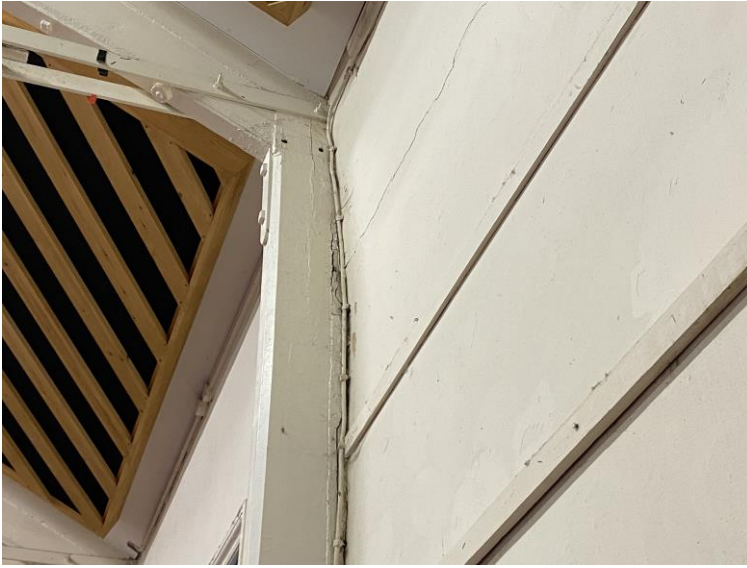
19.

Bulging to west wall of gym.

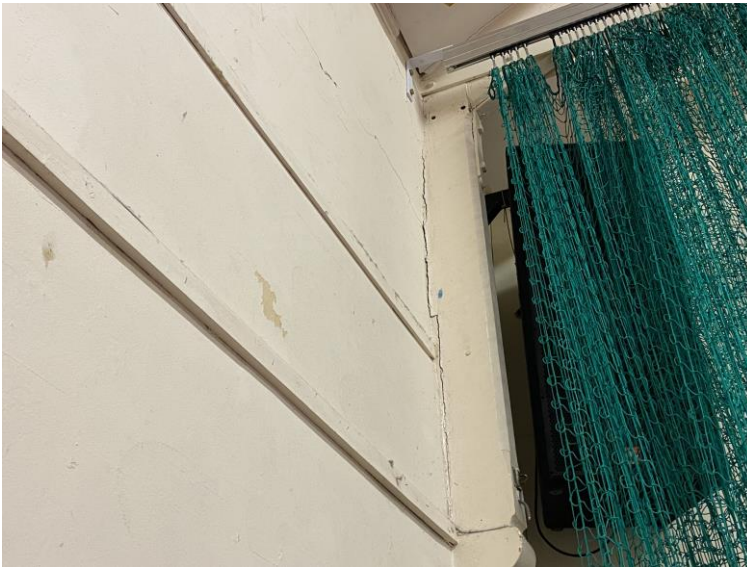
20.

Bulging to west wall of gym.

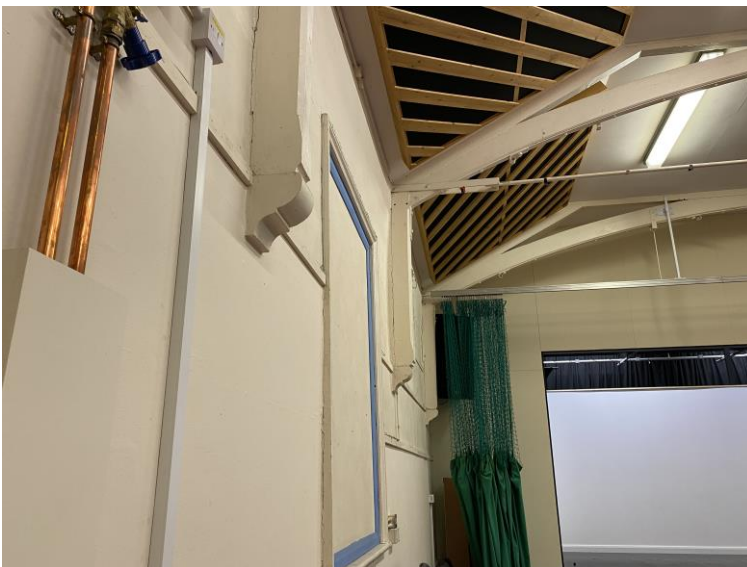
21.

Bulging to west wall of gym.

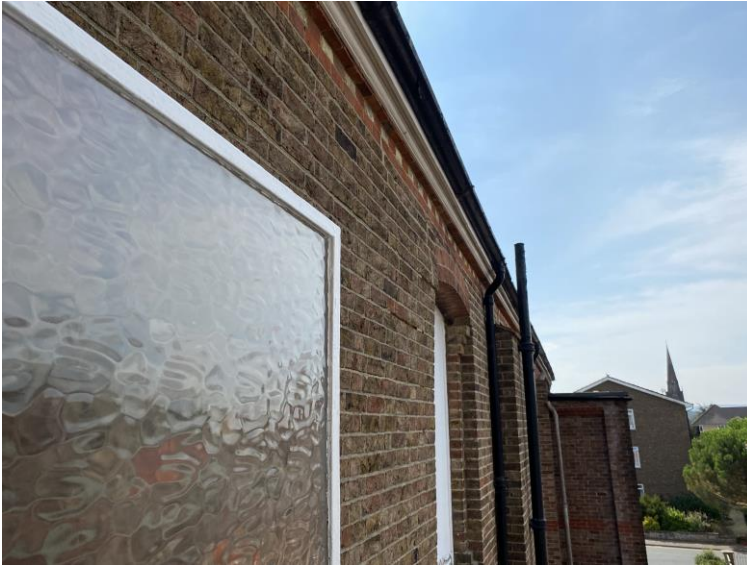
22.

Bulging and cracking to west elevation brickwork.

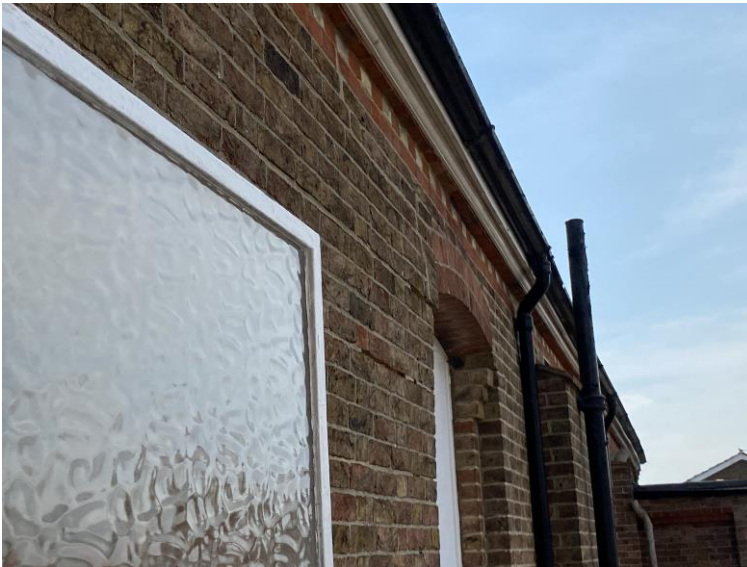
23.

Bulging and cracking to west elevation brickwork.

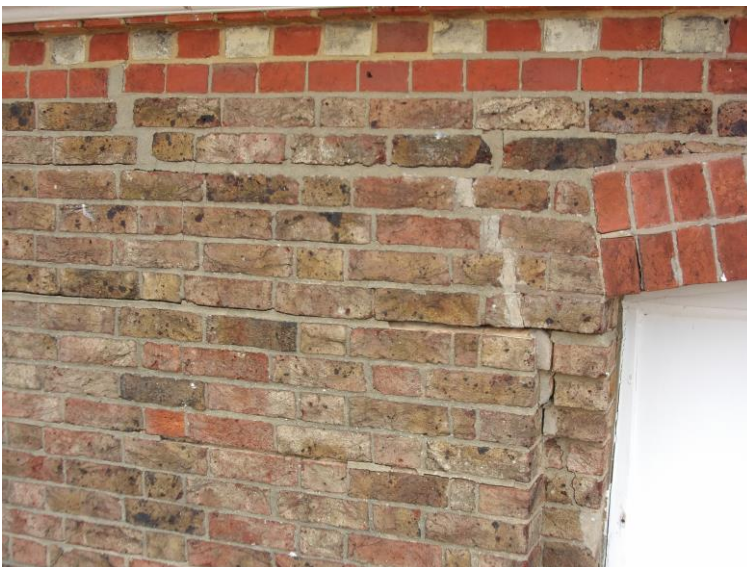
24.

Bulging and cracking to west elevation brickwork

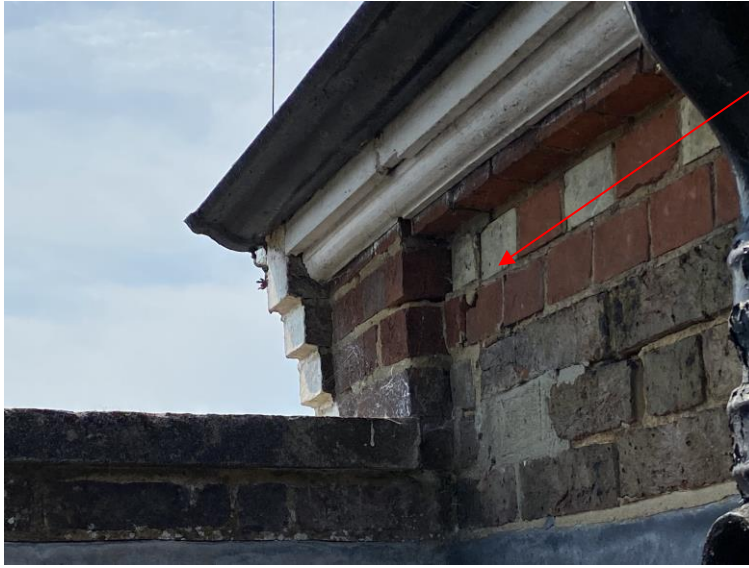
25.

Cracking to southeast corner at high level, and deteriorated brickwork mortar joints.

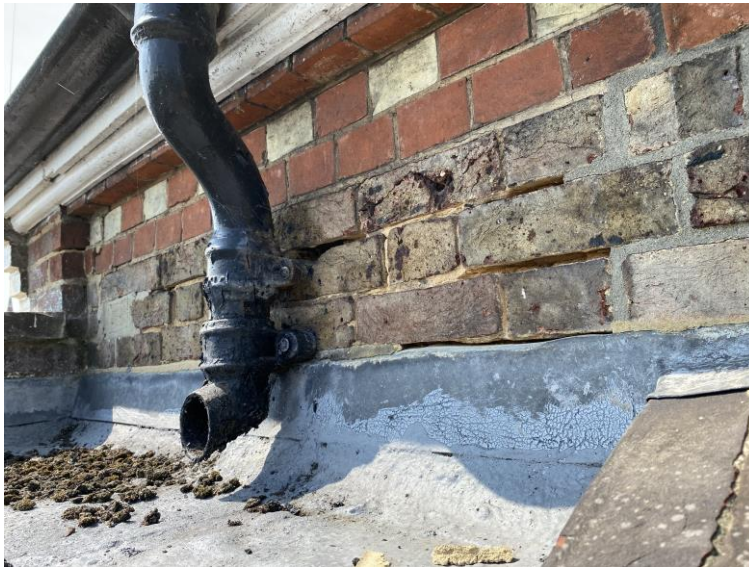
26.

Deteriorated brickwork mortar joints above southeast extension flat roof.

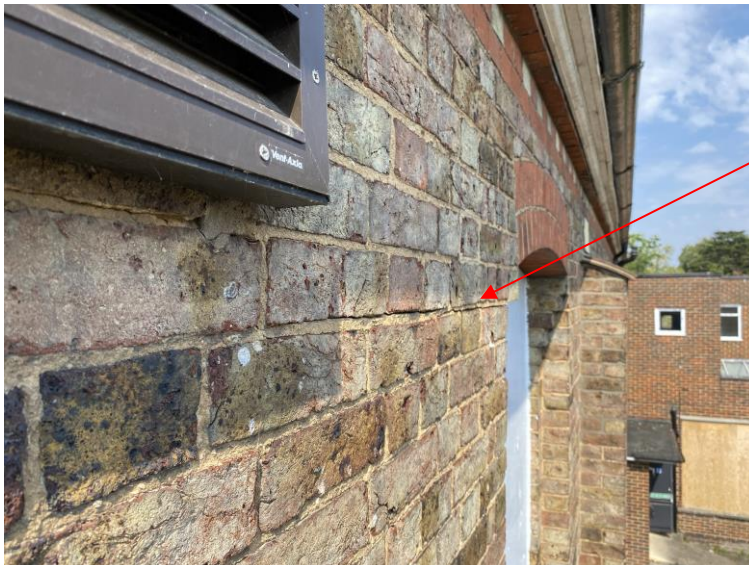
27.

Cracking through the mortar joints and displacement of the brickwork on the north side of the east elevation first floor fire escape door.

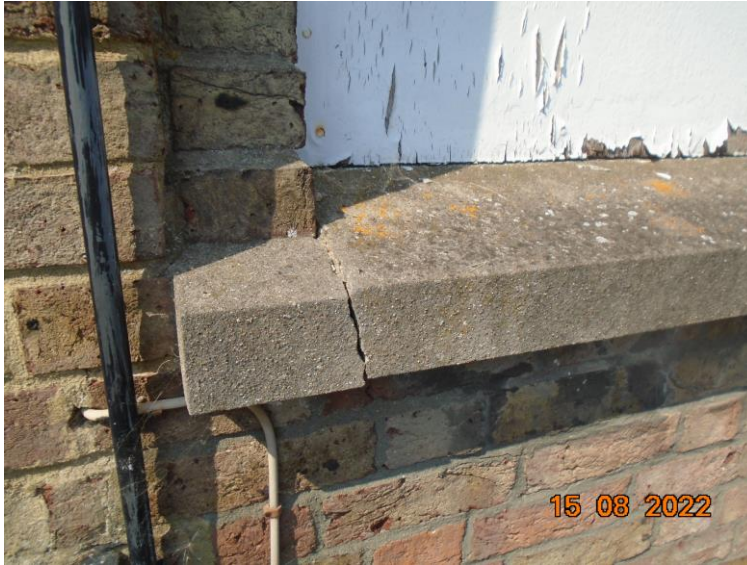
28.

Cracked concrete subsill adjacent to first floor east fire escape door.

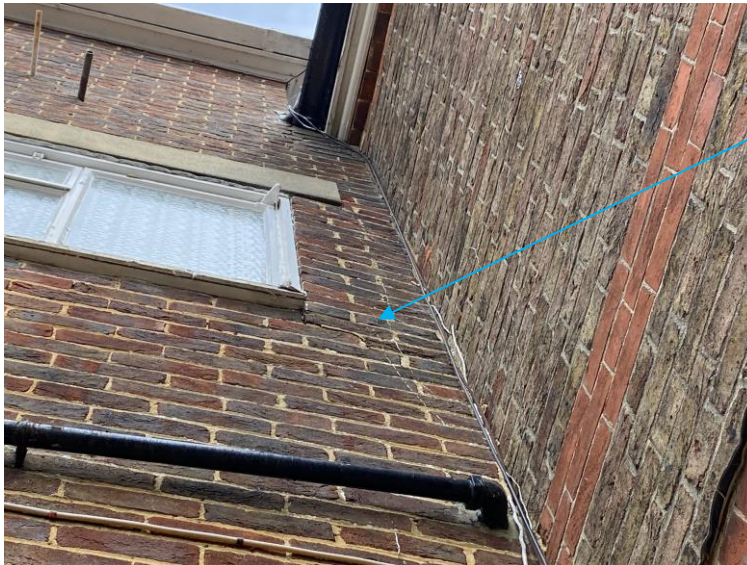
29.

Stepped cracking and displacement of the brickwork adjacent to the first floor female WCs.

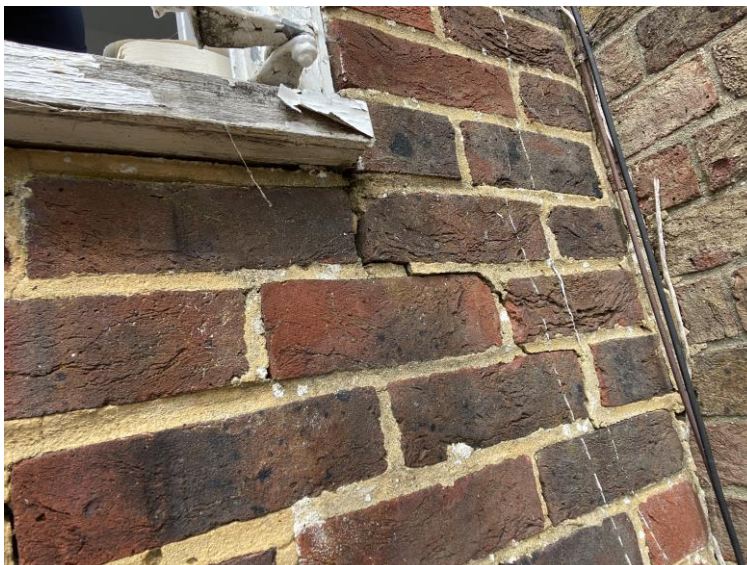
30.

Stepped cracking and displacement of the brickwork adjacent to the first floor female WCs.

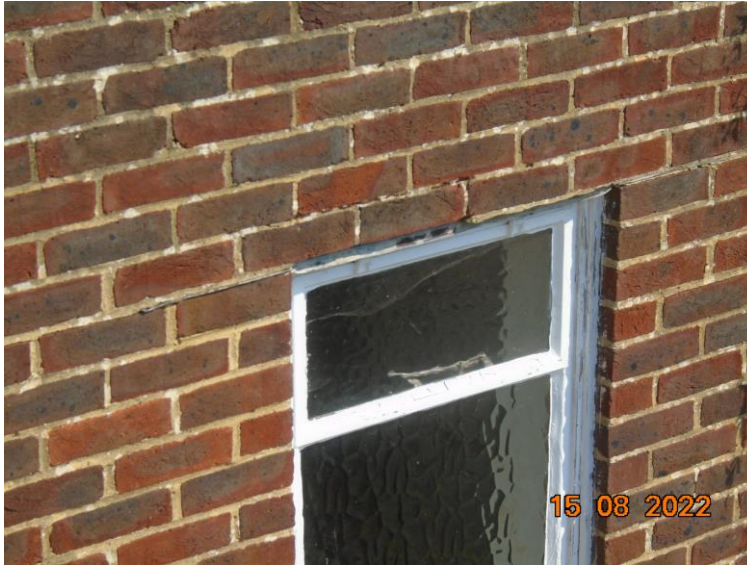
31.

Presumed lintel failure above art room store windows.

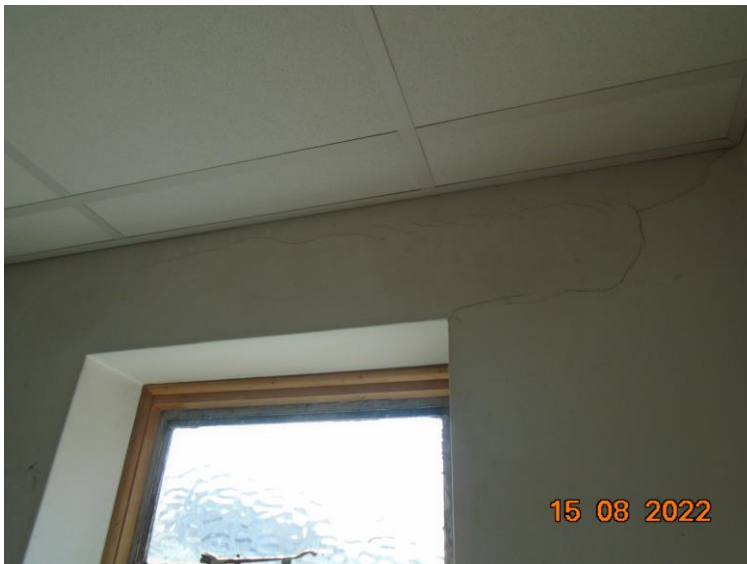
32.

Internal cracking above art room store windows – sign of lintel failure.

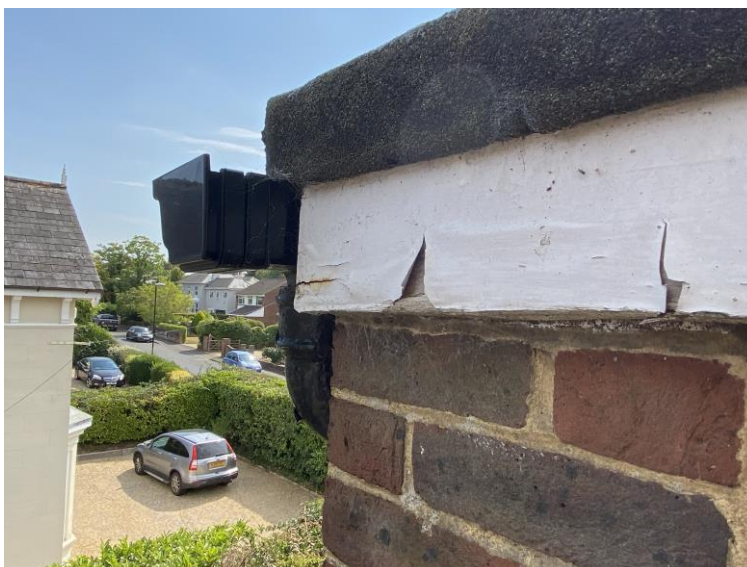
33.

Peeling paint to southeast extension timber fascia boards.

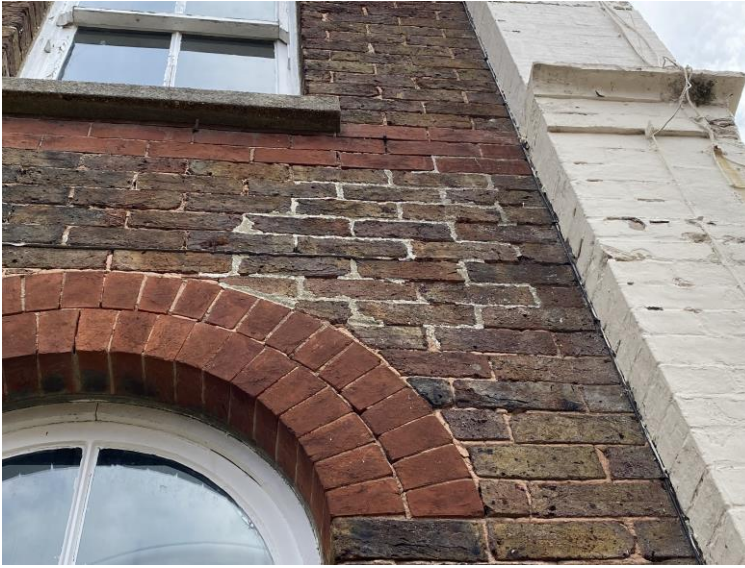
34.

Perished mortar joints to southwest extension brickwork.

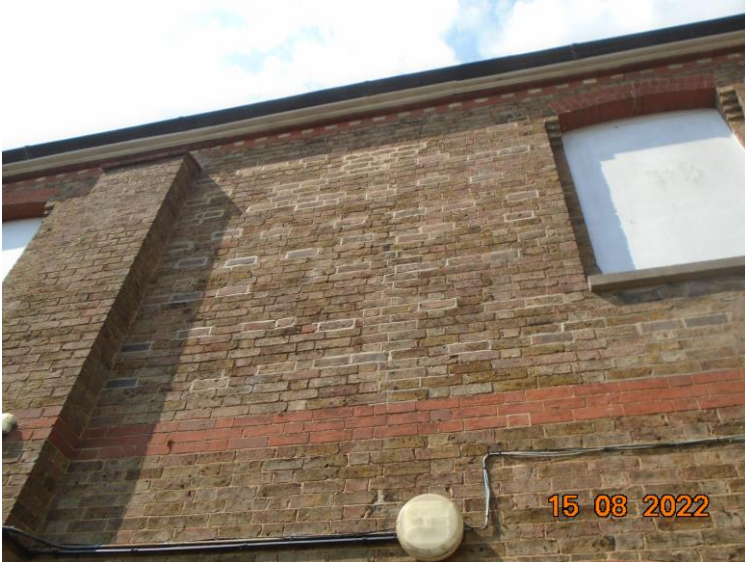
35.

Deteriorated mortar joints to east elevation.

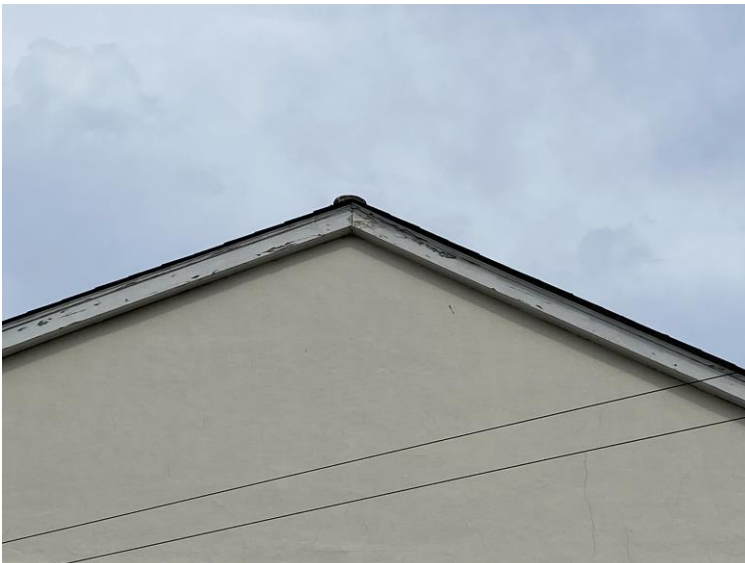
36.

Deteriorated paint to front elevation timber barge boards.

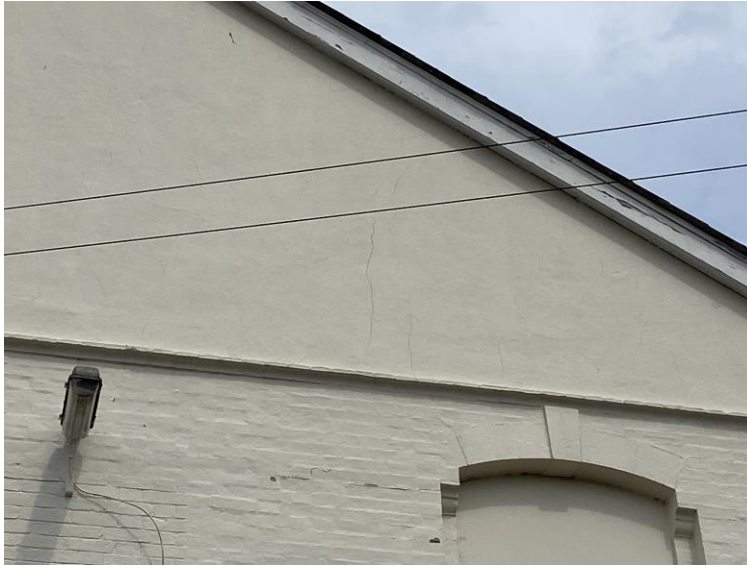
37.

Cracking to front gable end render.

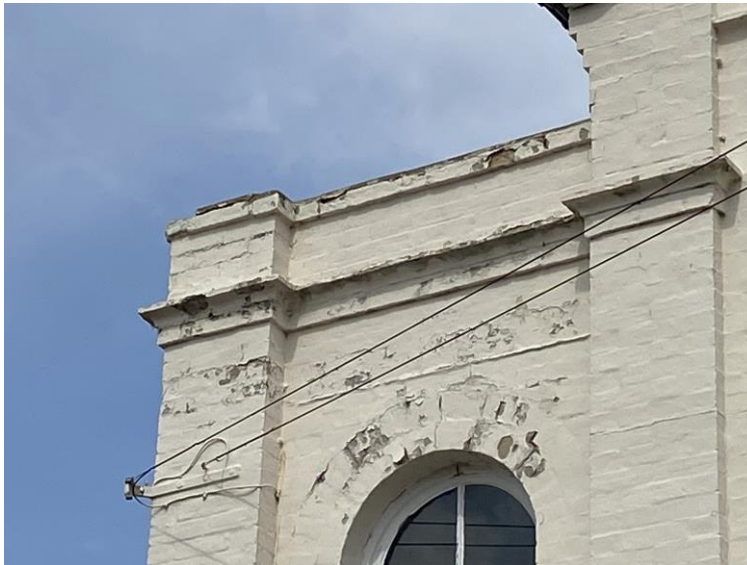
38.

Peeling paint from front elevation, eroded copings to parapet, and cornice.

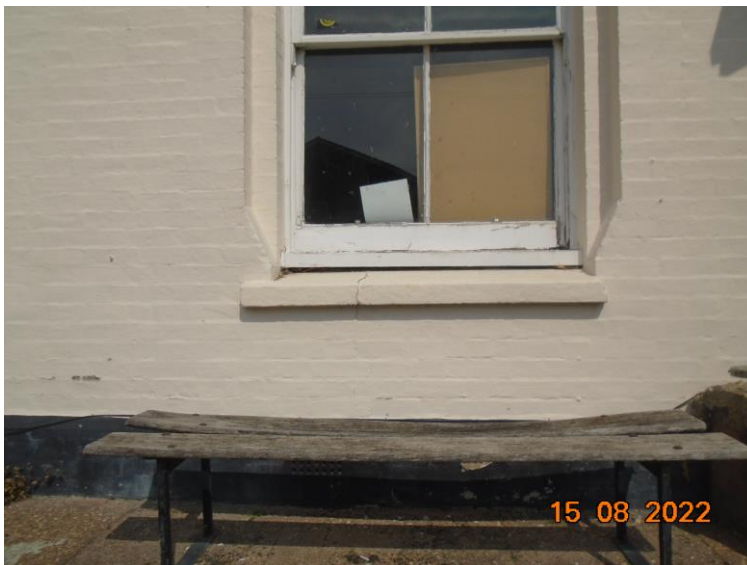
39.

Cracked concrete subsill to front elevation (stairwell).

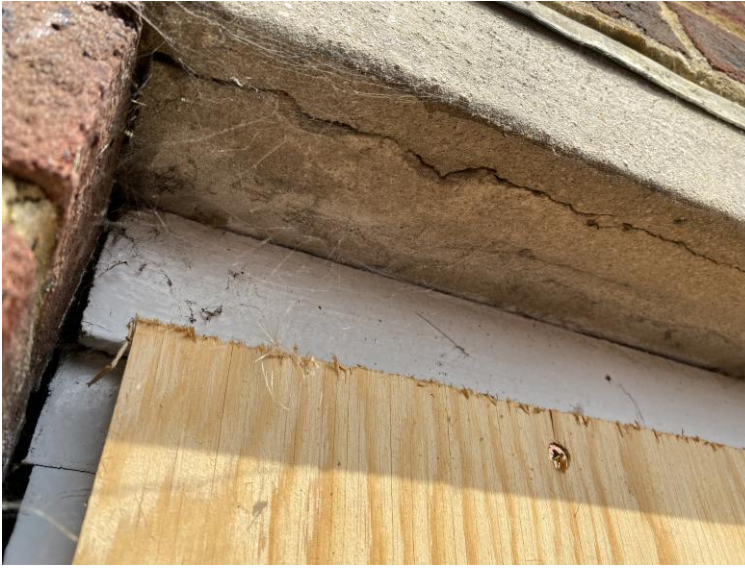
40.

Cracked concrete lintel above recreation room 3 front window.

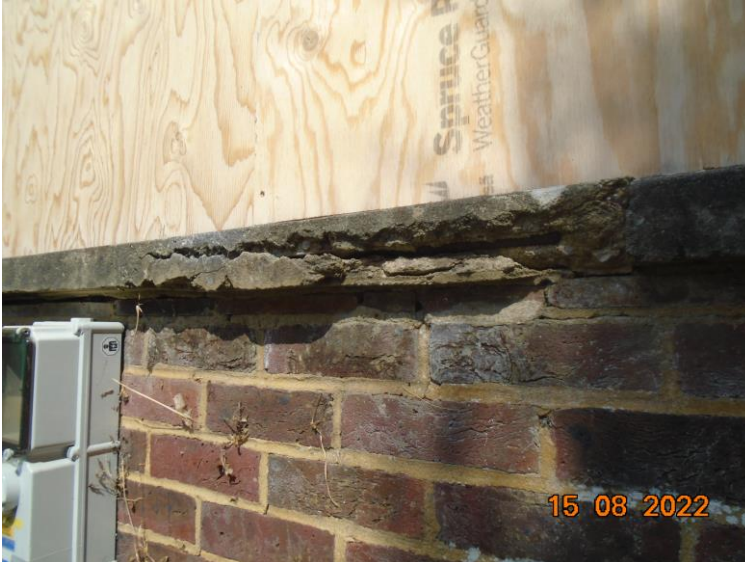
41.

Cracked and spalled concrete subsill below recreation room 3 window.

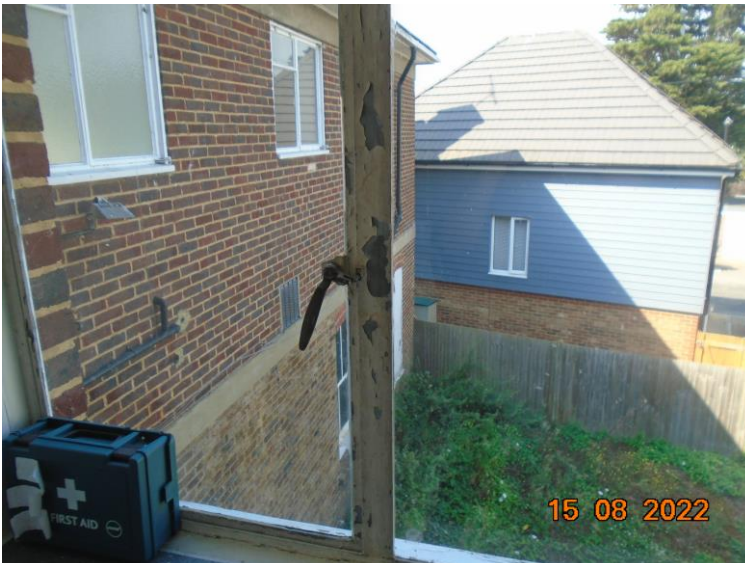
42.

Deteriorated paint to steel crittall windows.

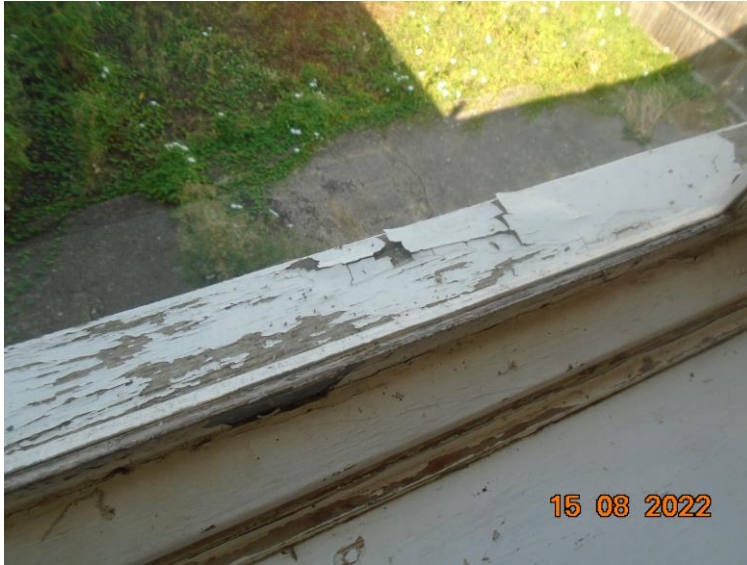
43.

Deteriorated timber subframe to steel
crittall windows.

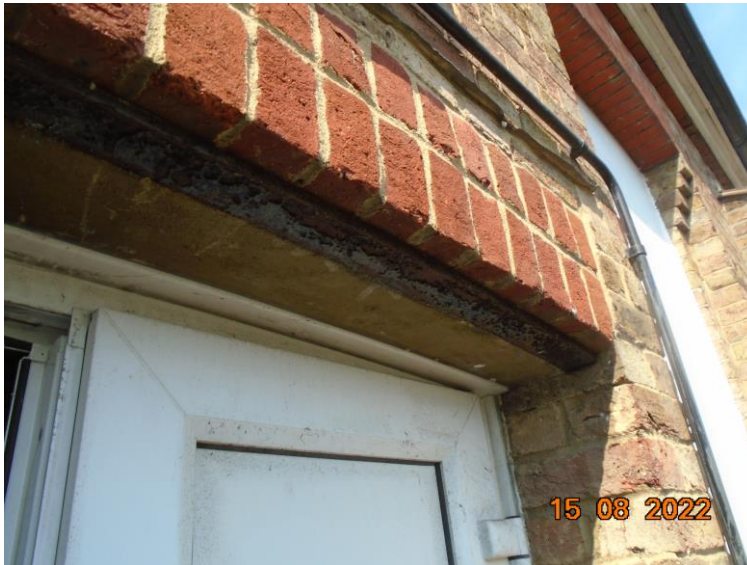
44.

Corrosion to steel lintel above east
elevation fire escape door.

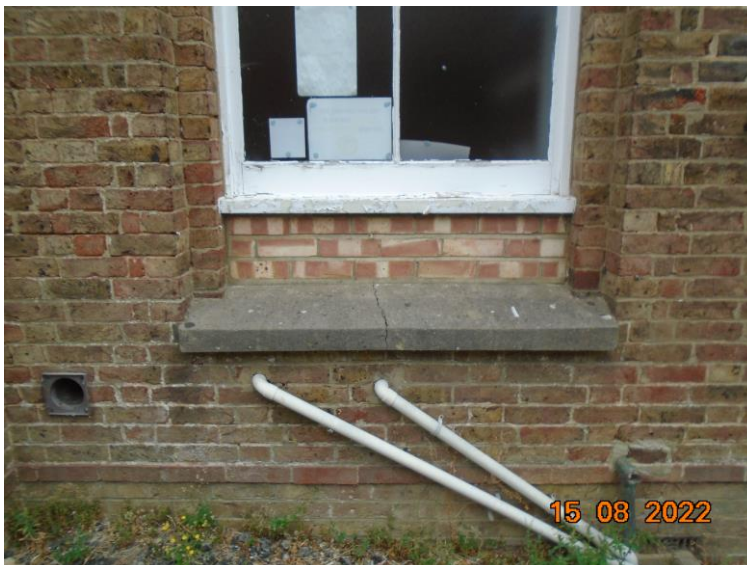
45.

Cracked concrete subsill to west
elevation.

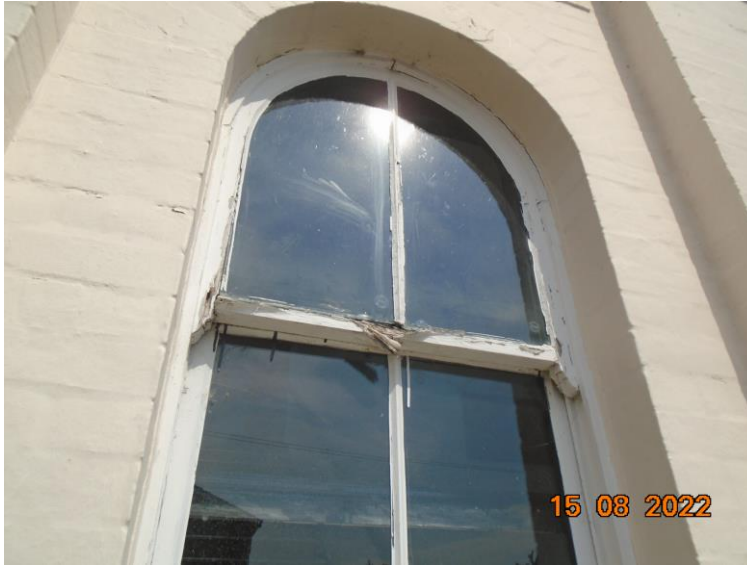
46.

Rotten timber to sash windows (front).

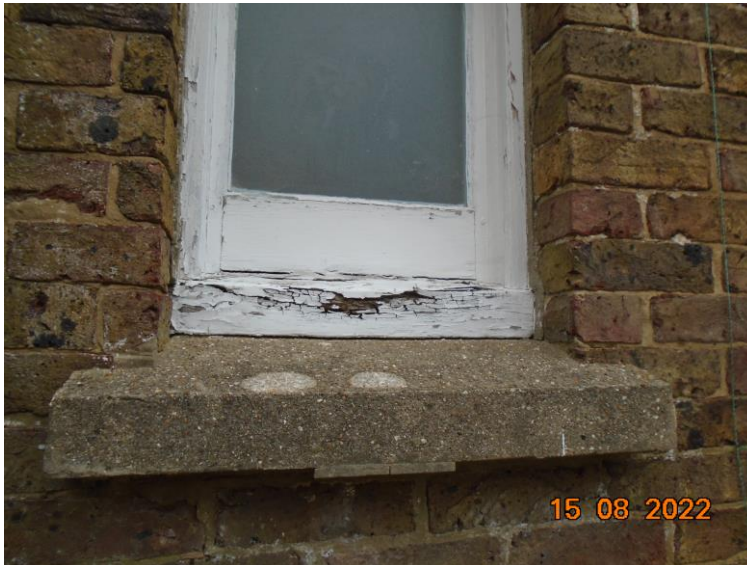
47.

Rotten timber to west elevation windows.

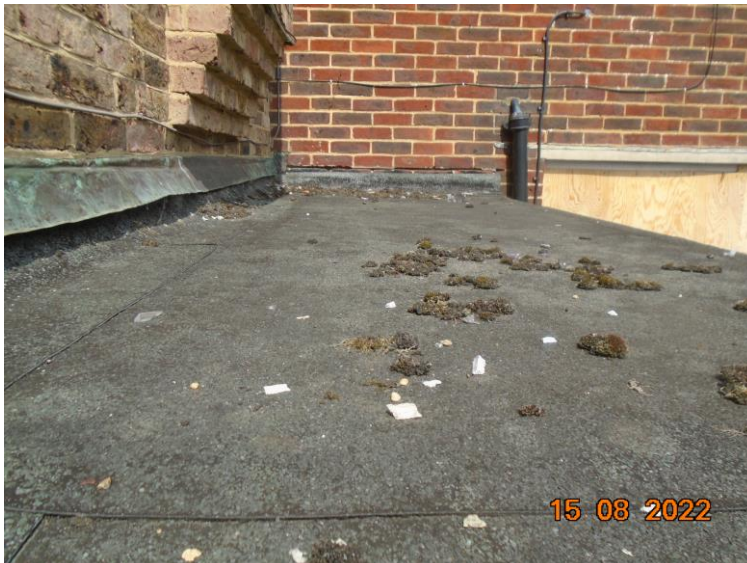
48.

Worn felt flat roof covering and missing flashings to east elevation canopy.

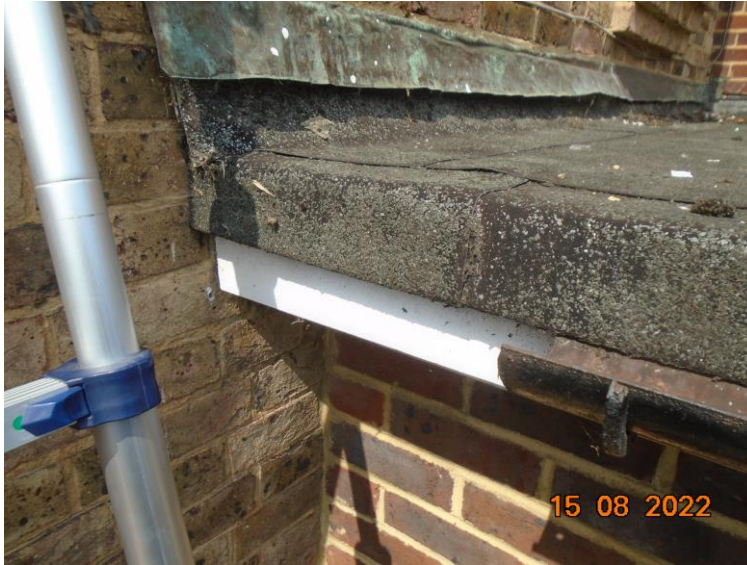
49.

Missing section of gutter to east elevation canopy.

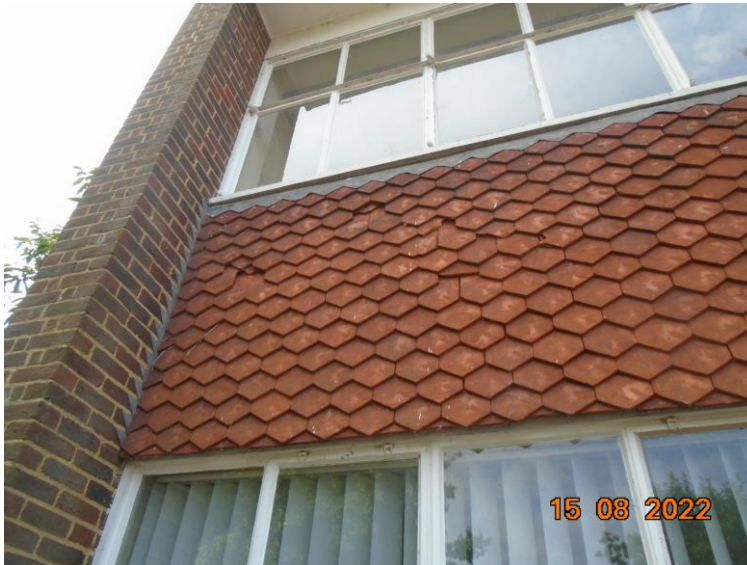
50.

Slipped and broken tiles to rear clay tile hung cladding.

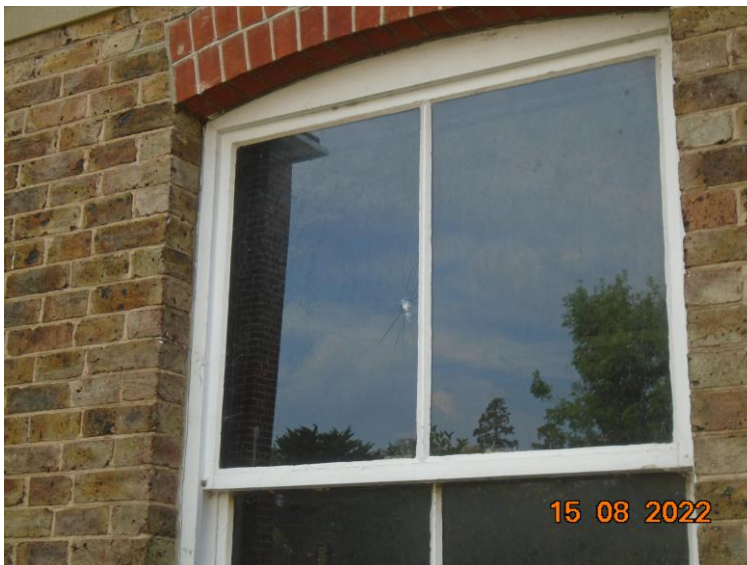
51.

Broken glazing to rear window of recreation room 2.

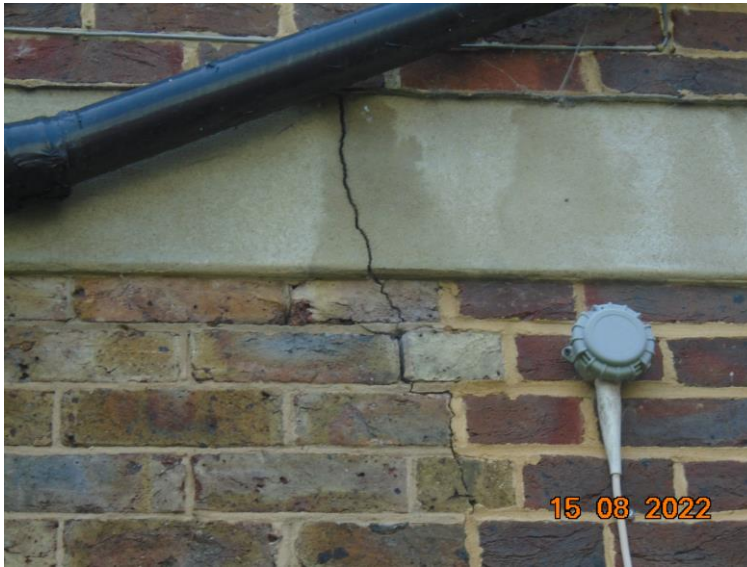
52.

Cracking to rear concrete band and masonry.

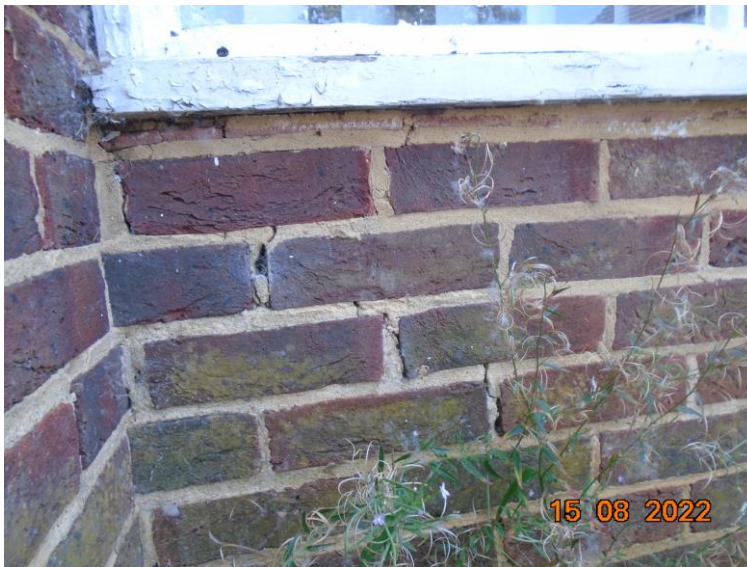
53.

Stepped cracking to rear wall of recreation room 3.
