BUILDING INSPECTION REPORT

BURGESS HILL PARK CENTRE

60 PARK ROAD

AUGUST 2022

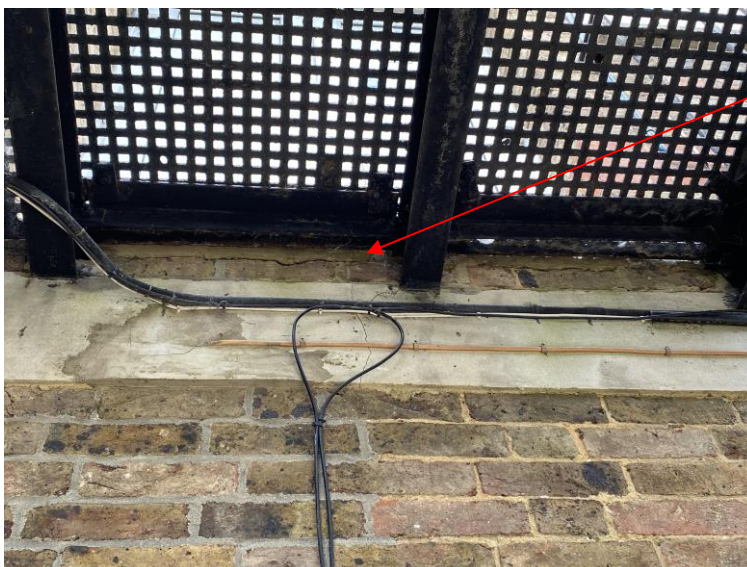
54.

Corroded metal fire escape staircase and cracked concrete and masonry.

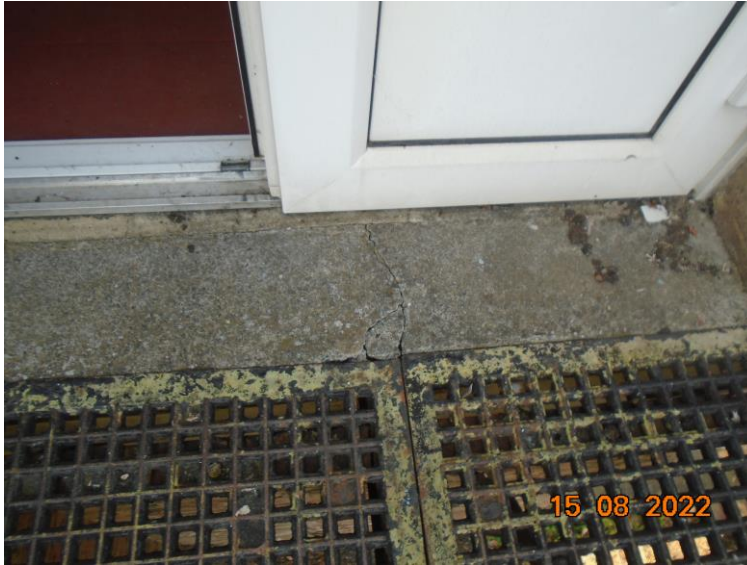
55.

Cracked concrete adjacent to metal fire escape staircase.

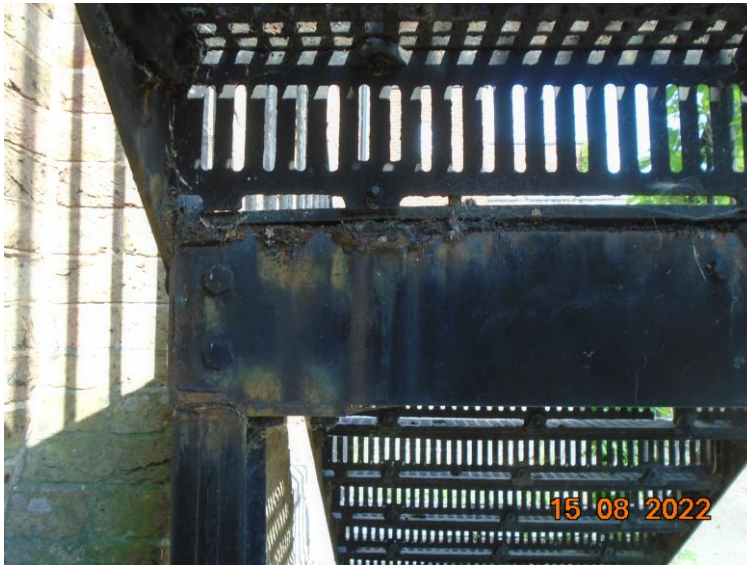
56.

Corroded metal fire escape staircase.

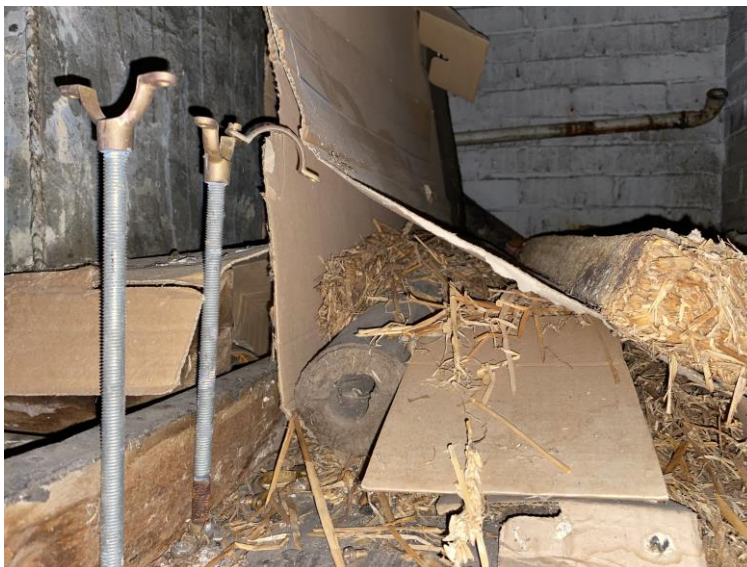
57.

Possible brown asbestos pipe insulation to roof plant room.

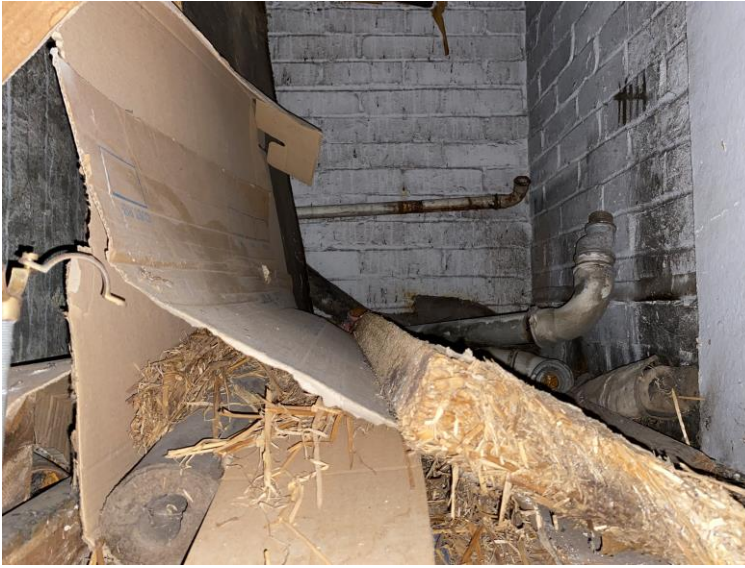
58.

Possible brown asbestos pipe insulation to roof plant room.

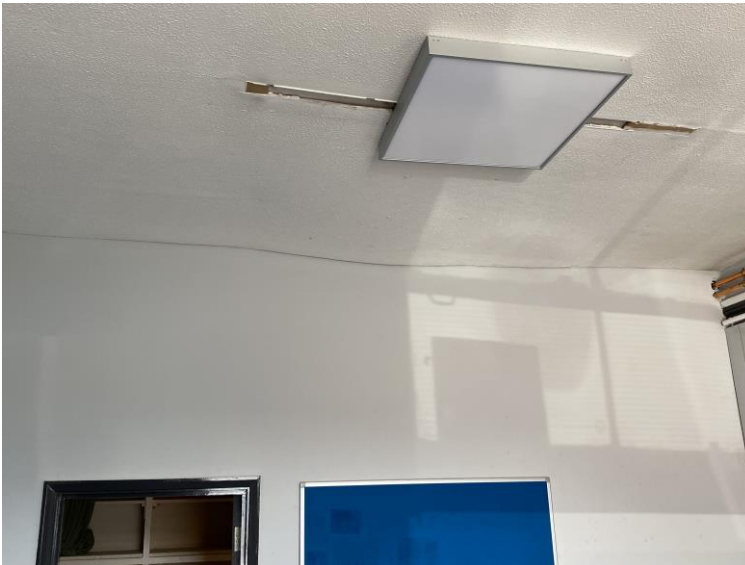
59.

Bowing ceiling to office 1.

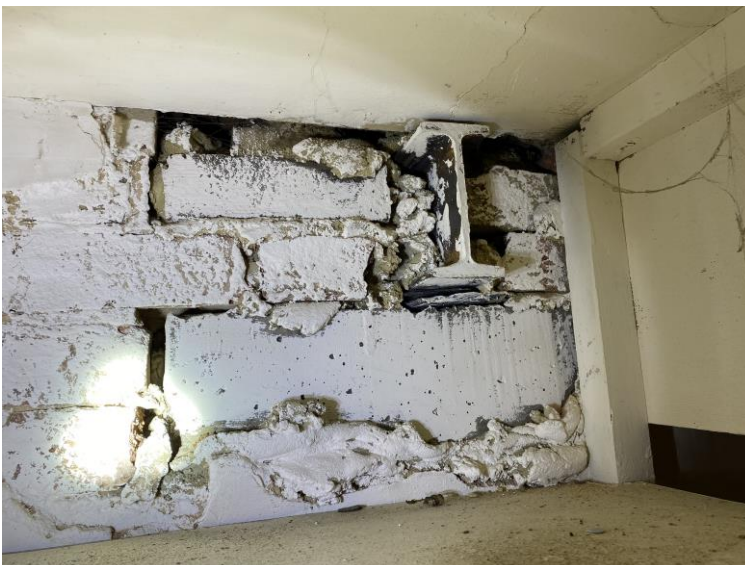
60.

Displaced brickwork and pad stone surrounding and below steel.

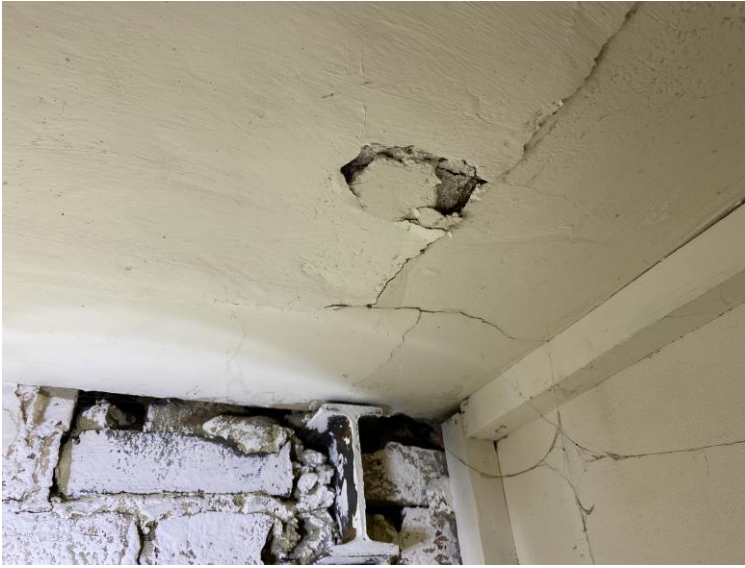
61.

Cracked and bowing ceiling to office 2.

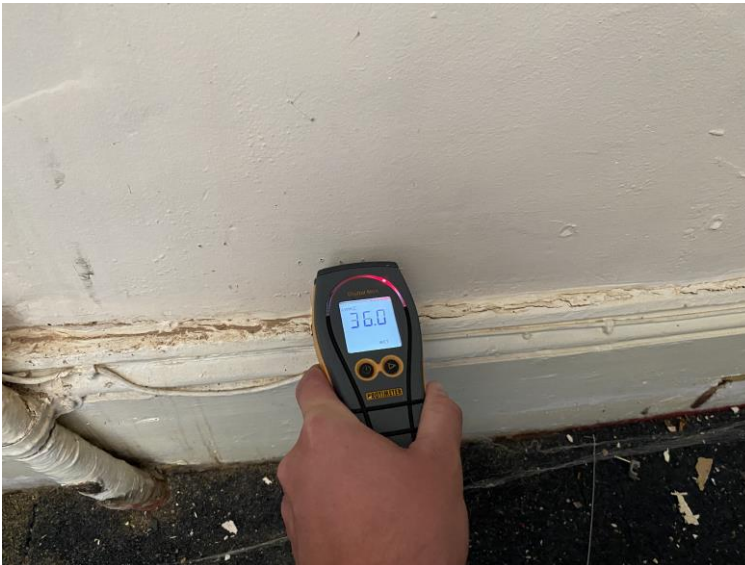
62.

Rising damp to front wall of office 1.

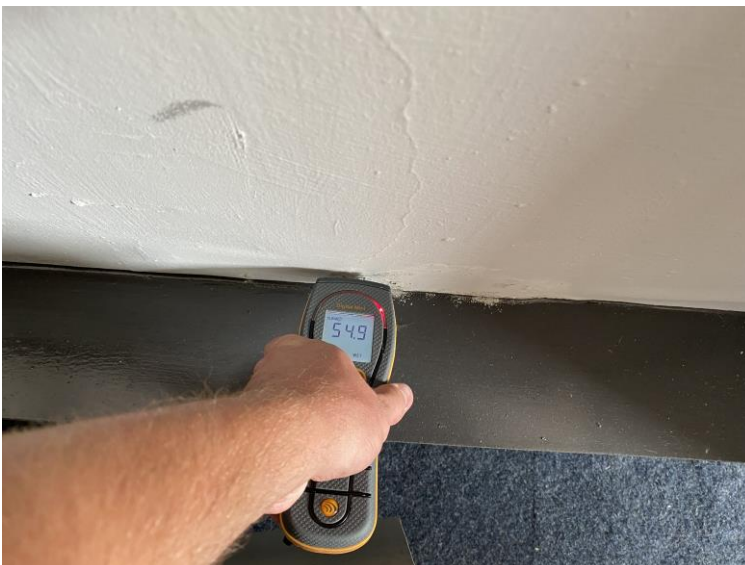
63.

Rising damp to east wall of office 1.

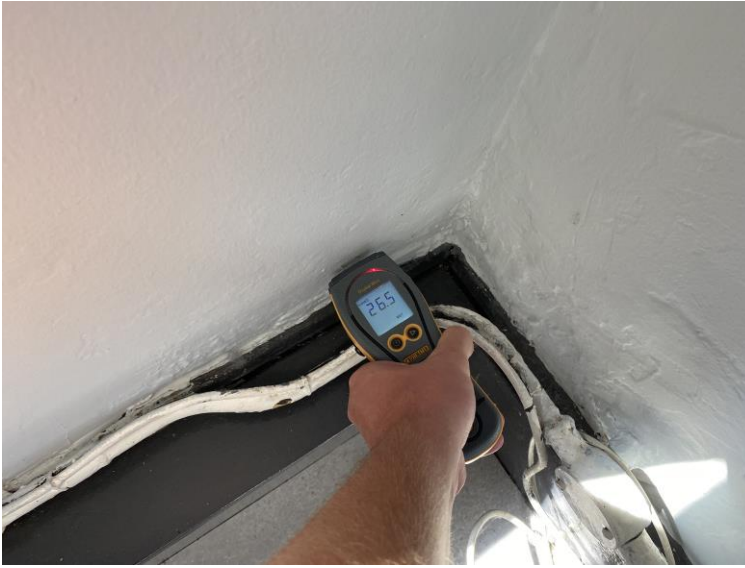
64.

Rising damp to northwest corner of recreation room 1.

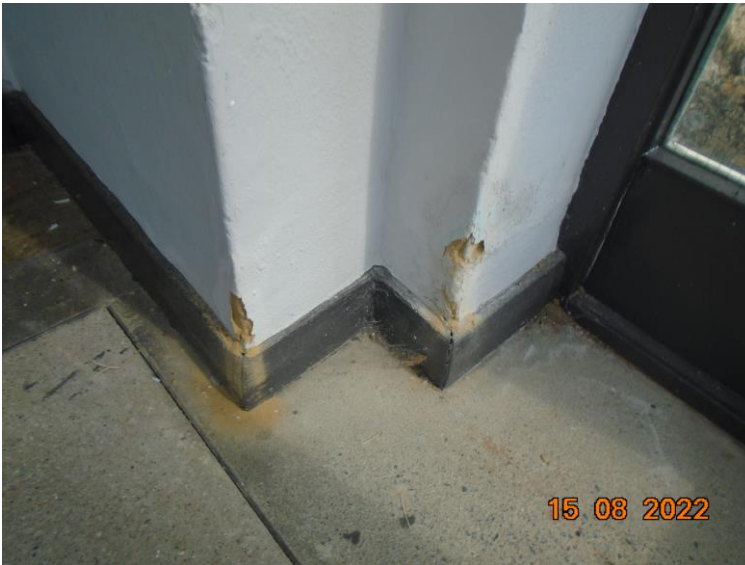
65.

Rising damp to entrance porch walls.

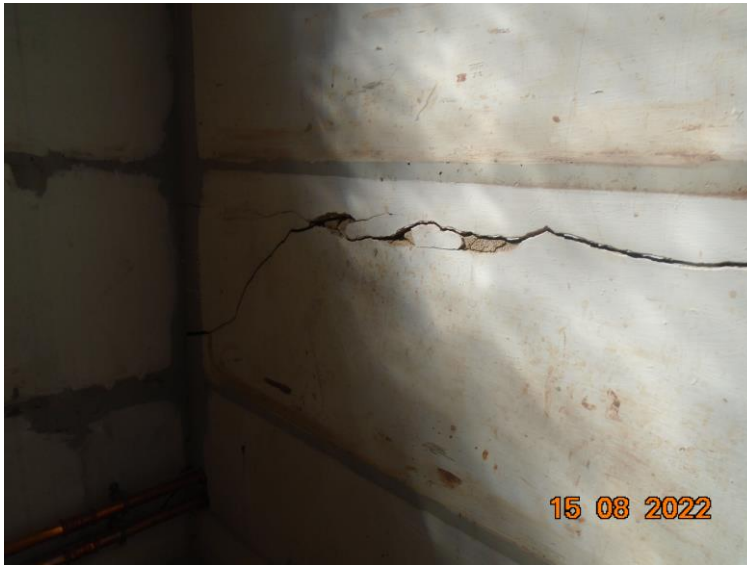
67.

Structural cracking to partition wall between art room stores.

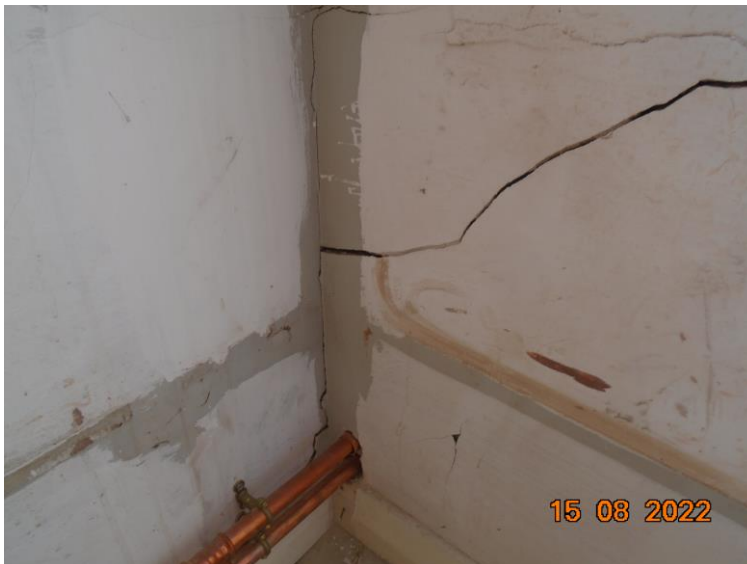
68.

Structural cracking to partition wall between art room stores.

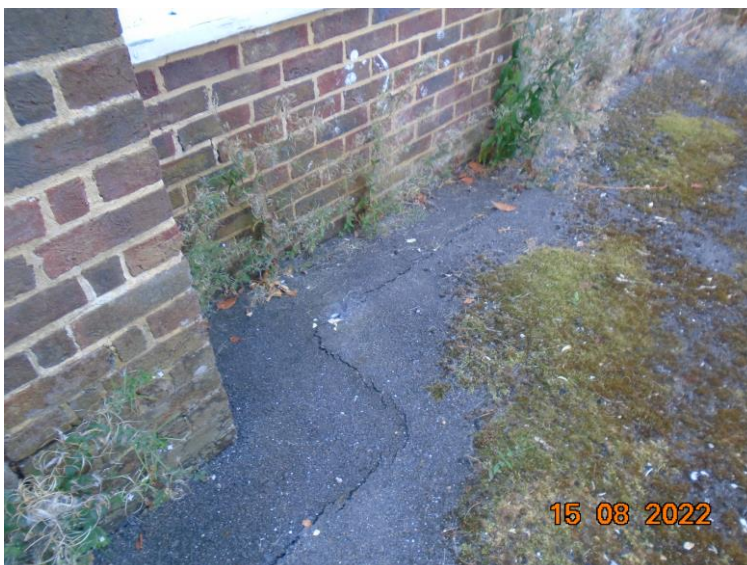
69.

Sunken tarmacadam to rear.
