ICENI CONSULTING SURVEY REPORT

Client:	Burgess Hill Town Council
Site:	Place & Connectivity Programme Phase 1, Burgess Hill
S38/S278/UU/LHA/Private/	Local Highway Authority
Highway Authority	West Sussex County Council
Date/Time	05/06/2023
Iceni Representative:	Robert Lee

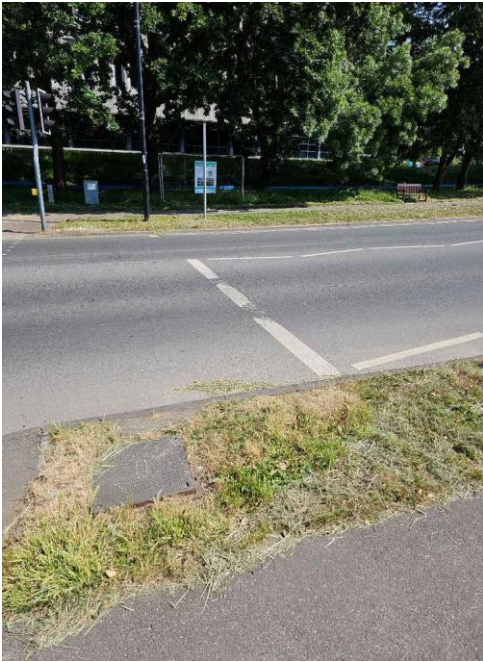
Area – 4b

Location	Carriageway & Crossing Point.
Description	Width 4.1m, Length 10.1m. Road surface looks to be 14mm SMA. Looking polished. Very little macro texture. White lining complies, little worn. Is it planned for Puffin to be upgraded to Toucan? As it should be as crossing point is connected to Shared use foot/cycleway.
Multi Photo

<p>Lat: 50.954261 Long: -0.134335</p>
Notes:	Drainage 30 to 33m between gullies either side of crossing point. No apparent issue.

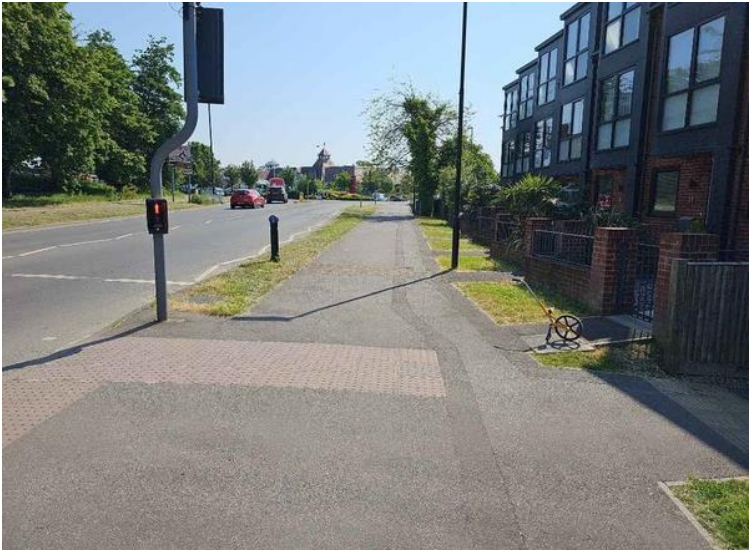
Area – 4c

Location	Southeastern side of QEW
Description	3.2m shared Foot/Cycleway. 1m verge & 1.3m verge (properties). Unnecessary corduroy slabs if to become Toucan. Cyclist to Dismount?
Multi Photo

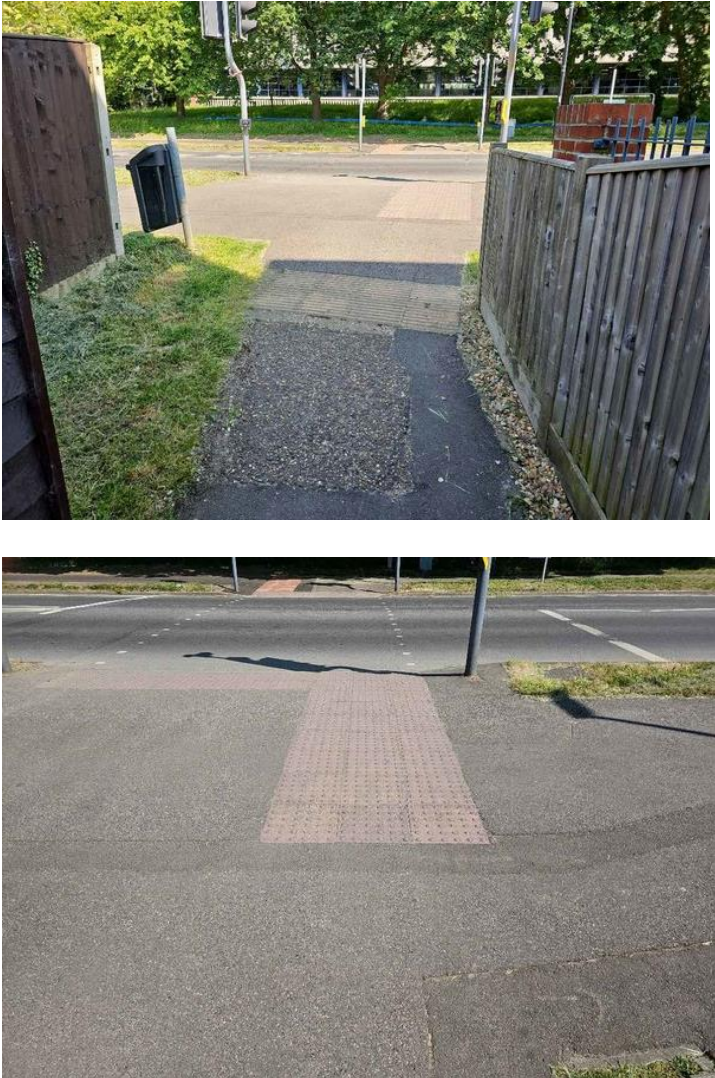
Area – 4e

Location	Footpath link into crossing point.
Description	No signing for entering shared space.
Multi Photo

<p>Lat: 50.954194 Long: -0.134339</p>
Notes:	Red Tactiles should extend to back of footway, currently 3.6m.

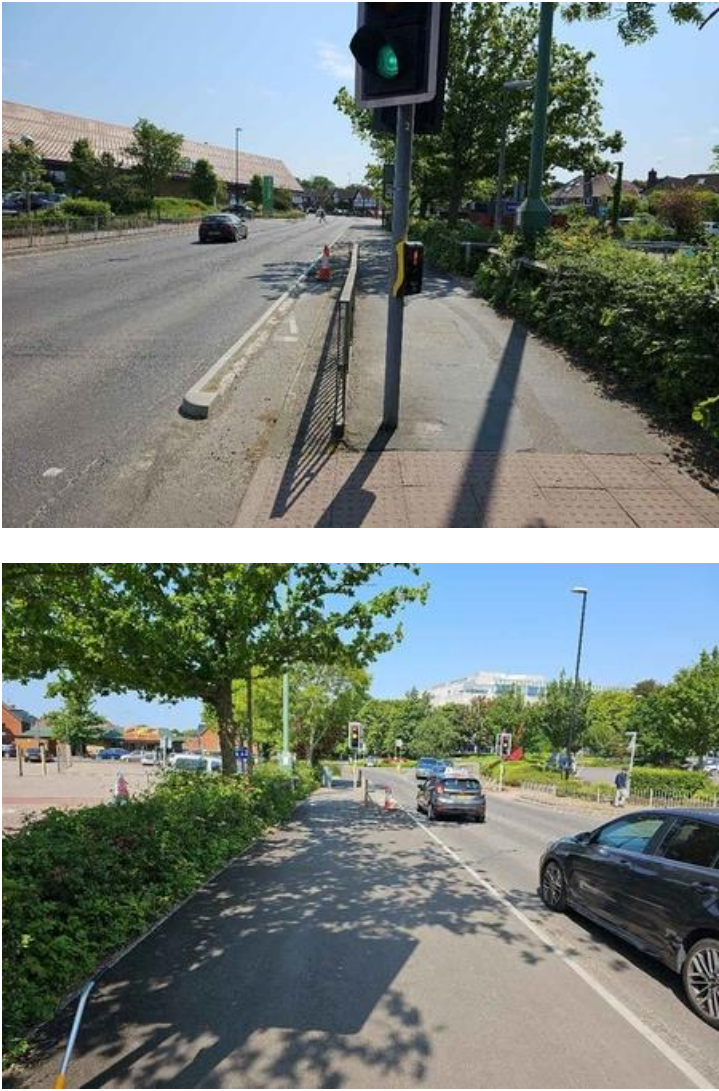
Area - 5a

Location	Station Road approach to RAB
Description	Road width 6.6m and foot/Cycleway width 3.8m. Road surface on approach to crossing in poor condition. Apparent reflective cracking from base course/subbase layers.
Multi Photo

<p>Lat: 50.954332 Long: -0.133564</p>
Notes:	<p>Unfinished Kerb works in channel. Not ideal. Drainage appears to be adequate in this area. Crossfield carriageway. 5 gullies with 11m to 8m spacing.</p>

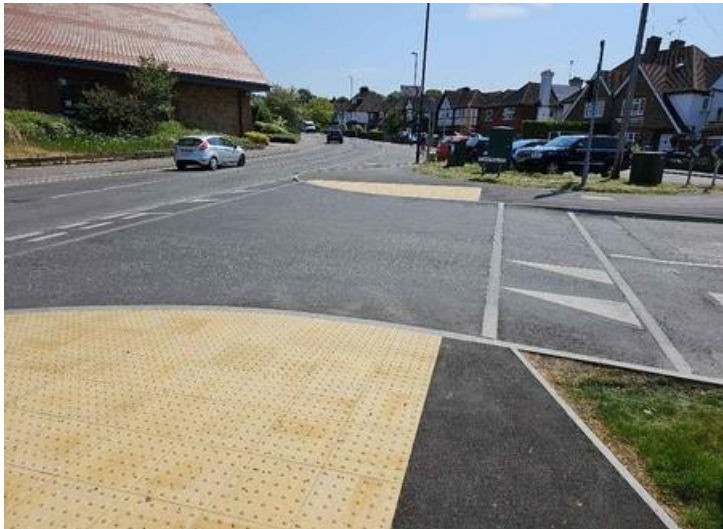
Area – 6a

Defect Location	Carriageway
Defect Description	Road width 8.3m. Ramp length 1.6m over 100 to 0mm kerb face. Seems OK.
Multi Photo

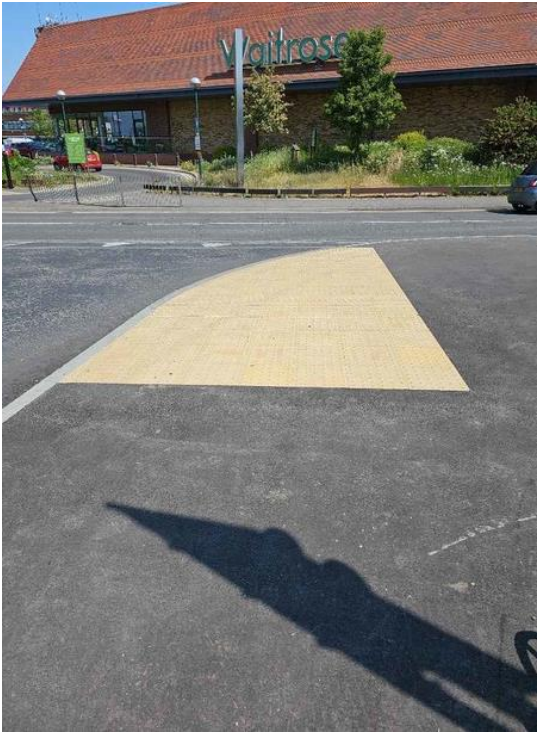
Area – 6c

Defect Location	Footways.
Defect Description	3.8m on shared approaches. Footway South 2.9m. Tactiles require an extra row. Min 1200mm to comply to Guidance but understand as area of slabs is vast.
Multi Photo

<p>Lat: 50.954099 Long: -0.131717</p>
<p>Notes:</p>	<p>Guardrail in place on footway why? Reduces width 2.4m narrowing to 1.7m (extent of new works). Understand that its near a Highway school but this limits available footway space.</p>

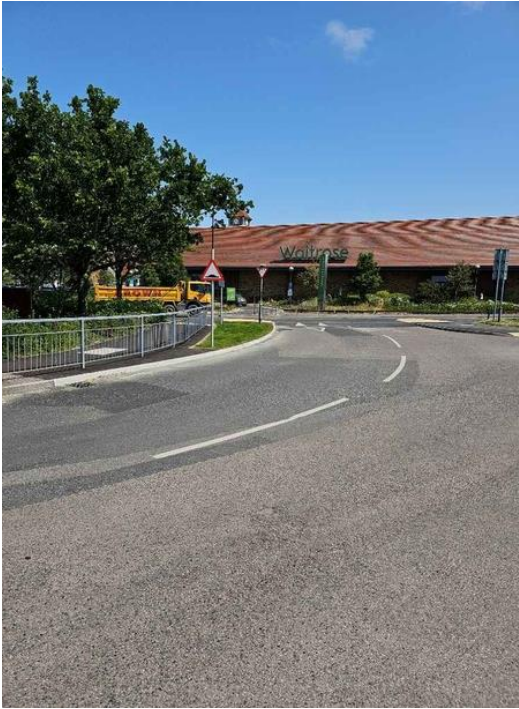
Area – 6d

Location	Road hump Sign on approach to junction.
Description	Mounting height is 1.96m. Needs raising to 2.1m. Distance to ramp approx. 12m, Incorrect siting position. Min 45m from hazard.
Multi Photo

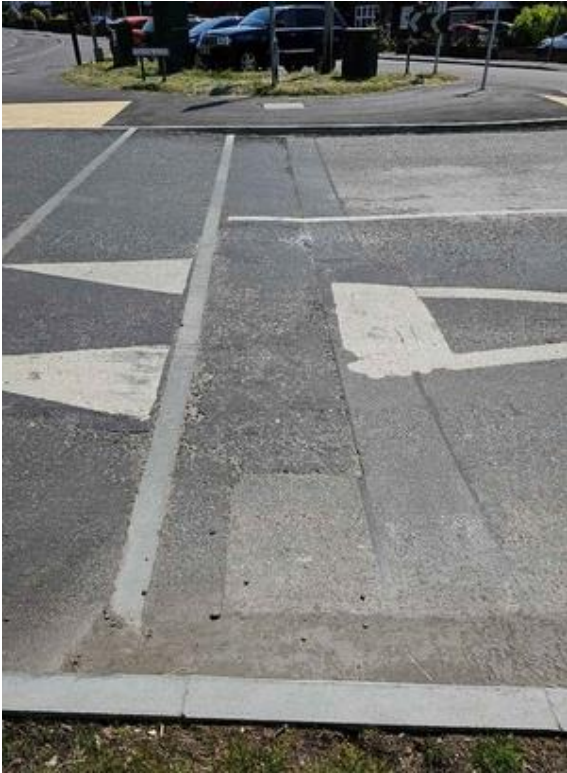
Area – 6g

Defect Location	Bottom of ramp
Defect Description	Surface course of HRA starting to pluck out
Multi Photo

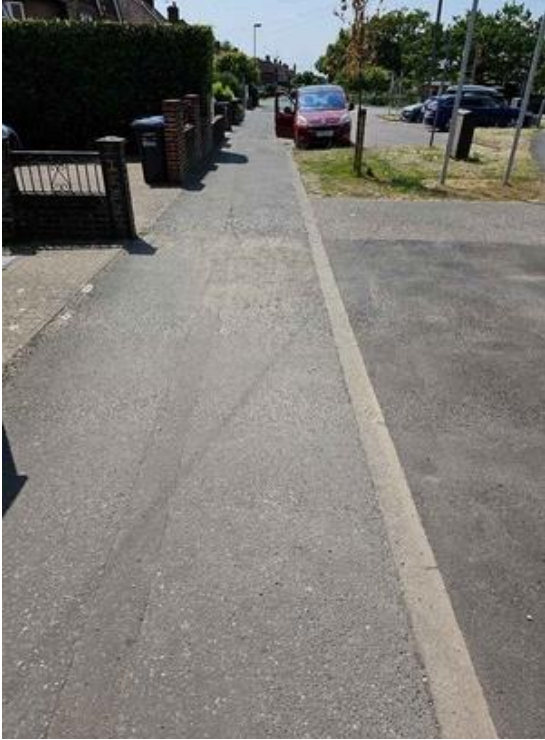
Area – 6i

Defect Location	Just west of Waitrose delivery access. Outside 67 and 65
Defect Description	Apparent Low spot in footway. Lots of detritus build up, possible sign of a retained surface water.
Multi Photo

<p>Lat: 50.954026 Long: -0.131119</p>
Notes:	Wet visit would be beneficial to determine if a problem.

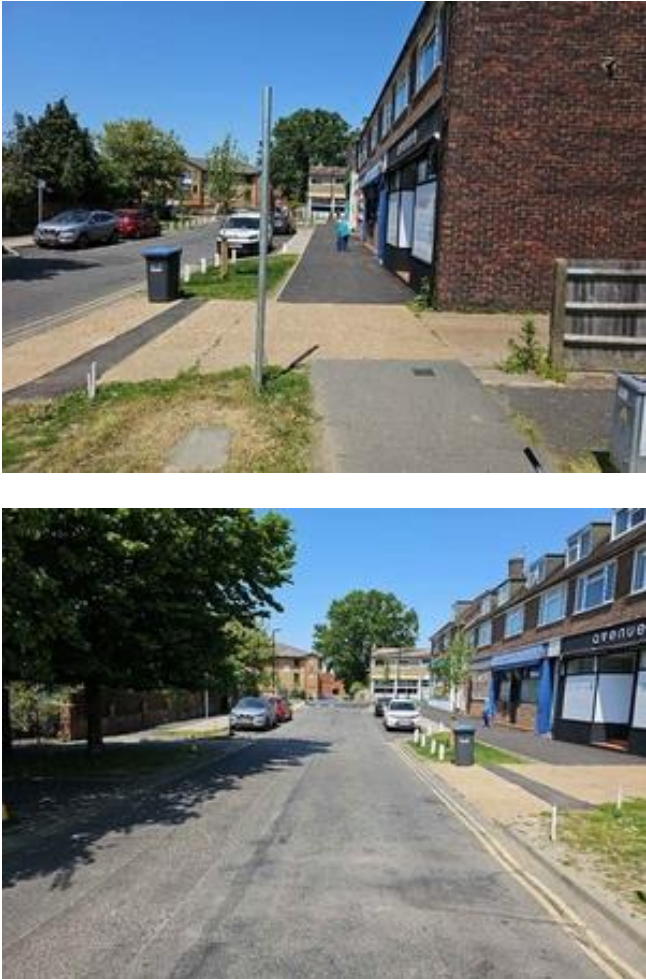
Area – 8e

Location	Queens Crescent carriageway & Eastern footway
Description	Road width 6.3m. Eastern footway 2.6m. Hardstanding 1.18m. Parking Bay 2m. Ramp length 2no. 1.5m & Table length 4m.
Multi Photo

<p>Lat: 50.954239 Long: -0.129946</p>
<p>Notes:</p>	<p>215mm x 50mm Blocks used in hardstanding areas. Sign post installed but No signage. No Corduroy Paving to Inform visually impaired user of share Ped/Cycle route.</p>

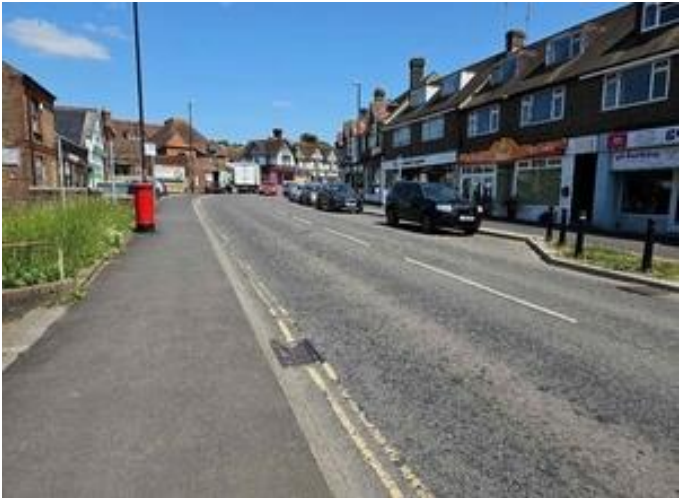
Area – 9b

Defect Location	Station Road Carriageway (Looks as though been reduce from 2 Lanes to one on approach to lights).
Defect Description	Width 8.1m at lights. Width 6.5m at start of parking bay (Outside 49).
Multi Photo

<p>Lat: 50.954463 Long: -0.129493</p>
<p>Notes:</p>	<p>New Kerb line installed southern side. Poor repair of surface course to carriageway (in front of kerbs).</p>

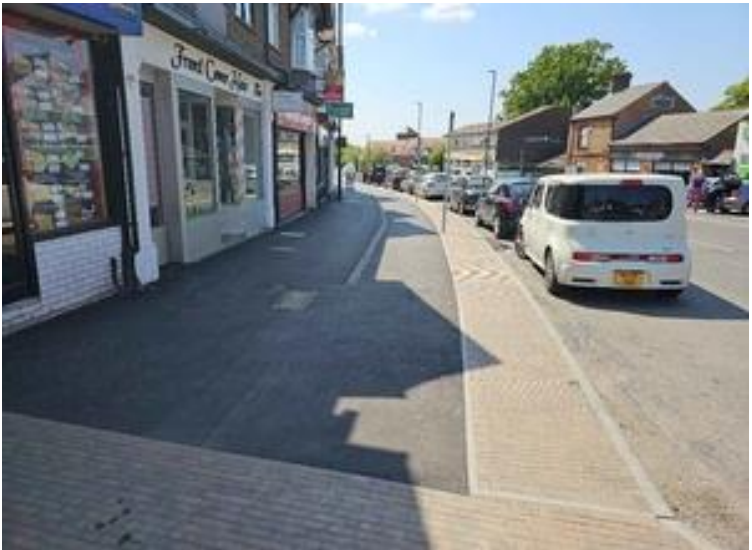
Area – 9c

Location	Footway southern side (Outside Shops) Station Road
Description	Blocked paved hardstand Laid in Stretcher Course. 6mm Asphalt Concrete surface. O/S no.49 Hardstand width 1m. Shared use footway width 4.4m O/S no.43 Hardstand width 1m. Shared use footway width 3.9m. O/S no.35 Hardstand width 1m. Shared use footway width 4m.
Multi Photo

<p>Lat: 50.954331 Long: -0.129554</p>
<p>Notes:</p>	<p>There is no signage except for parking restrictions. Silver sand required between blocks. Concrete fillets required to base of posts. Drainage is served by ACO's. Unusual Pattern to lay blocks in the highway. Usually Herringbone 90° or 45° pattern which provides extra load bearing capacity.</p>

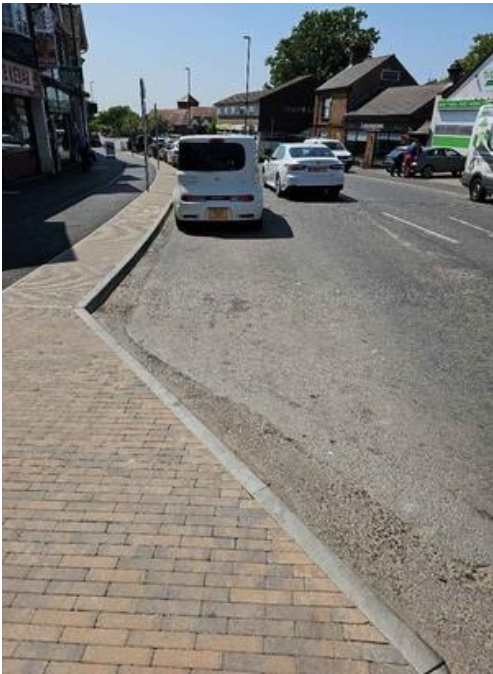
Area – 9d

Location	Layby Station Road
Defect Description	O/S 49 width 2.2m O/S 35 width 2.3m. Carriageway surface course appears in poor condition possibly temporary surface. Kerb face measuring 145mm.
Multi Photo

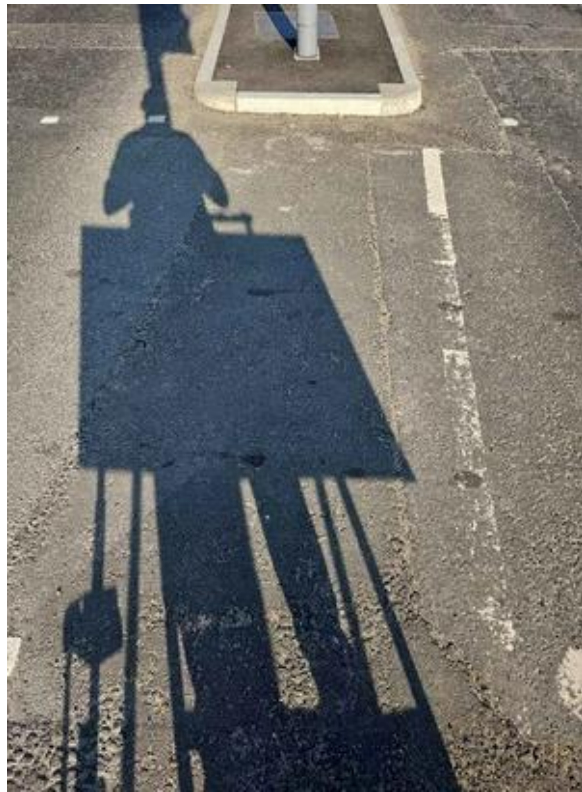
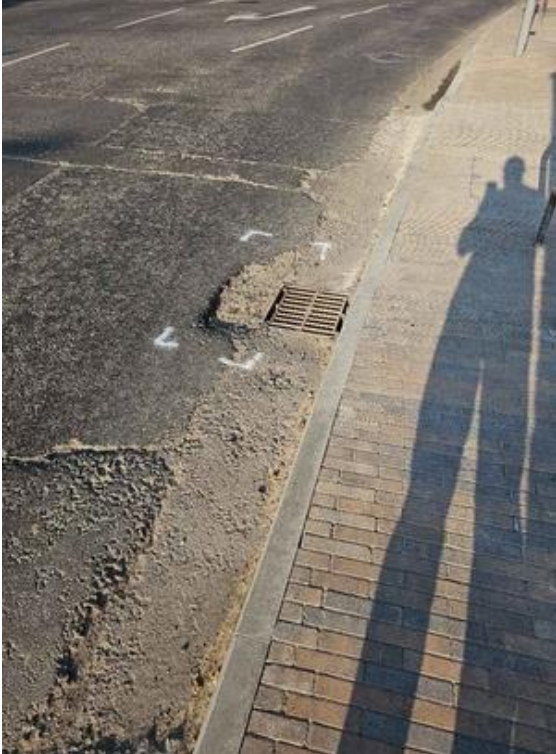
Area – 10b

<p>Lat: 50.954405 Long: -0.128346</p>
<p>Notes:</p>	<p>Crossing point outside 24 uneven surface. Road surface throughout junction in poor state of repair. No ADS signage on approaches to new layout.</p>

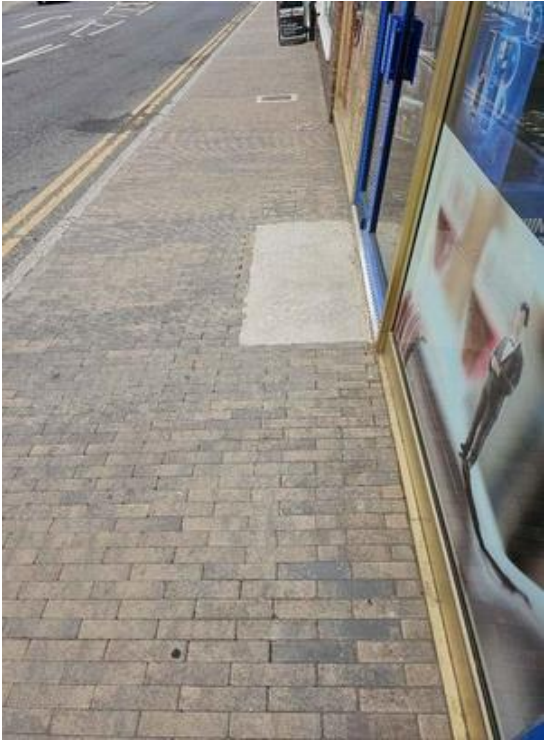
<p>Loose block adjacent to Concrete Slab.</p>

<p>Lat: 50.954328 Long: -0.128031</p>
Notes:	Blocks loose outside no. 12 food and wine, adjacent to concrete slab. Tactile require extra row (1200mm). Gully installed as per drawing.

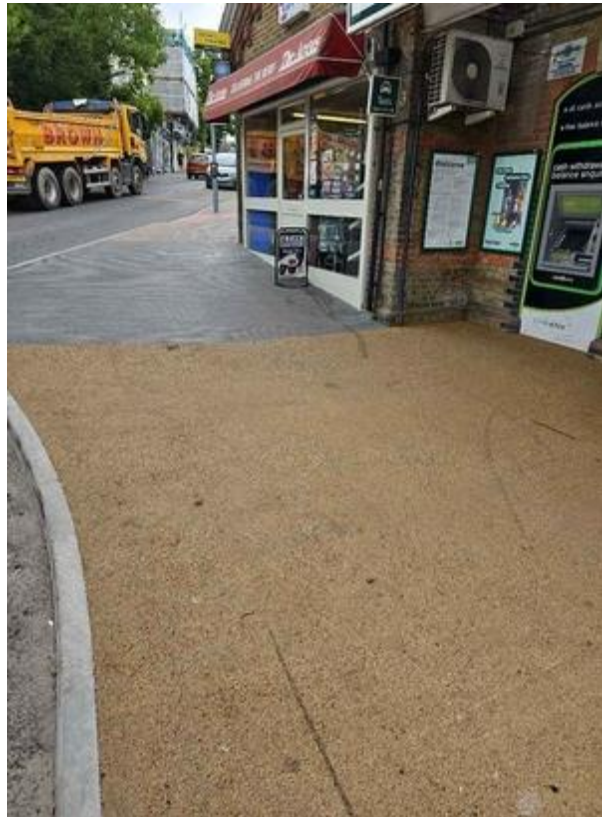
Down pipe with no drainage.

<p>Lat: 50.953936 Long: -0.127515</p>
<p>Notes:</p>	<p>Downpipe to left of Station Entrance (looking at station) appears to have no drainage. Rainwater will run across Entrance. Could make area hazardous during wet weather and freezing temperatures. Corduroy Slabs on exit of Station? Blocks require sanding in areas.</p>

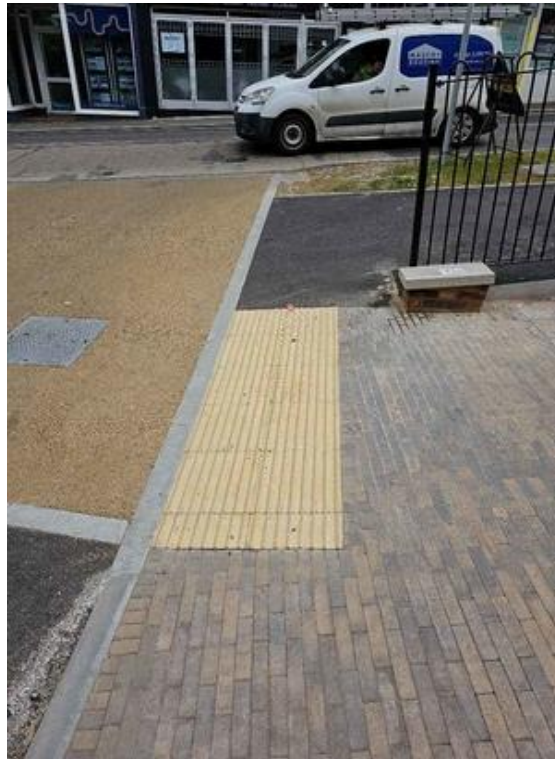
Steep gradient where footpath and foot/cycleway join.

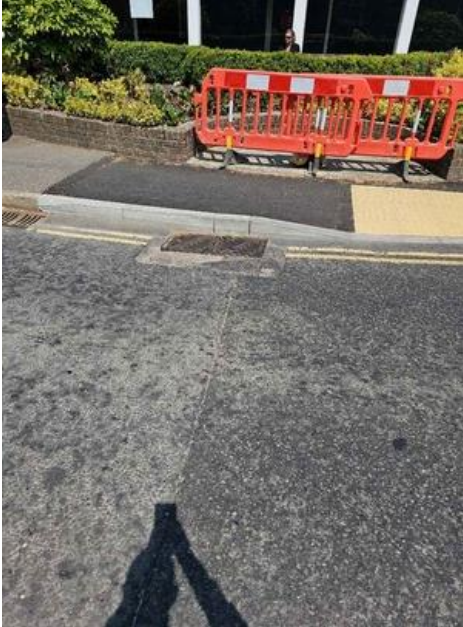
<p>Poor repair around gully</p>
<p>Location / GPS</p>

<p>Lat: 50.953006 Long: -0.125988</p>
<p>Notes:</p>	<p>Unfinished surface course. No idea on what is shared or unsegregated. Corduroys required for entering shared space. cycles crossing? No signs or lines. Poor repair around gully.</p>

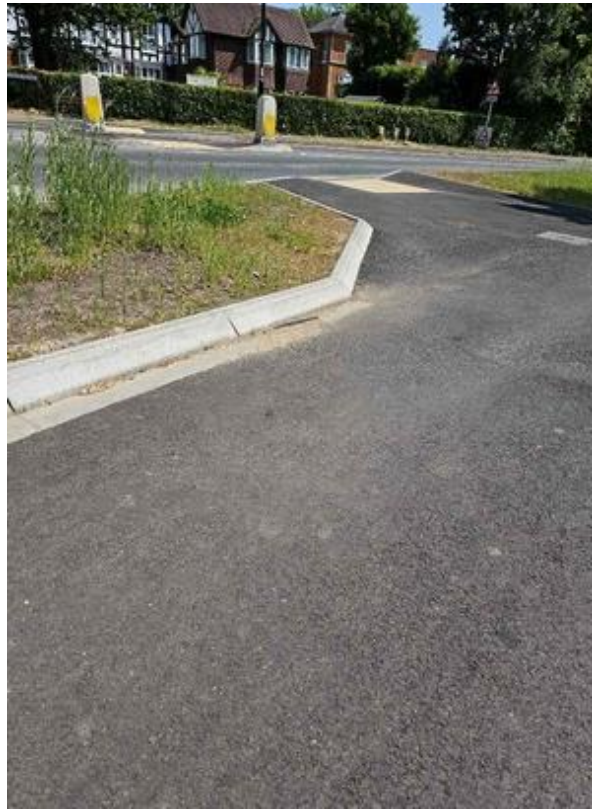
low spot

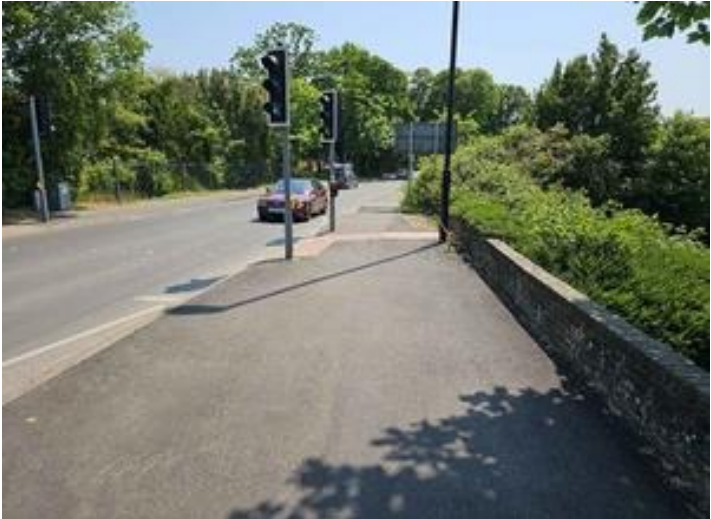
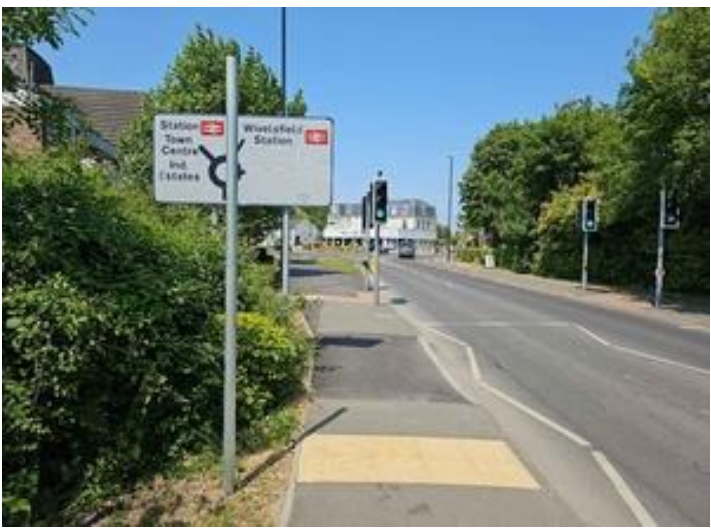
Defect Location	Foot/Cycleway Western side.
Defect Description	Corduroys required for entering shared space. Width of crossing 3.2m.
Multi Photo

<p>Cycle Connection?</p>
