ICENI CONSULTING SURVEY REPORT

Client:	Burgess Hill Town Council
Site:	Place & Connectivity Programme Phase 1, Burgess Hill
S38/S278/UU/LHA/Private/	Local Highway Authority
Highway Authority	West Sussex County Council
Date/Time	05/06/2023
Iceni Representative:	Robert Lee

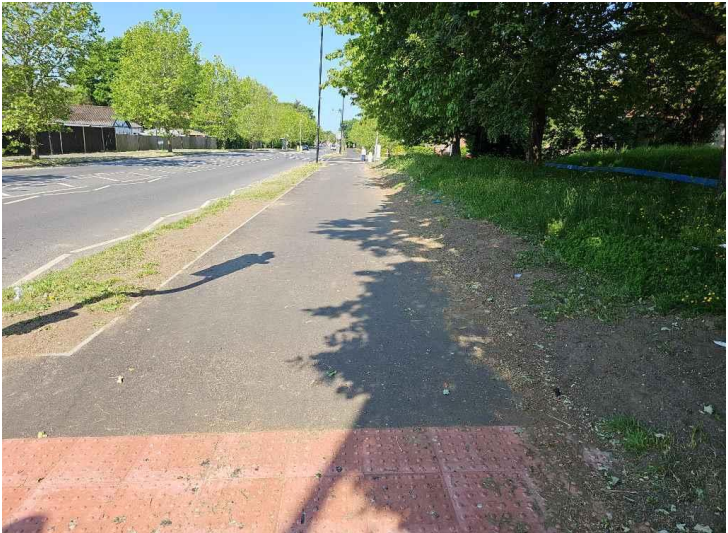
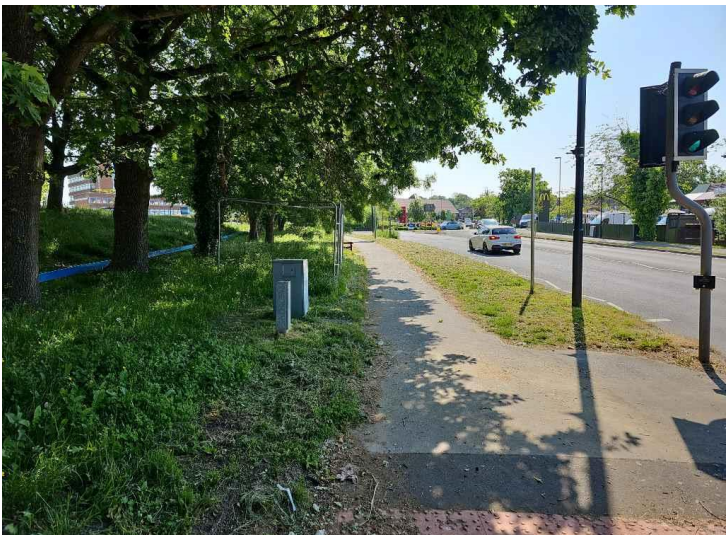
Area – 4A

Location	Northen side of QEW
Description	Shared foot/Cycleway Dimensions 3.5m Asphalt surface. 1.5m verge. Appears to be 5.9m of verge from back edge of kerb to Highway Boundary and 3m to closest tree. No signage.
Multi Photo

<p>Lat: 50.954404 Long: -0.134328</p>
Notes:	Workmanship appears to be good. Red Tactiles in accordance

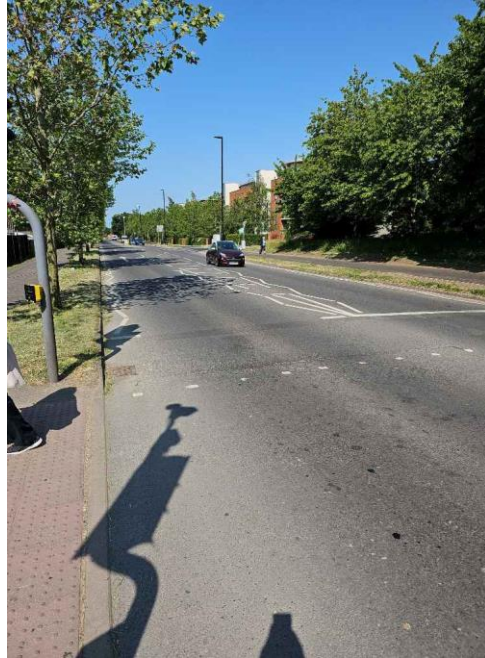
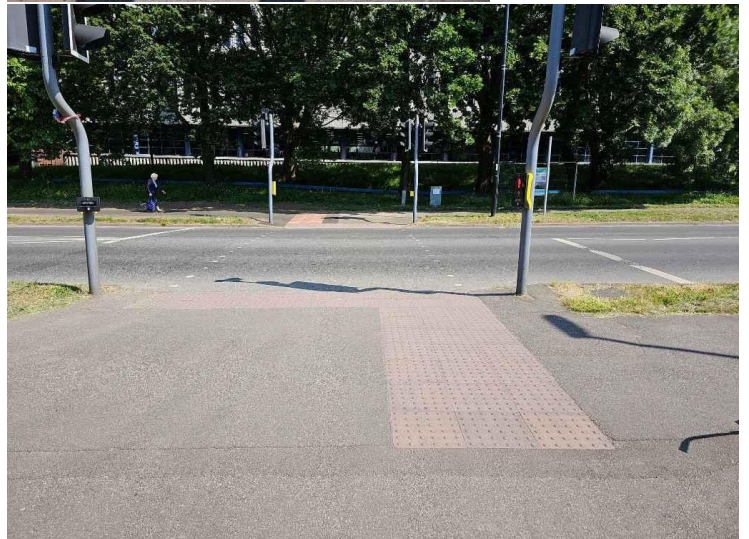
Area – 4b

Location	Carriageway & Crossing Point.
Description	Width 4.1m, Length 10.1m. Road surface looks to be 14mm SMA. Looking polished. Very little macro texture. White lining complies, little worn. Is it planned for Puffin to be upgraded to Toucan? As it should be as crossing point is connected to Shared use foot/cycleway.
Multi Photo

<p>Lat: 50.954261 Long: -0.134335</p>
Notes:	Drainage 30 to 33m between gullies either side of crossing point. No apparent issue.

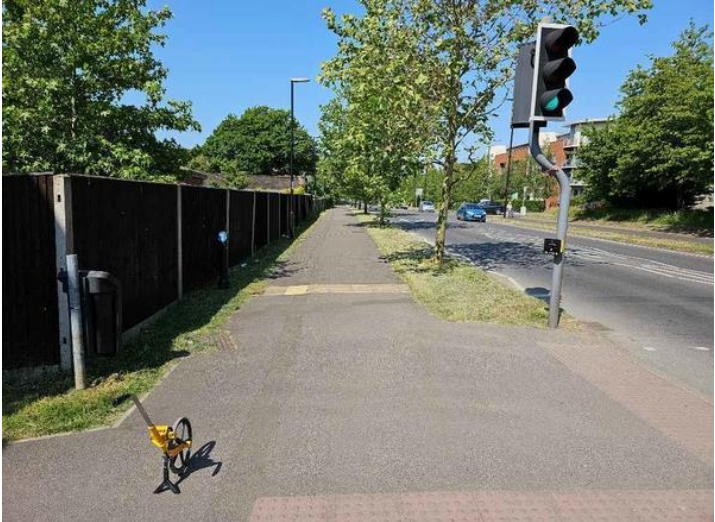
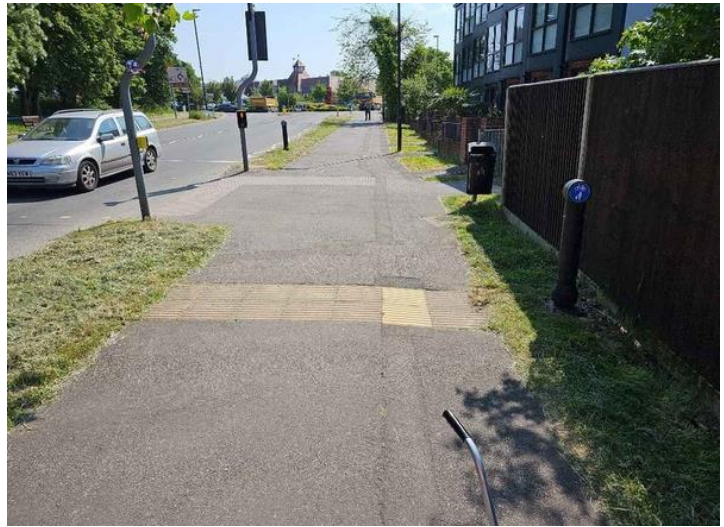
Area – 4d

Location	Southwestern side of QEW
Description	3m shared foot/Cycleway. 1.8m and 0.8m of verge. Unnecessary Corduroy Paving.
Multi Photo

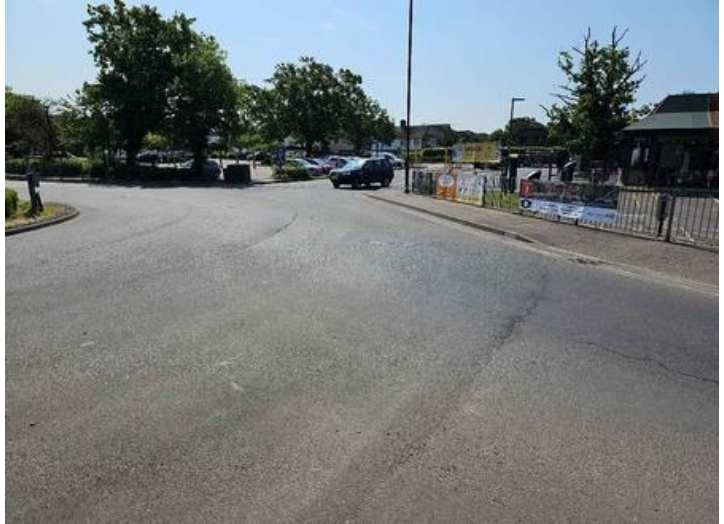
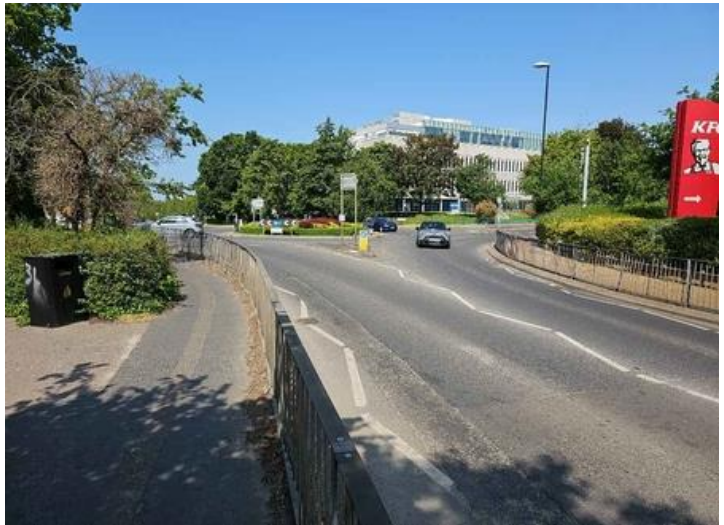
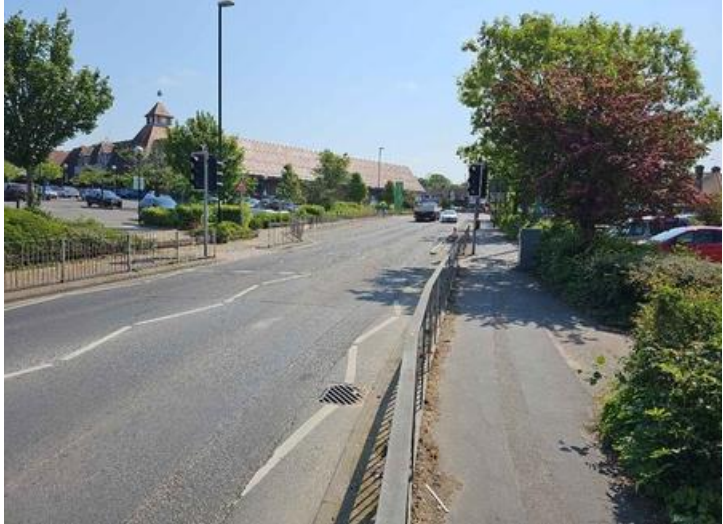
<p>Lat: 50.954313 Long: -0.133576</p>
Notes:	Eastern Arm of RAB surveyed only. Further works still required.

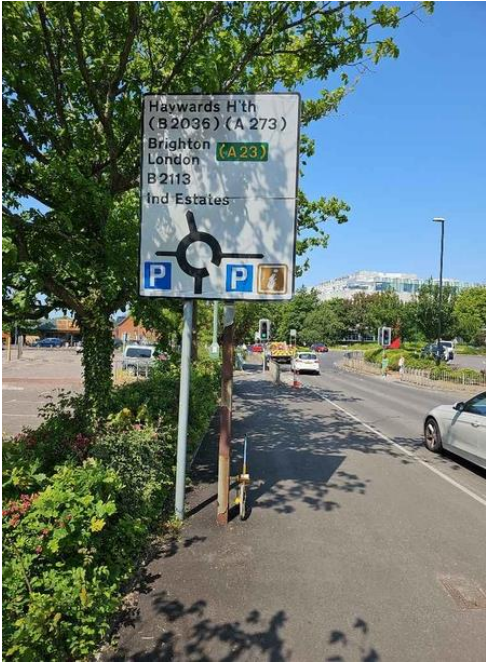
Area – 5b

Location	ADS sign within shared foot/Cycleway
Description	Mounting height needs raising to 2.3m. Currently 219mm.
Multi Photo

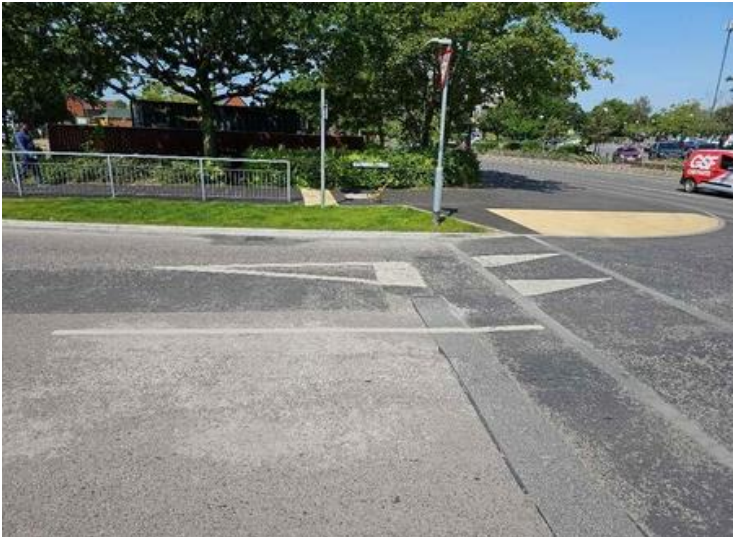
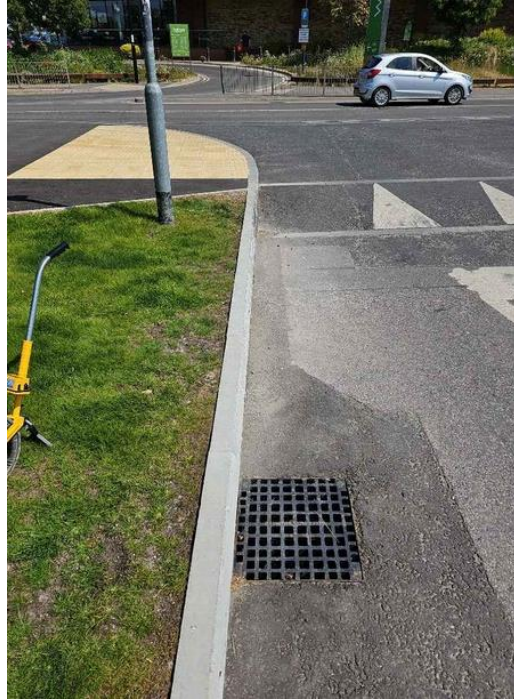
Area – 6b

Location	SW Side, Bottom of Ramp
Description	Evidence of ponding. Gully not located in low spot
Multi Photo

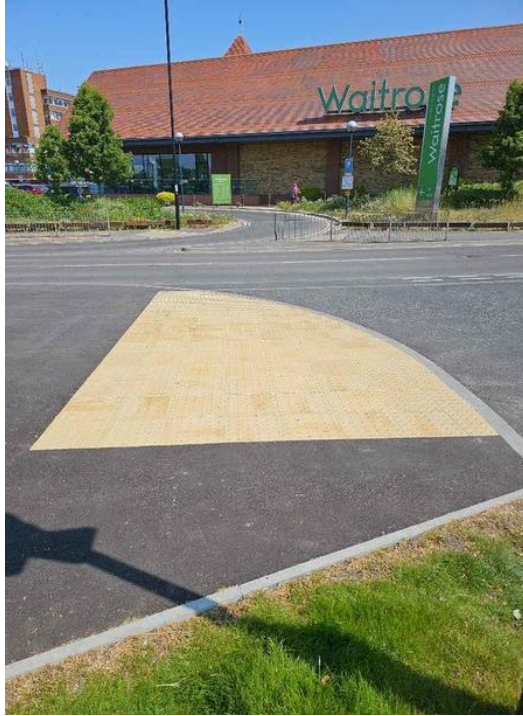
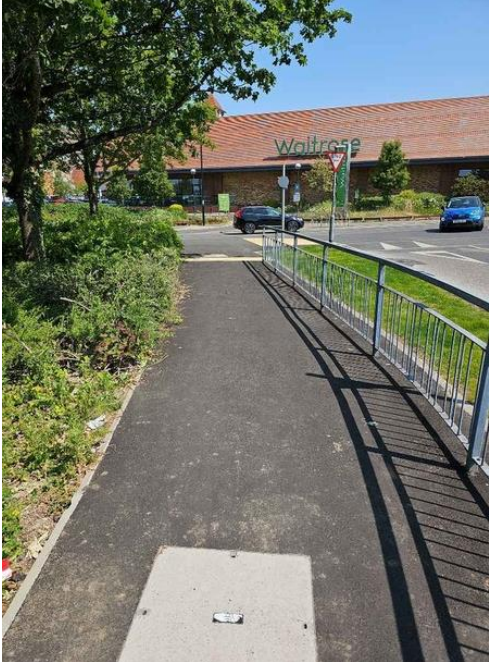
Defect Location	Footways.
Defect Description	3.8m on shared approaches. Footway South 2.9m. Tactiles require an extra row. Min 1200mm to comply to Guidance but understand as area of slabs is vast.
Multi Photo

<p>Lat: 50.954099 Long: -0.131717</p>
<p>Notes:</p>	<p>Guardrail in place on footway why? Reduces width 2.4m narrowing to 1.7m (extent of new works). Understand that its near a Highway school but this limits available footway space.</p>

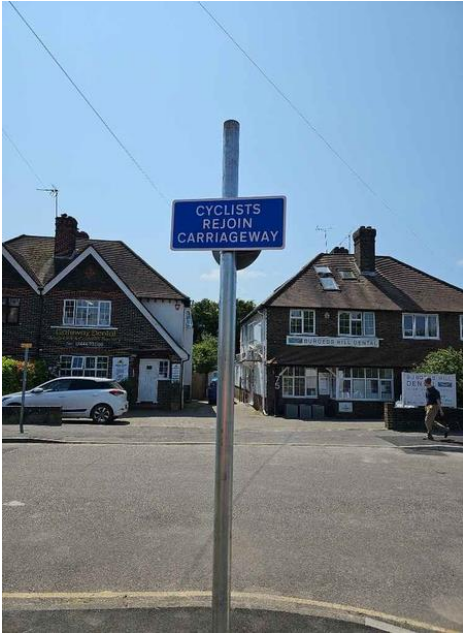
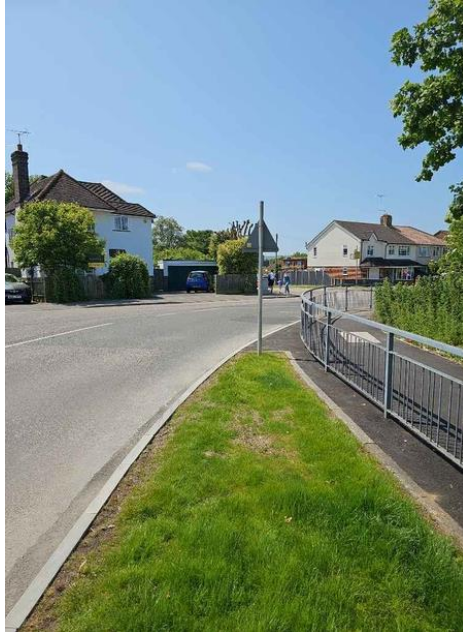
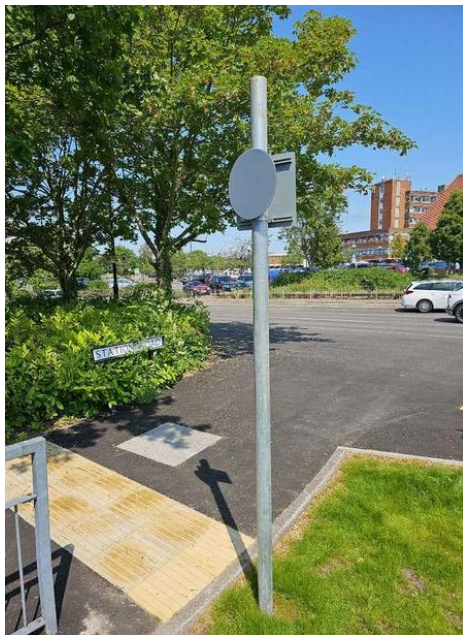
Area – 6e

Location	In and around Junction.
Description	3no. Signpost extends beyond Sign and no apparent capping.
Multi Photo

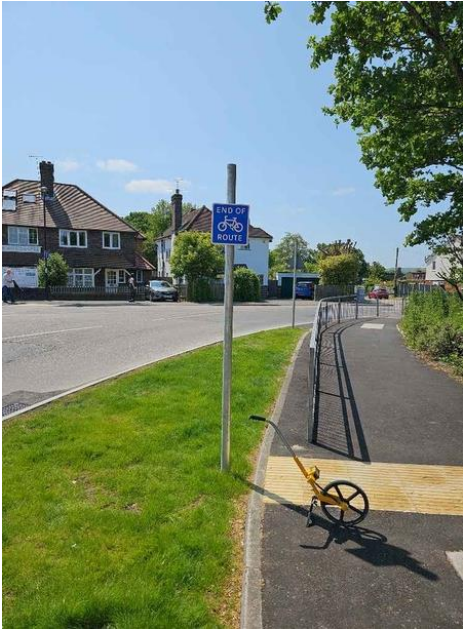
Area – 6f

Location	Mounting height of end of route sign
Description	1.96m. Requires raising to 2.1m
Multi Photo

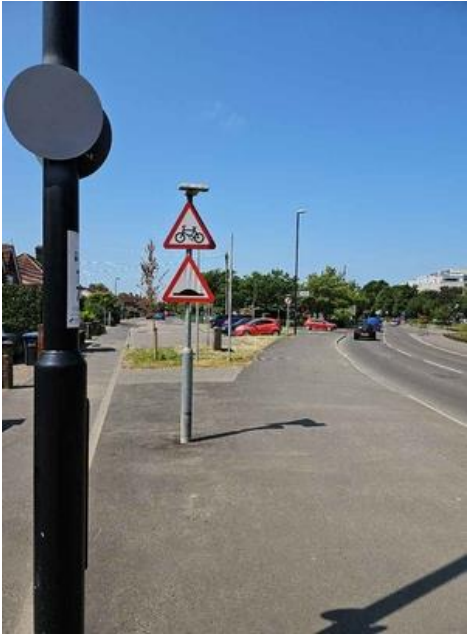
Area – 6h

Location	On Eastern approach to junction.
Description	Sub plate with arrow required. Don't believe either of these signs require lighting in accordance with TSRGD 2016
Multi Photo

Notes:	Greyed out back-to-back signage. Presumably Shared Ped/Cycle route to diag.956.
---------------	---

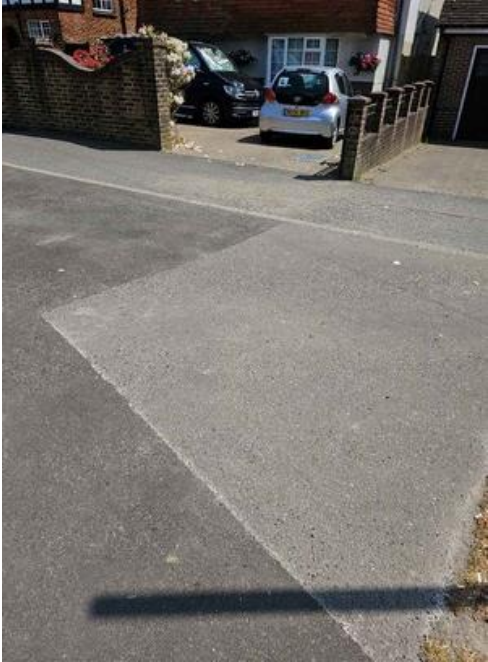
Defect Location	Just west of Waitrose delivery access. Outside 67 and 65
Defect Description	Apparent Low spot in footway. Lots of detritus build up, possible sign of a retained surface water.
Multi Photo

<p>Lat: 50.954026 Long: -0.131119</p>
Notes:	Wet visit would be beneficial to determine if a problem.

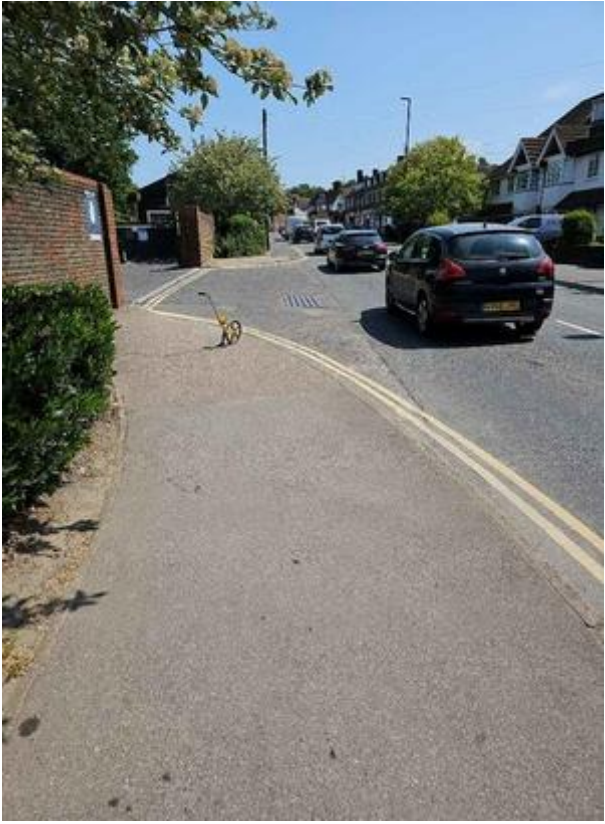
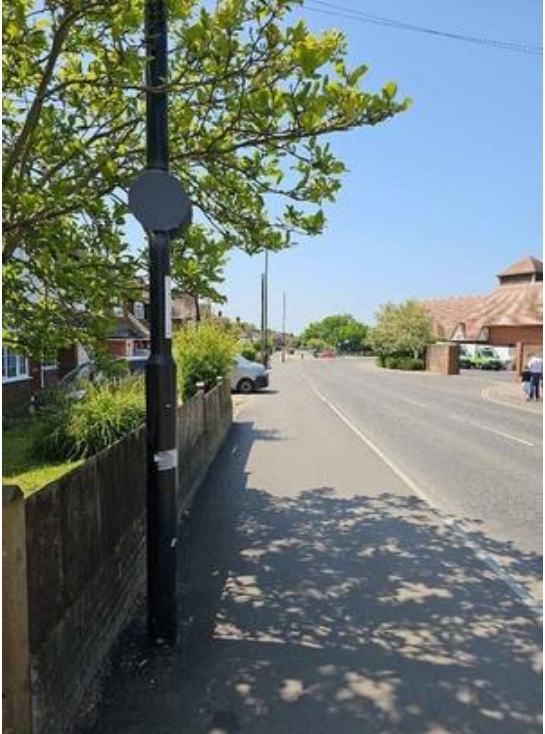
Area - 7a

Location	Carriageway & Footway
Description	Shared foot/Cycleway width 3.2m. Road width 6.75m. Northern footway width 2.3m.
Multi Photo

<p>Lat: 50.954174 Long: -0.130729</p>
<p>Notes:</p>	<p>Workmanship appears to be good. Drainage as existing which appears to be adequate. Greyed out back-to-back signage. Presumably Shared Ped/Cycle route to diag. 956.</p>

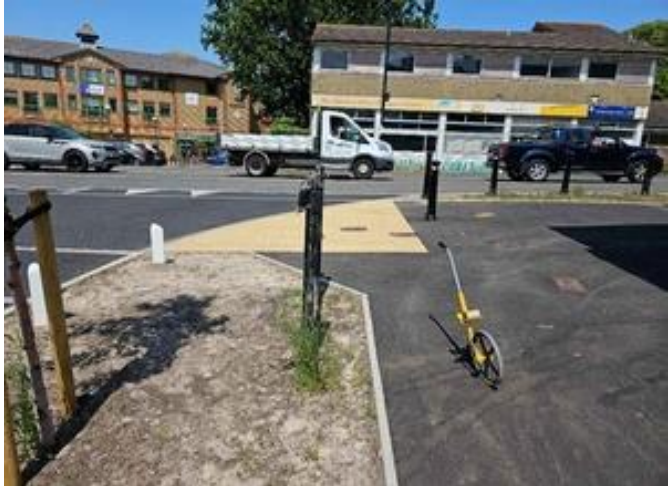
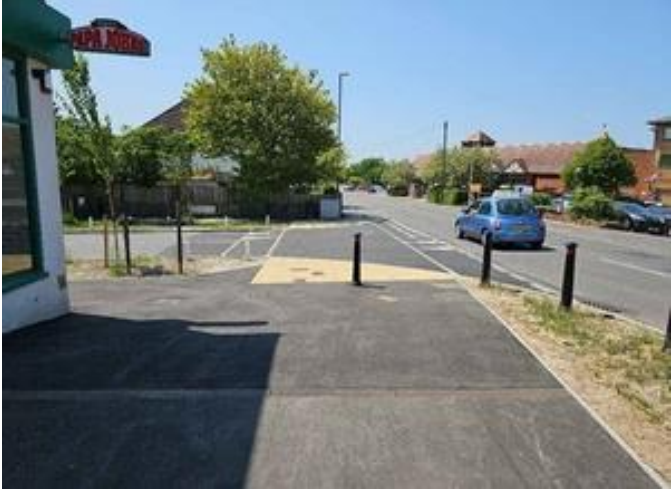
Area - 8a

Location	Southeastern Footway (Station Road)
Description	Foot/Cycleway width 5.9m. Tactile doesn't appear to be compliant, but there are a number tactiles.
Multi Photo

<p>Lat: 50.954256 Long: -0.129804</p>
<p>Notes:</p>	<p>No signage.</p>

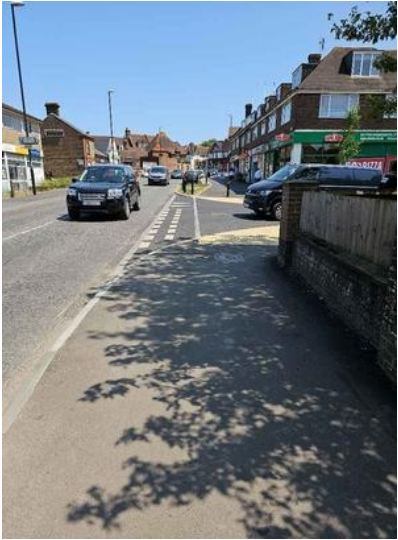
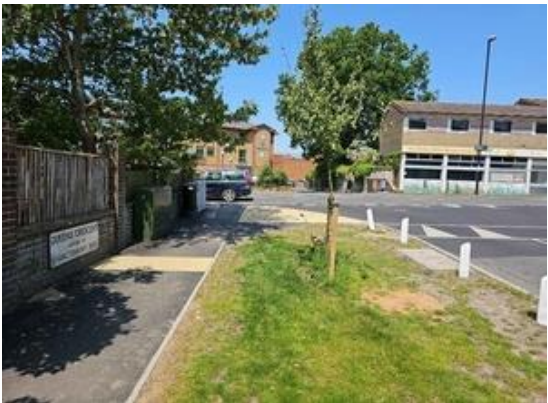
Area – 8c

Location	Southwestern Foot/Cycleway (Station Road)
Description	Width 2.7m. Tactile doesn't appear to be complaint. No signage for shared use including in Queens Crescent
Multi Photo

<p>Lat: 50.954229 Long: -0.129899</p>
Notes:	No signage.

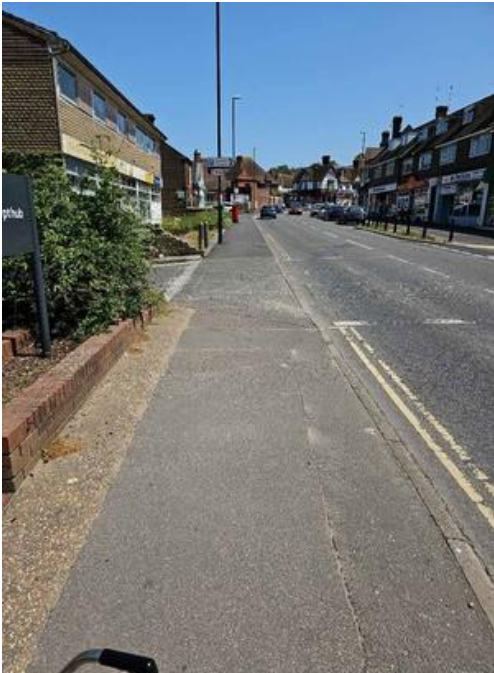
Defects – 8d

Defect Location	Northernside footway. As existing. No work carried out.
Defect Description	Width 2.4m
Multi Photo

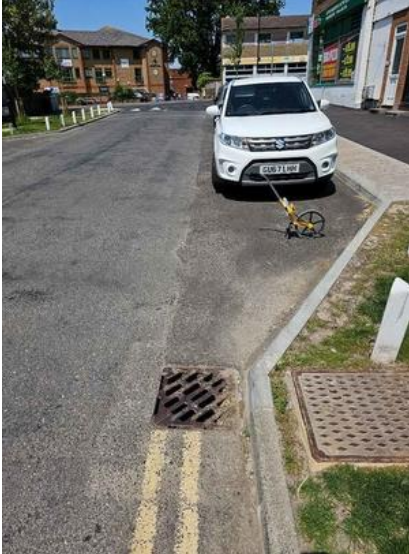
<p>Lat: 50.954239 Long: -0.129946</p>
<p>Notes:</p>	<p>215mm x 50mm Blocks used in hardstanding areas. Sign post installed but No signage. No Corduroy Paving to Inform visually impaired user of share Ped/Cycle route.</p>

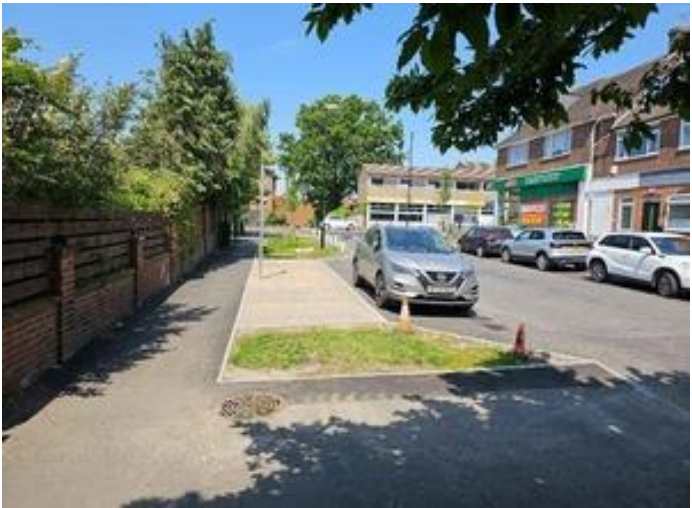
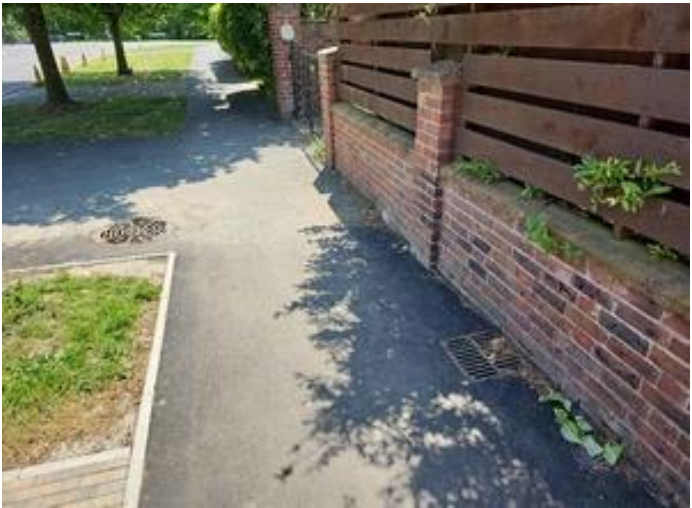
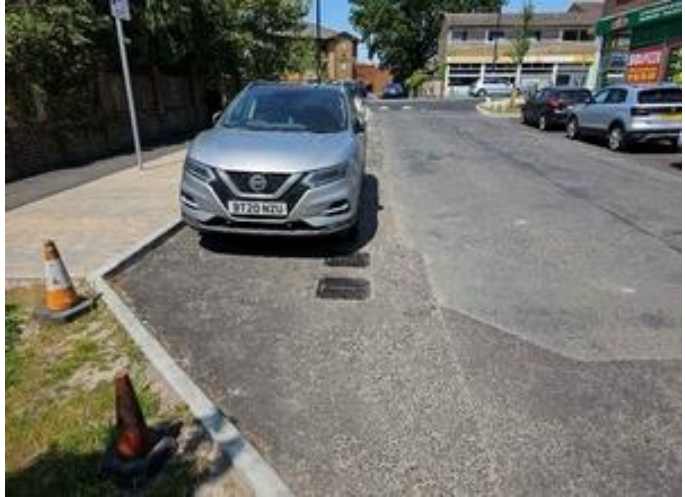
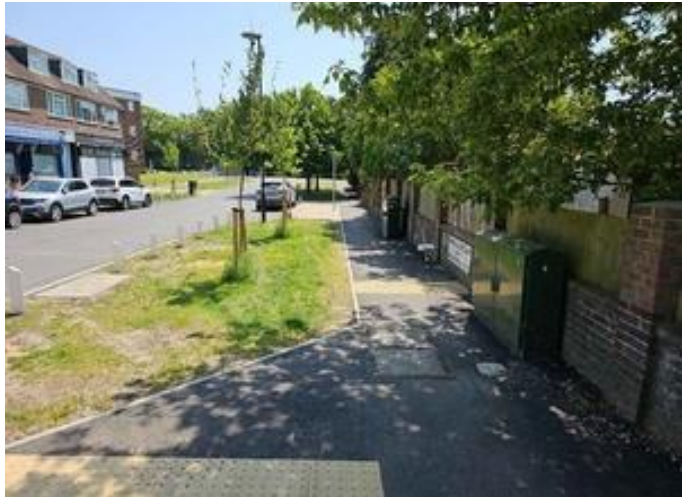
Area – 8f

Location	Queens Crescent Western footway & Parking Bay
Description	Footway width 1.8m, Hardstanding 2.4m, Parking Bay 2m width. Drainage doesn't appear to be quite right. High spot in new asphalt to layby doesn't tie into levels in front of vehicle access causing a low spot with no drainage.
Multi Photo

<p>Lat: 50.953979 Long: -0.129705</p>
Notes:	215mm x 50mm Blocks used in hardstanding areas. No signage or post.

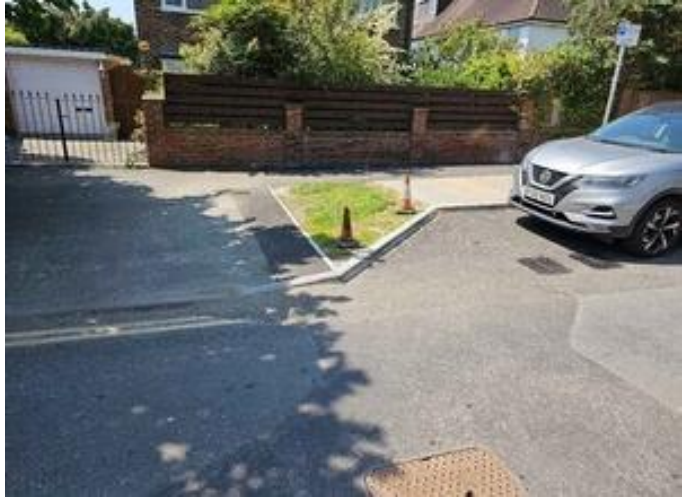
High spot within new asphalt

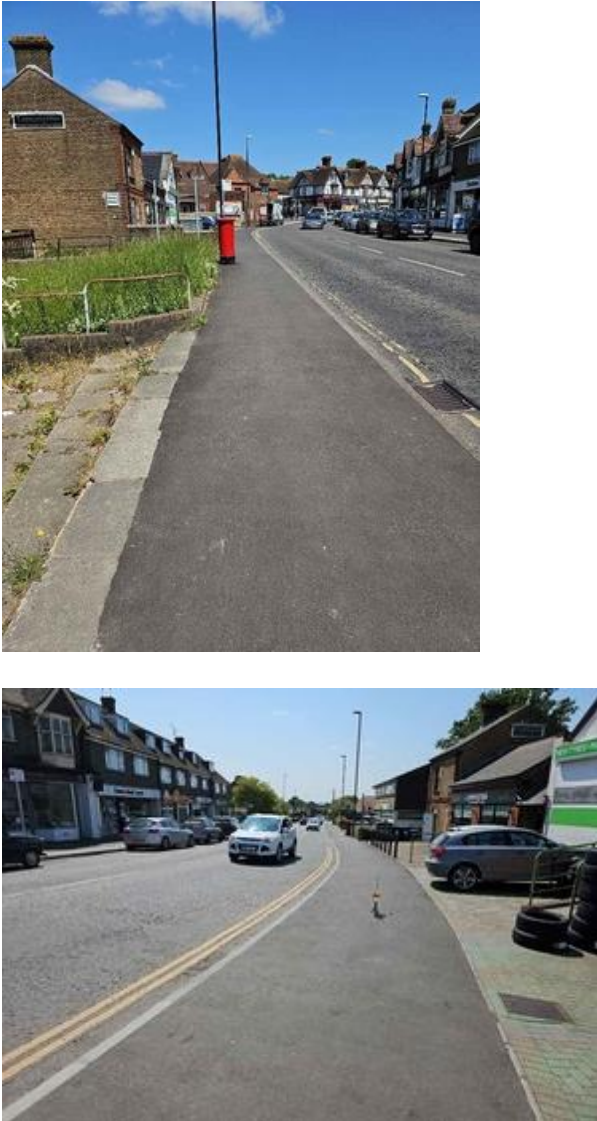
Defects - 9a

Defect Location	Station Road Northern Footway
Defect Description	Apparent new surface course of 6mm AC. Width 2.2m widens to 2.8m just past More Than Tyres.
Multi Photo

<p>Lat: 50.954498 Long: -0.129144</p>
Notes:	It's believed this is to remain as a footway only.

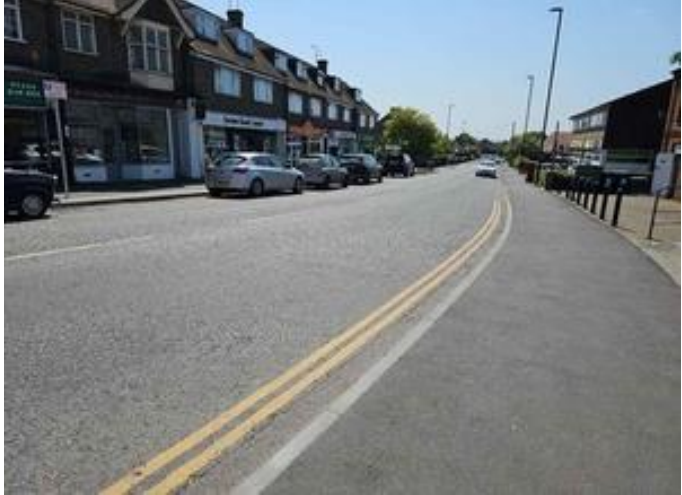
Area – 9b

Defect Location	Station Road Carriageway (Looks as though been reduce from 2 Lanes to one on approach to lights).
Defect Description	Width 8.1m at lights. Width 6.5m at start of parking bay (Outside 49).
Multi Photo

<p>Lat: 50.954463 Long: -0.129493</p>
<p>Notes:</p>	<p>New Kerb line installed southern side. Poor repair of surface course to carriageway (in front of kerbs).</p>

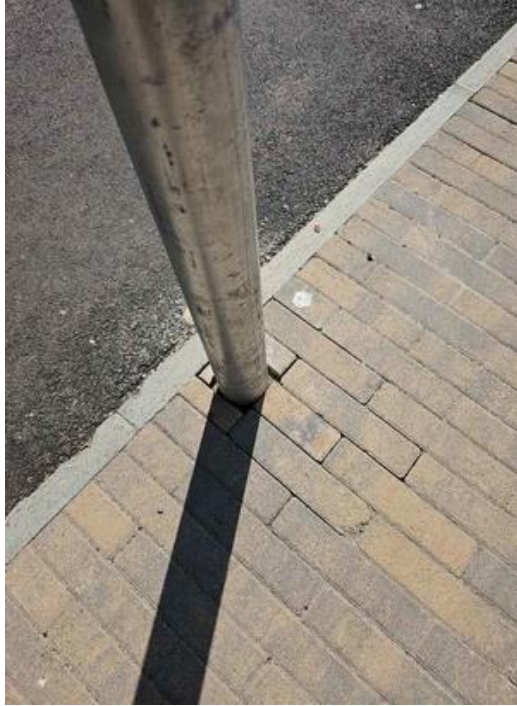
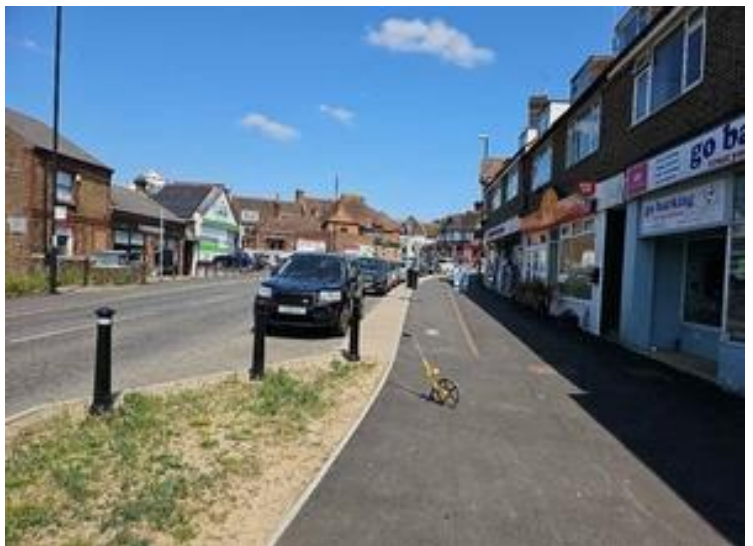
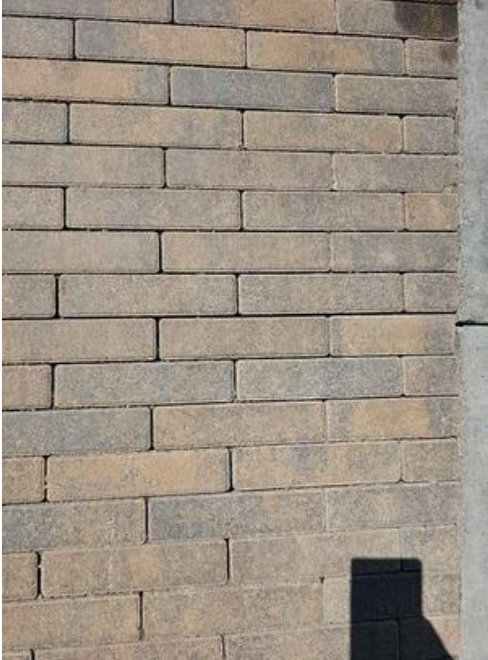
<p>Lat: 50.954331 Long: -0.129554</p>
<p>Notes:</p>	<p>There is no signage except for parking restrictions. Silver sand required between blocks. Concrete fillets required to base of posts. Drainage is served by ACO's. Unusual Pattern to lay blocks in the highway. Usually Herringbone 90° or 45° pattern which provides extra load bearing capacity.</p>

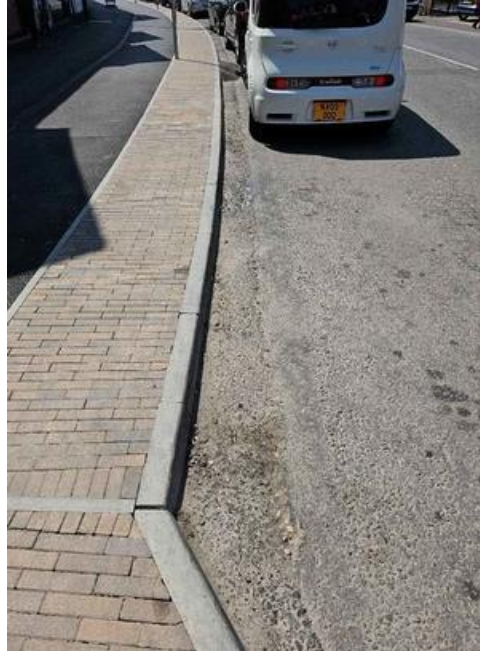
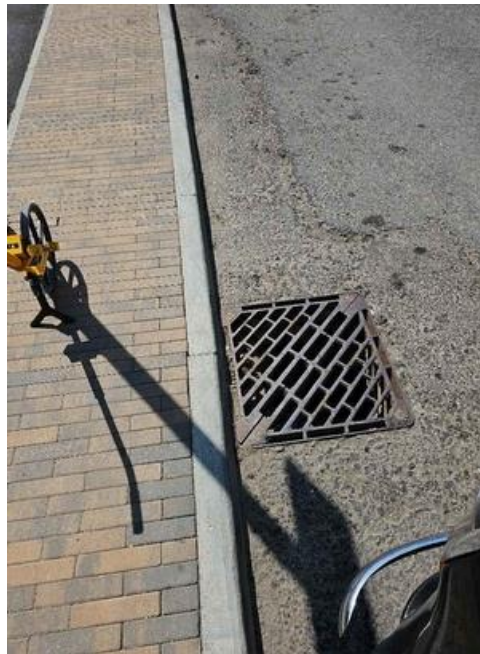
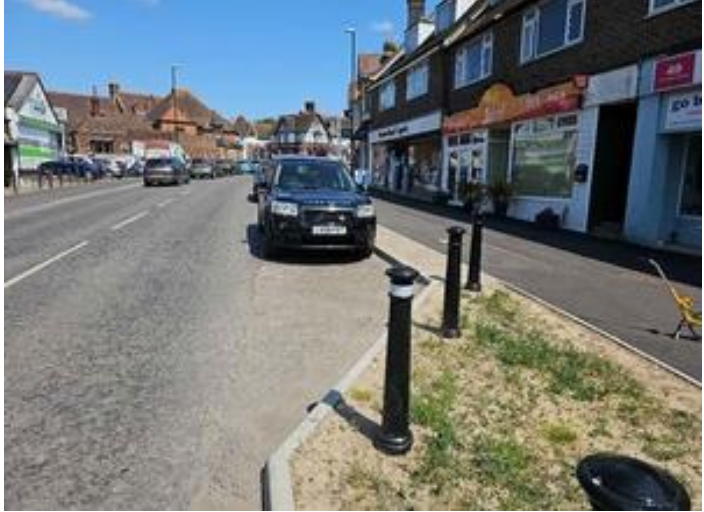
Location	Layby Station Road
Defect Description	O/S 49 width 2.2m O/S 35 width 2.3m. Carriageway surface course appears in poor condition possibly temporary surface. Kerb face measuring 145mm.
Multi Photo

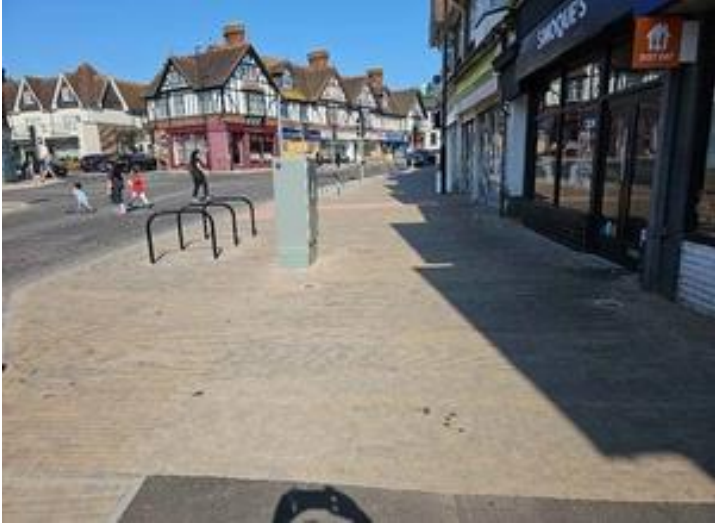
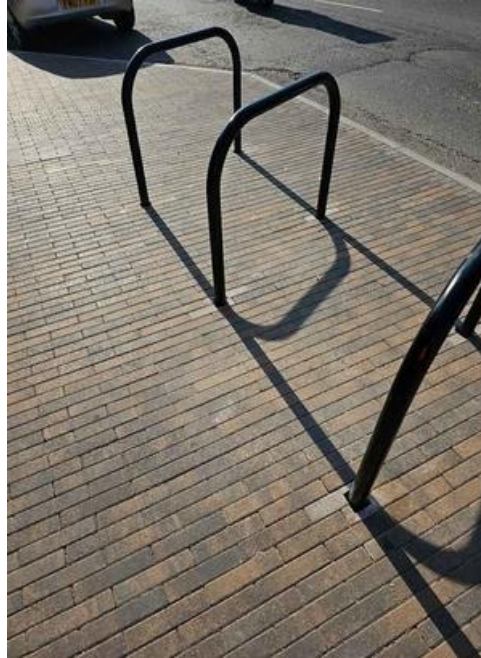
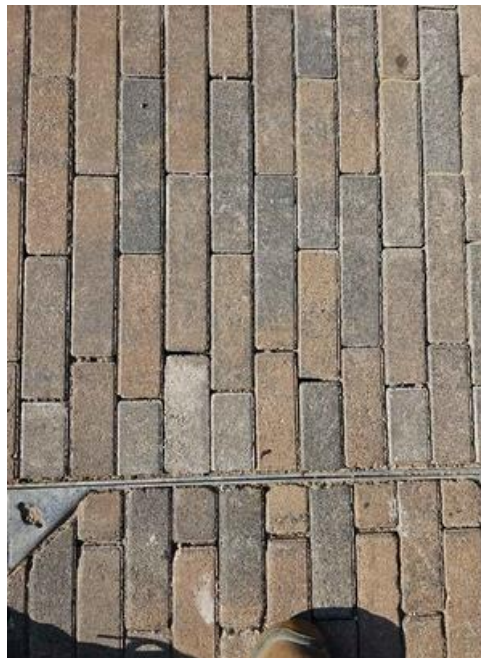
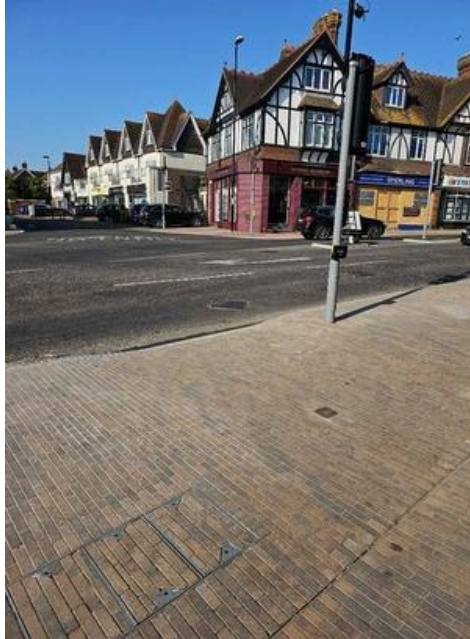
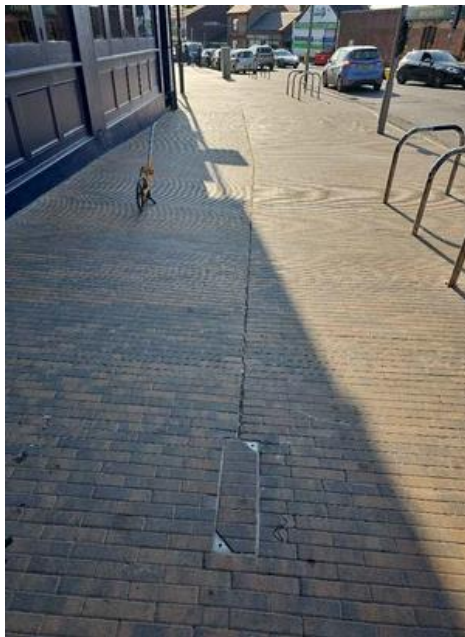
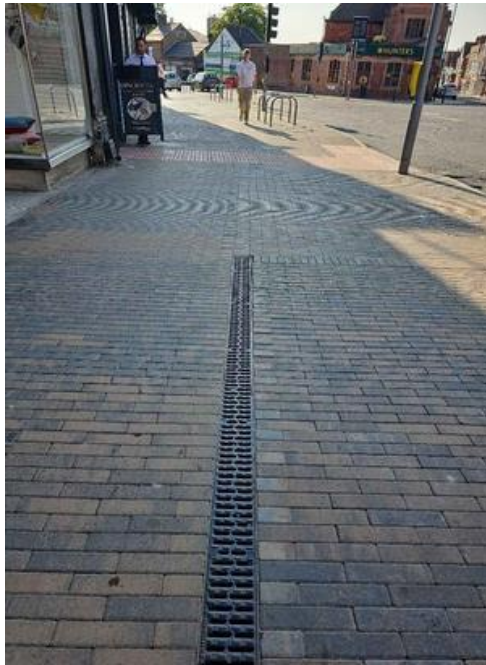
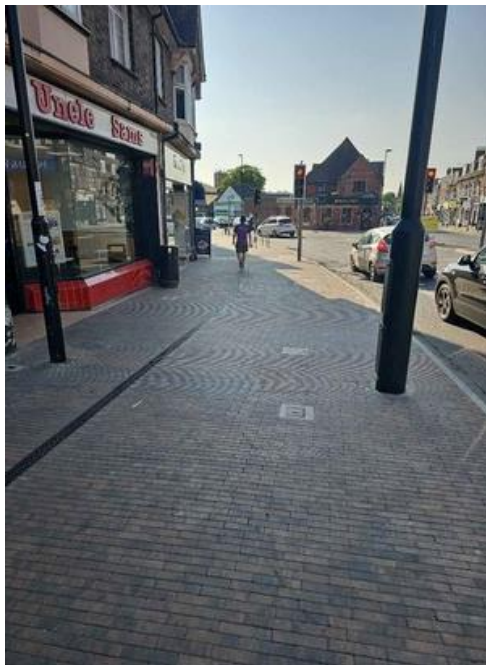
Location	Southern Foot/Cycleway Station Road
Description	<p>Blocks 215mm x 50mm surface.</p> <p>O/S 35 Shared use footway width 5.1m.</p> <p>O/S 33 Shared use footway width 7.2m.</p> <p>O/S 29 Shared use footway width 6.3m (1.9m from Kerb to end of cycle stand, 4.4m to shop front).</p> <p>O/S 23 Shared use footway width 4.6m.</p>
Multi Photo

<p>Church Road Car Park WHSmith let Place Boots Lemongrass Lucky Take Away Little India The Railway Burgess Hill Flavour Bennett Oakley Solicitors upmarket22</p> <p>Lat: 50.954406 Long: -0.128587</p>
Notes:	<p>Cycle Stands require concrete fillets. Blocks require sand in places. No signage for shared use route. Drainage seems adequate. Outside 23 & 25 some blocks are uneven. Cycle crossing point unable to understand how cyclist connect in route from Church Road.</p>

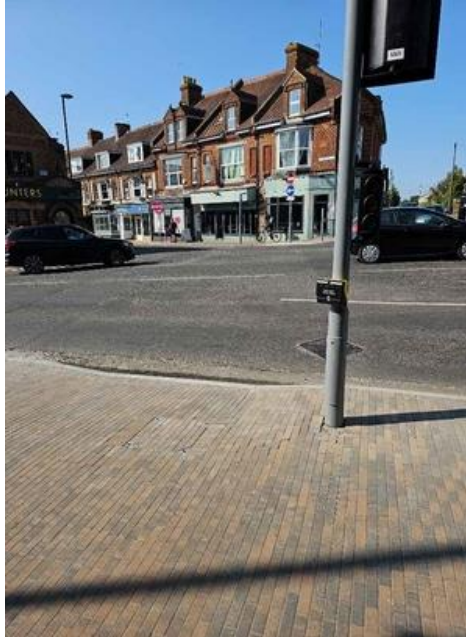
Cycle crossing point? (Not in use).

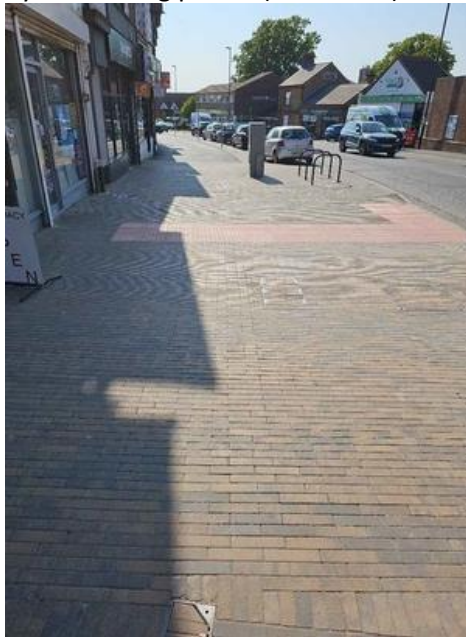
No drainage in this location. Wet weather visit required.

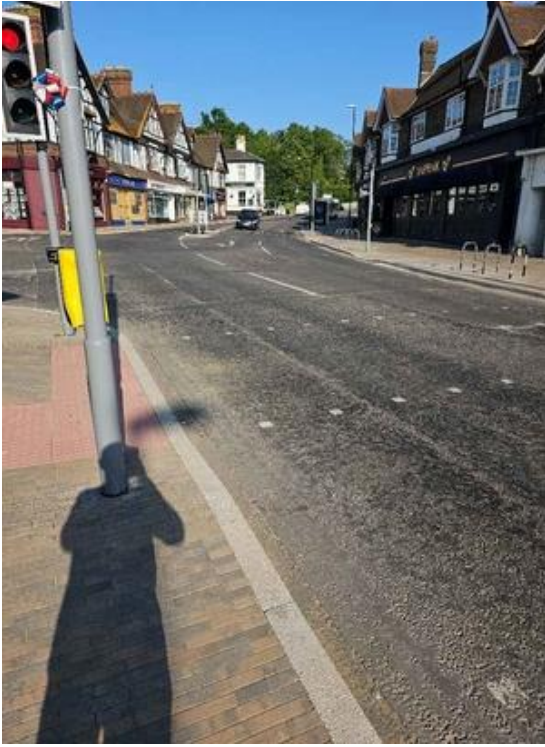
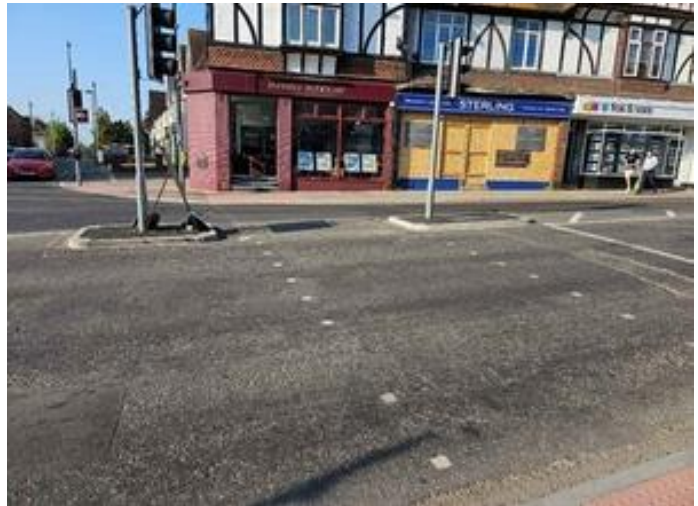
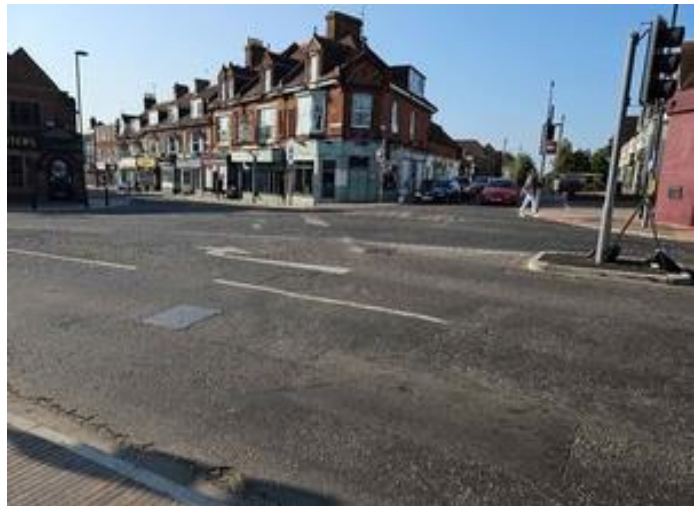
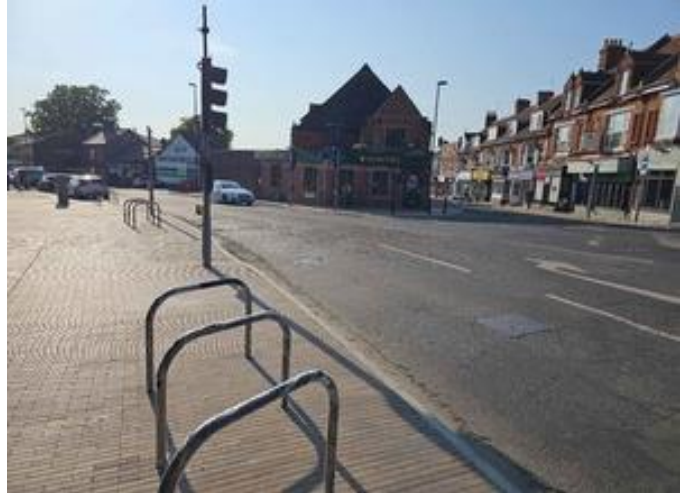
Location	Carriageway Station Road
Description	Width at crossing 8.4m (Outside 31). Width at crossing 13m (Outside 25)
Multi Photo

<p>Lat: 50.954405 Long: -0.128346</p>
<p>Notes:</p>	<p>Crossing point outside 24 uneven surface. Road surface throughout junction in poor state of repair. No ADS signage on approaches to new layout.</p>

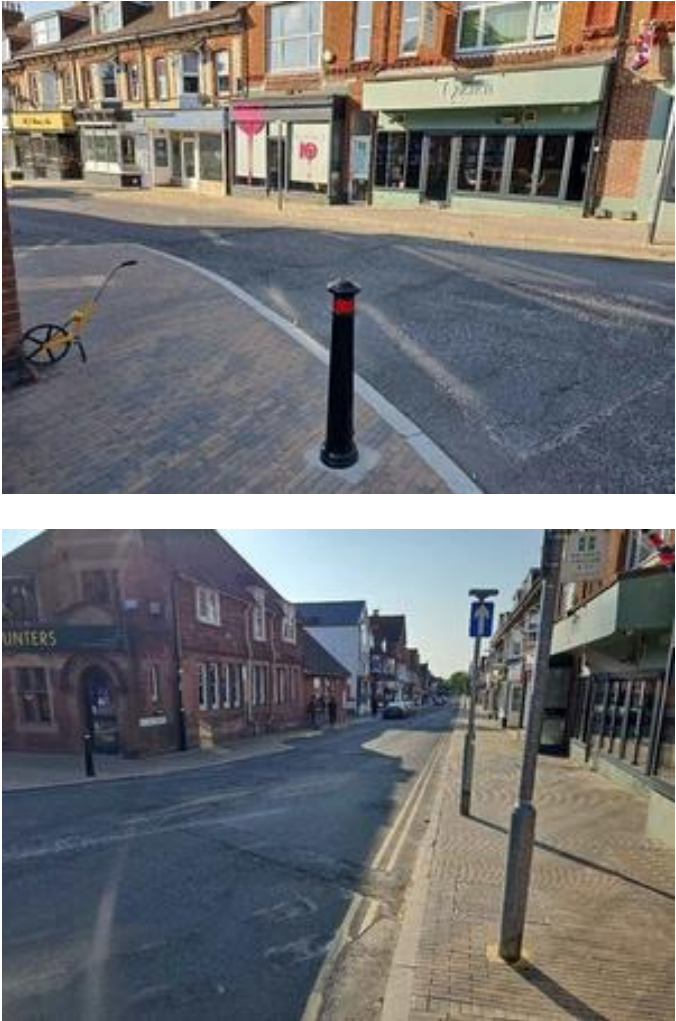
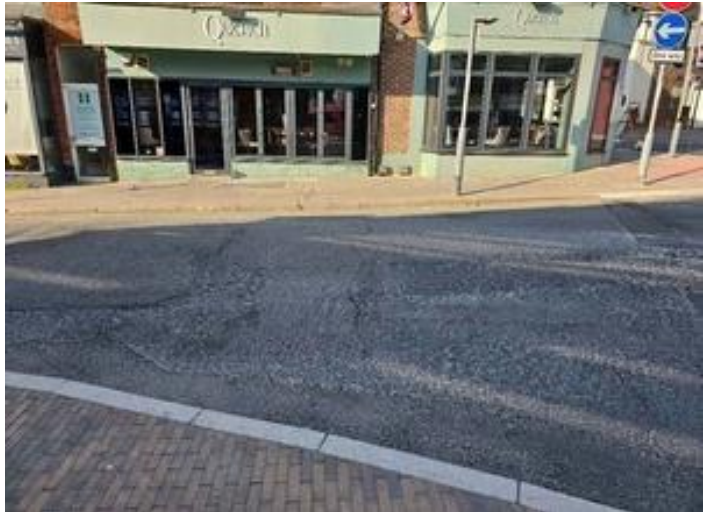
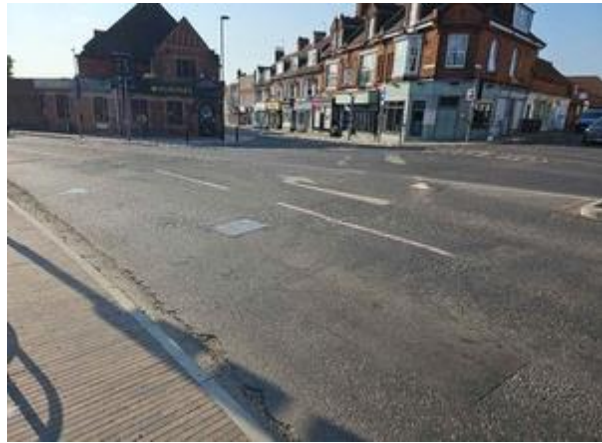
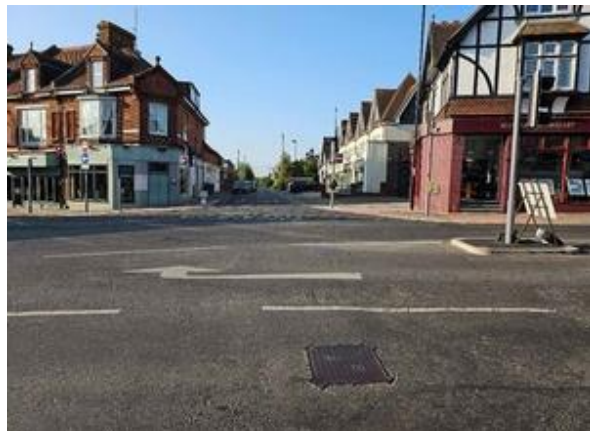
Defect Location	Church Road
Defect Description	Carriageway width 5m. Blocks 215mm x 50mm in footway. Northern Footway 3.2m. Southern varies, minimum width 2m.
Multi Photo

Road Surface in poor condition. No footway connectivity across Church Road. Kerb face dropped to 30mm on southern side and

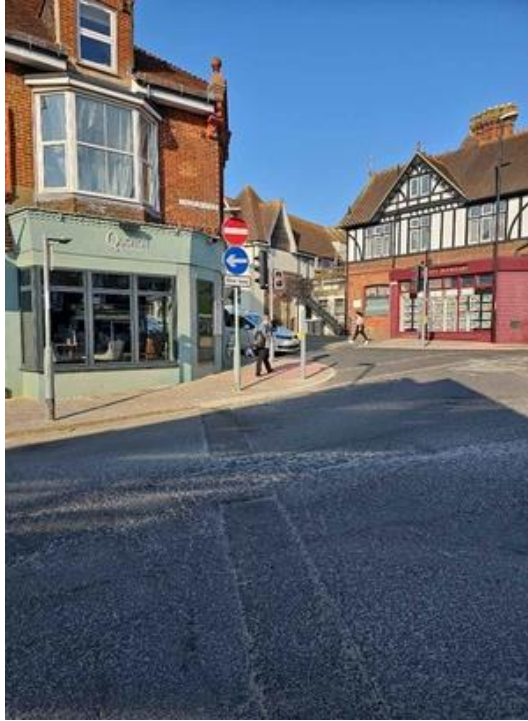
No Entry and One Way on the same post. Confusing in this location.

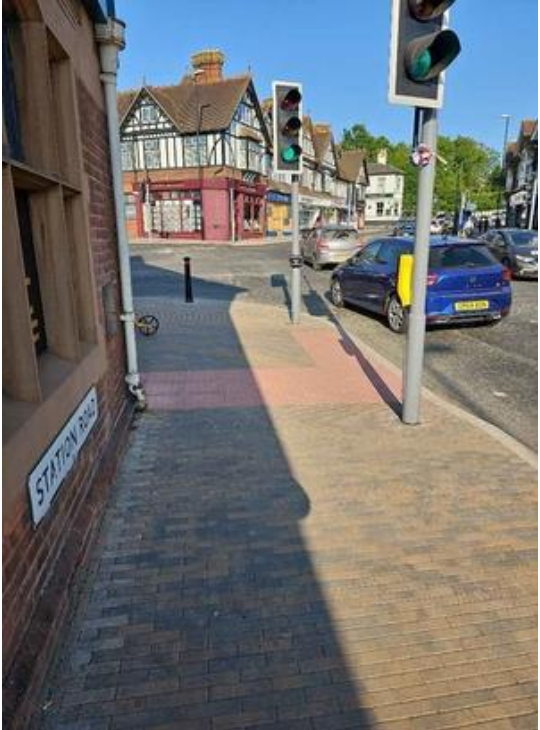
Location	Station Road. Footway Northern West side
Description	Blocks 215mm x 50mm in footway. Width of footway at crossing point 3m (Outside 31)
Multi Photo
