ICENI CONSULTING SURVEY REPORT

Client:	Burgess Hill Town Council
Site:	Place & Connectivity Programme Phase 1, Burgess Hill
S38/S278/UU/LHA/Private/	Local Highway Authority
Highway Authority	West Sussex County Council
Date/Time	05/06/2023
Iceni Representative:	Robert Lee

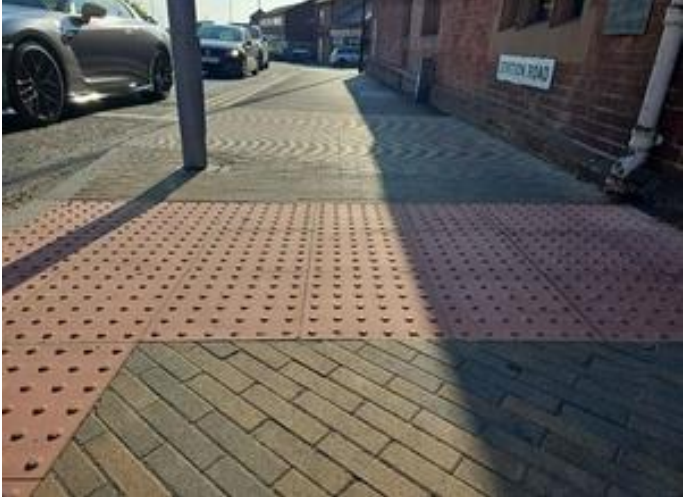
<p>Significant level difference in blocks</p>
<p>Location / GPS</p>

<p>Lat: 50.954523 Long: -0.128727</p>
<p>Notes:</p>	<p>Level difference on blocks adjacent to crossing point (O/S 31) doesn't appear to be correct. Potential trip hazard. 30mm on upstand on radius from Station Road into Church Road.</p>

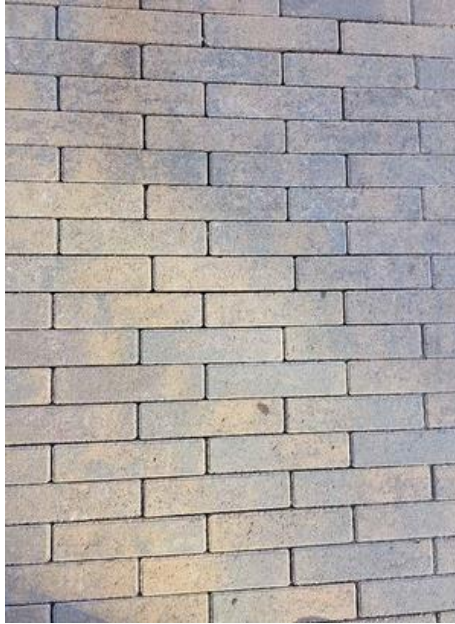
Sand required

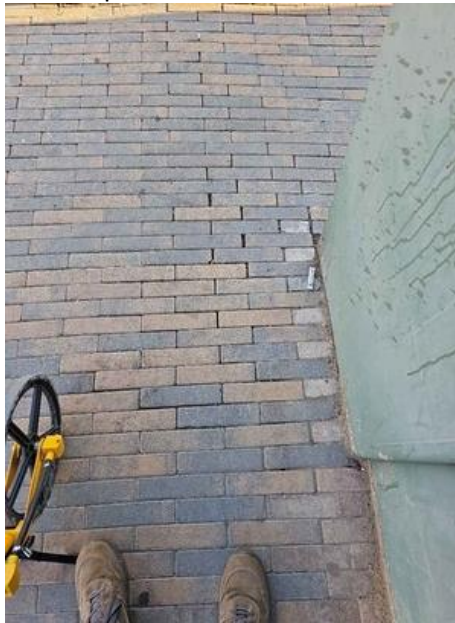
Poor finish on blocks. Open joints.

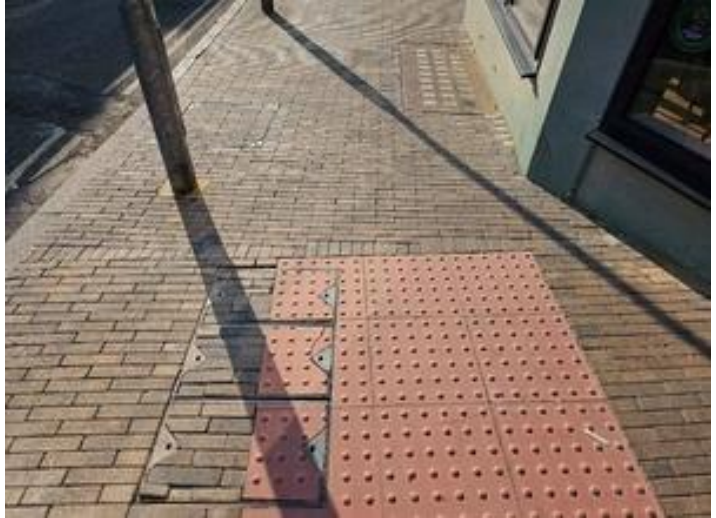
A row of stretcher course would have been better

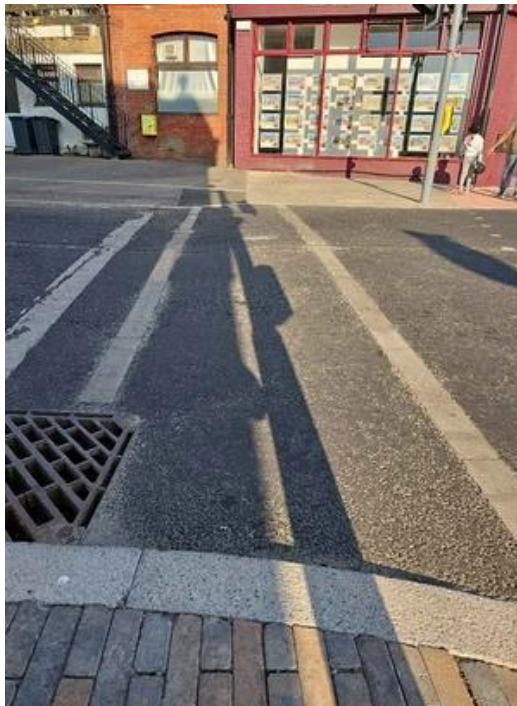
Gully within Ramp

<p>Lat: 50.954436 Long: -0.128525</p>
Notes:	<p>Sand required in between blocks. Not great workmanship with blocks, especially some of the cuts. Location of gully within ramp. Ramps appears to be too steep. Levels don't seem correct. Cars grounding out. RAMP LAID TO KERB ON EASTERN SIDE. NOT CORRECT. No ADS sign on approach. 'No entry' light sign 300mm diameter, OK. 3m lanes.</p>

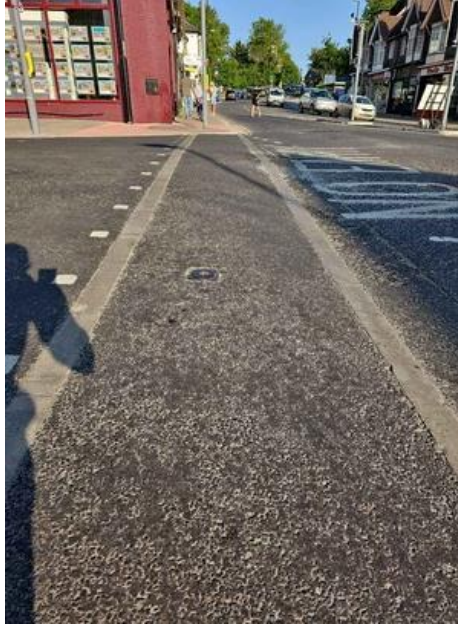
Surface plucking out

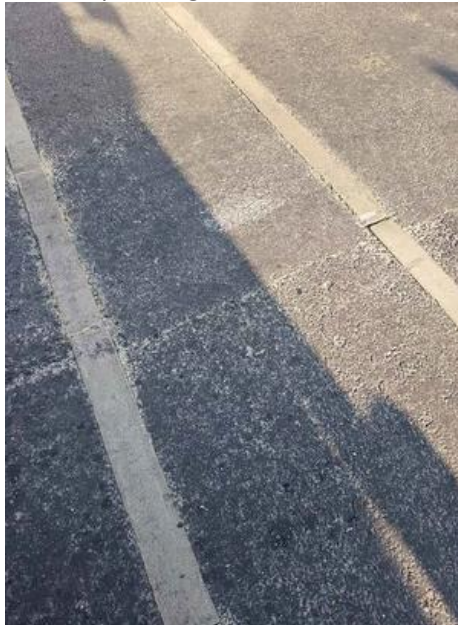
Evidence of ground out on ramp

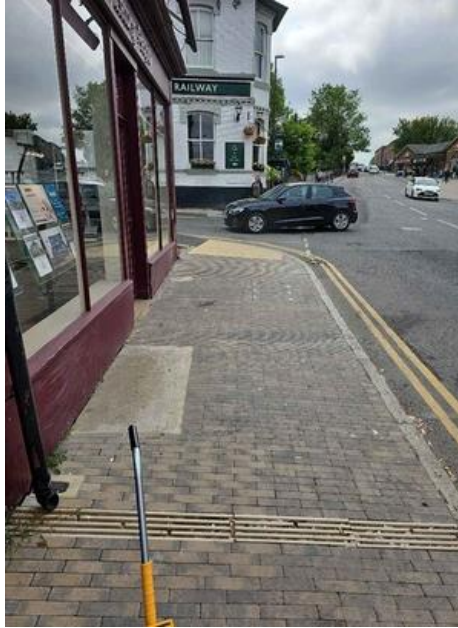
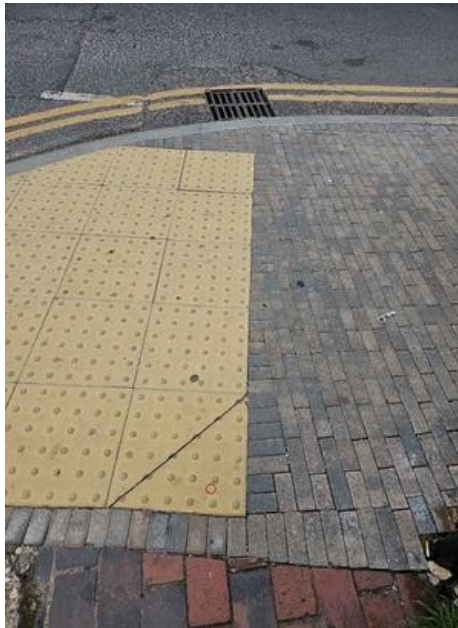
<p>Lat: 50.954328 Long: -0.128031</p>
Notes:	Blocks loose outside no. 12 food and wine, adjacent to concrete slab. Tactile require extra row (1200mm). Gully installed as per drawing.

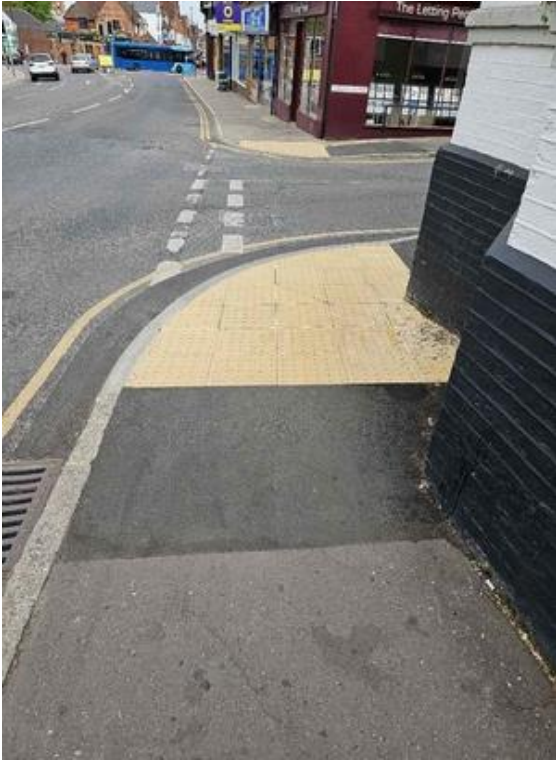
Location	Northeastern side footway (JW Grove Road)
Description	Yellow and white lining requires refreshing within channel.
Multi Photo

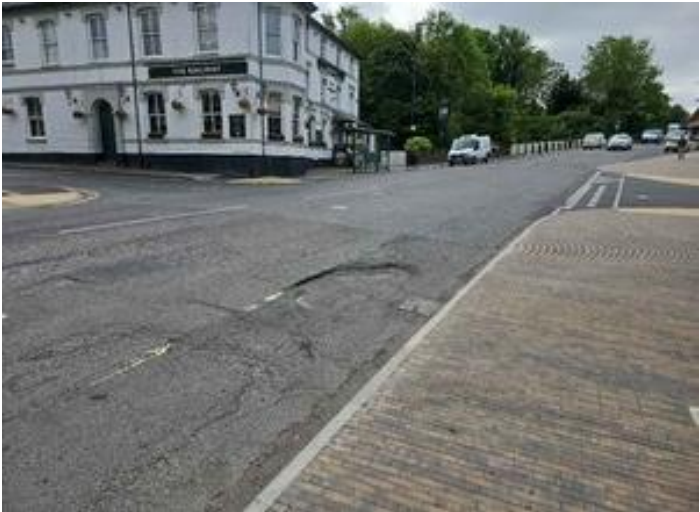
Location	Carriageway Station Road
Description	Total width 11.1m. 6m Lane for Westbound flows.
Multi Photo

<p>Lat: 50.954226 Long: -0.127892</p>
Notes:	Road Surface in very poor state of repair in. Entire section of surface course missing. BUS cage road marking at stop completely missing, where footway has been widened.

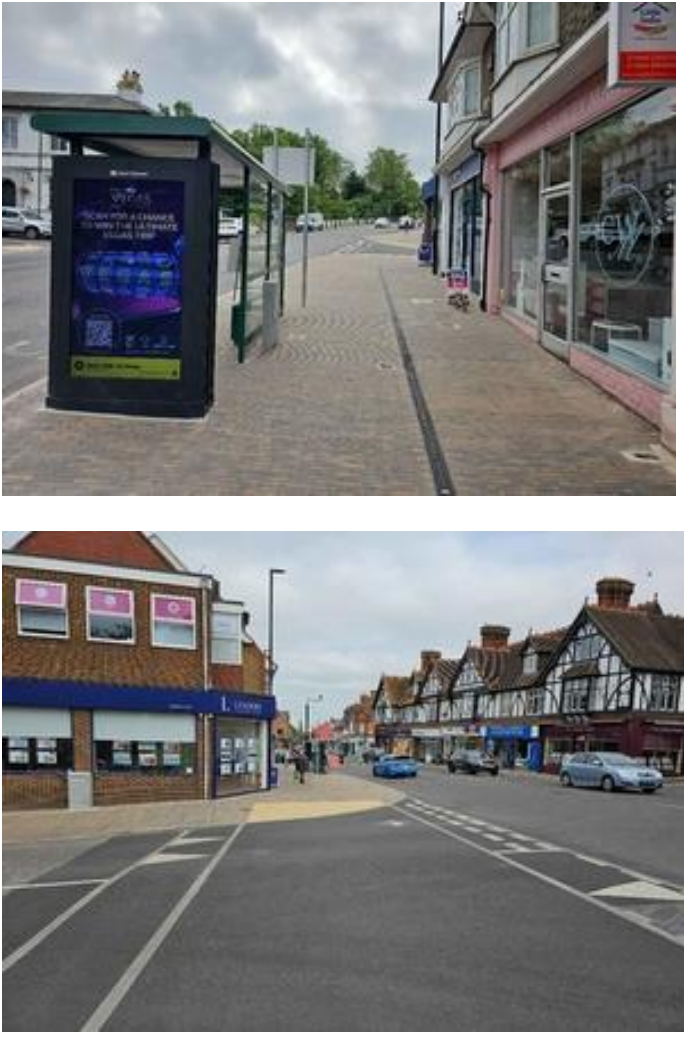
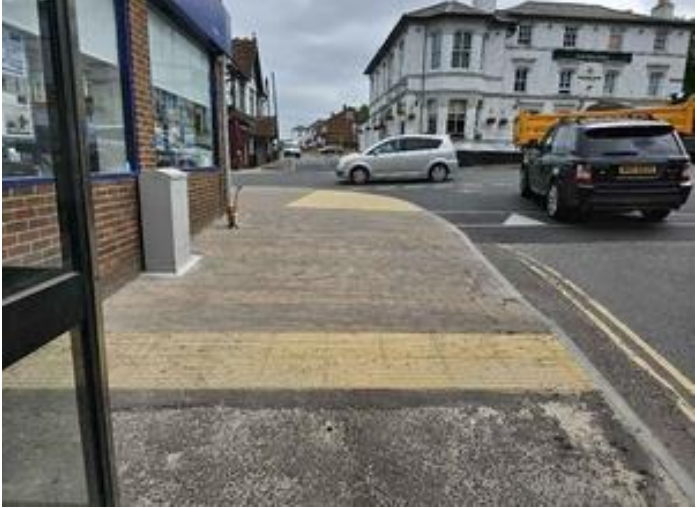
Location	Southwestern Foot/Cycleway
Description	Outside no. 17 Width 5.7m. Narrows to 3.6m at bus shelter.
Multi Photo

<p>Lat: 50.954080 Long: -0.127868</p>
<p>Notes:</p>	<p>Blocks 215mm x 50mm. Require sanding places. Tactiles extra row? No signage for shared footway Cycleway. No footway markings either.</p>

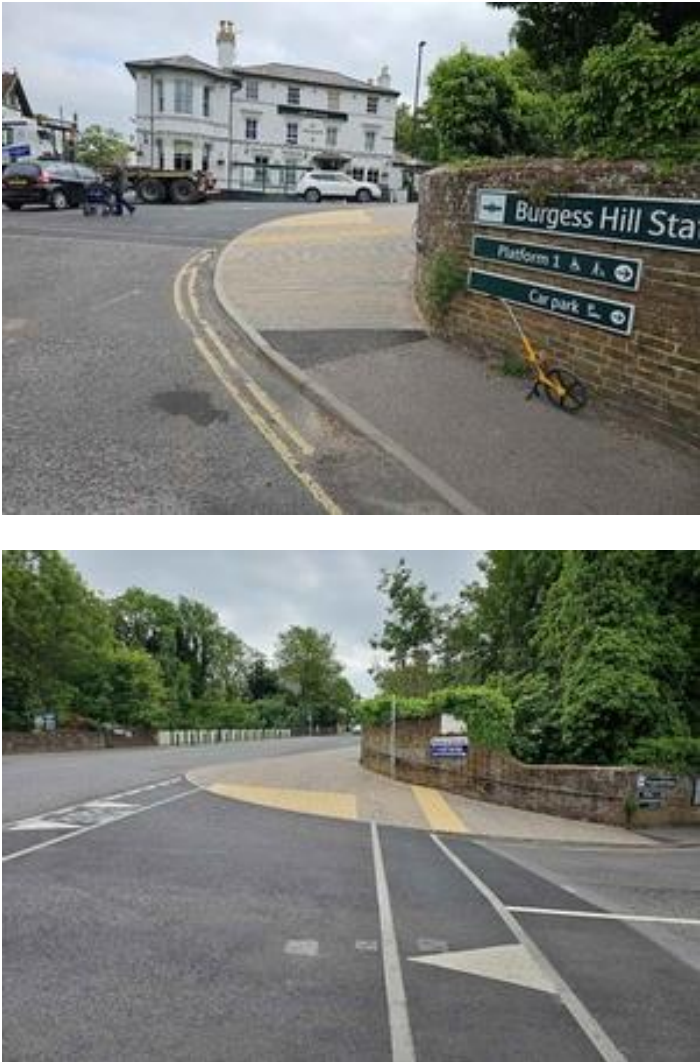
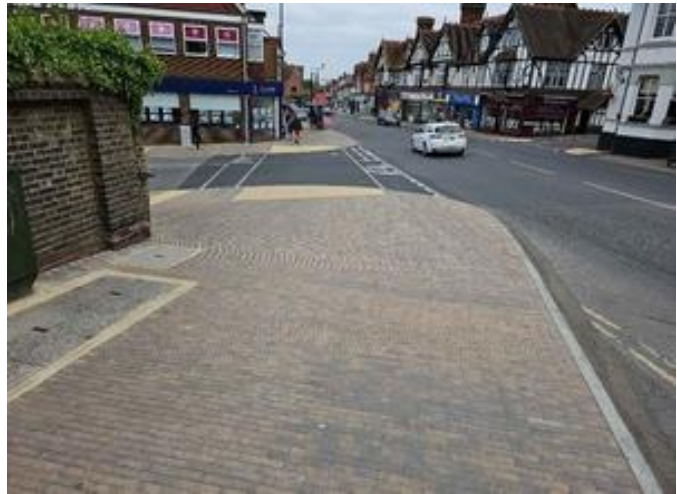
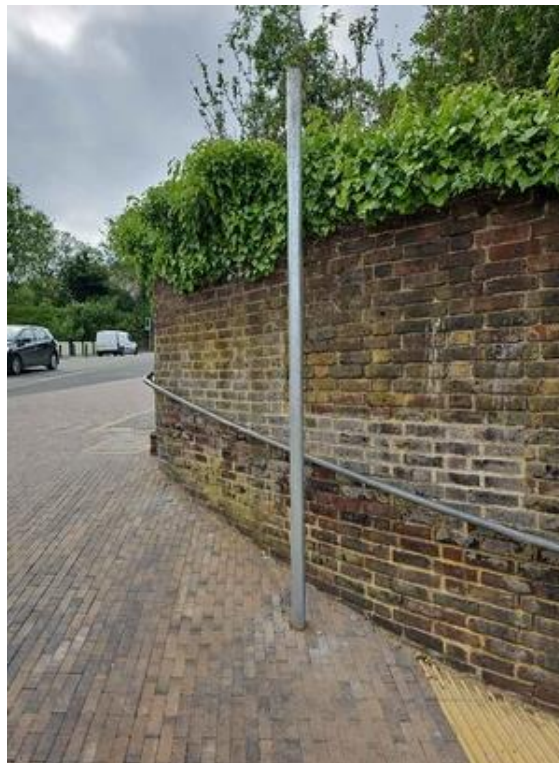
Location	Southeastern Foot/Cycleway
Description	Width 4.7m at junction. Steep incline to foot/cycleway. Unable to determine exact gradient. Appears to follow existing levels to Station.
Multi Photo

<p>Lat: 50.954068 Long: -0.127811</p>
Notes:	Blocks 215mm x 50mm. Require more sanding. Tactiles extra row? Signpost in place but no sign.

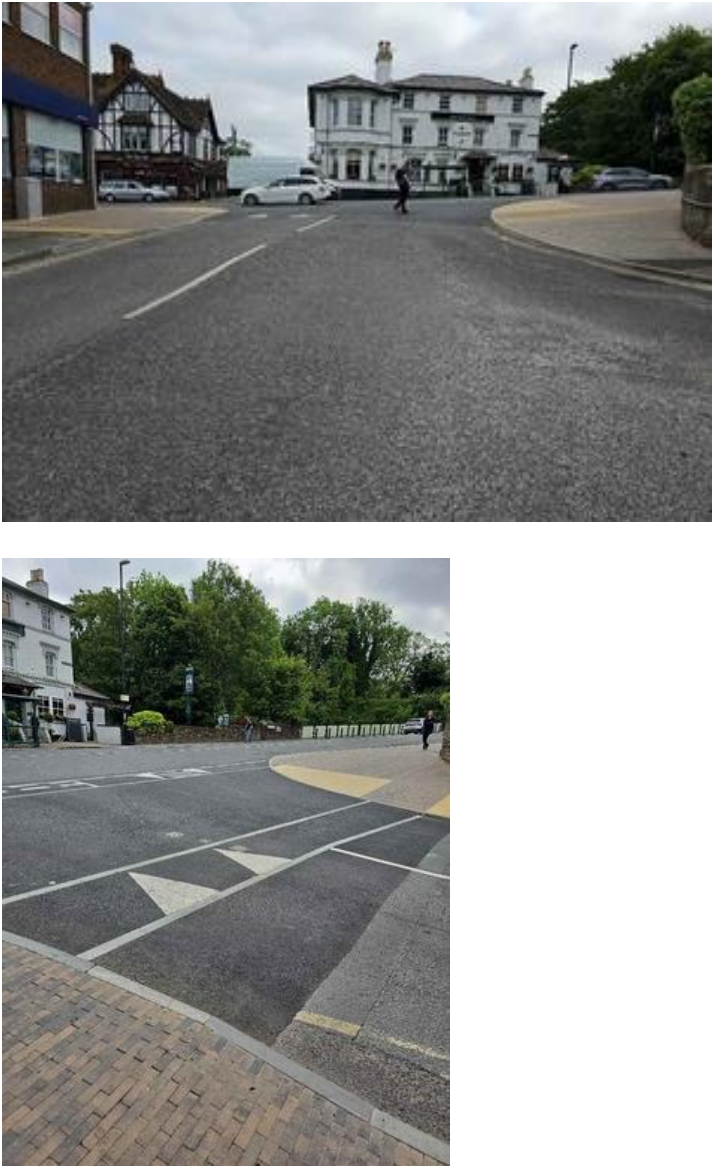
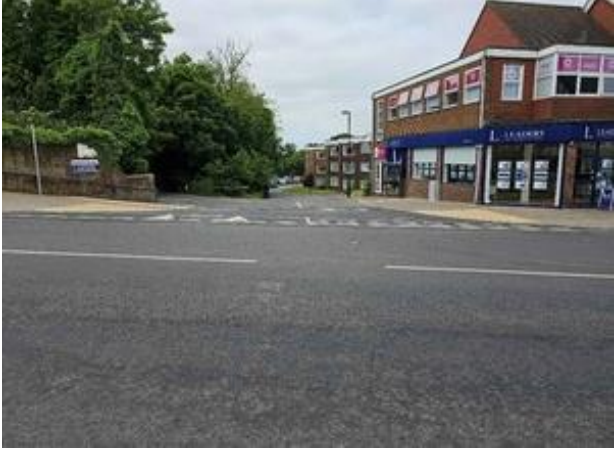
Location	Wolstonbury Way Carriageway
Description	Width 8.9m at its narrowest. Ramps 1.2m long, table 4.2m long
Multi Photo

<p>Lat: 50.954123 Long: -0.127897</p>
<p>Notes:</p>	<p>Asphalt surface possibly 10mm SMA. Ramp nonexistent around gas covers. It looks as though table has been constructed to the covers level rather than raising covers. Yellow lines need repainting and centre line. Bus stop is within visibility envelope. Advertising board worsens the issue. Cantilever shelter may have been better option.</p>

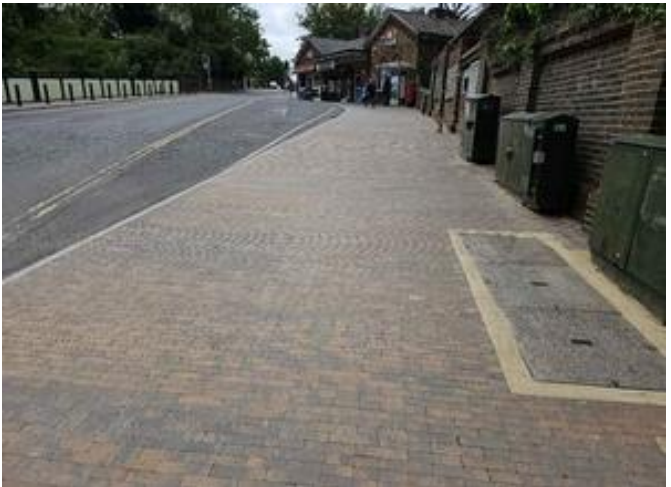
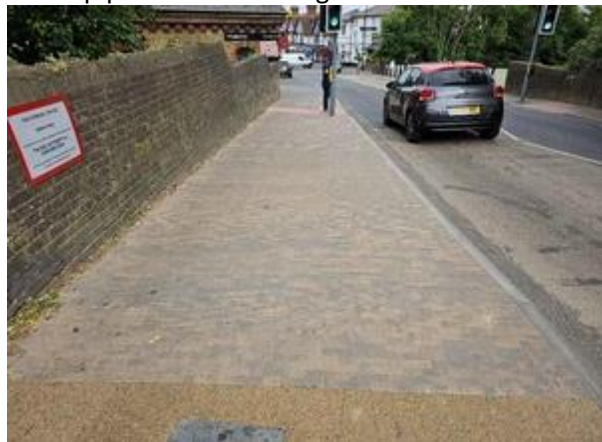
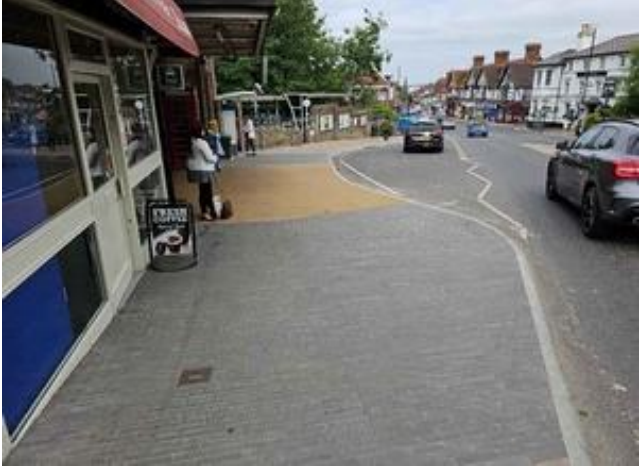
Location	Southern Foot/Cycleway
Description	<p>Width 3.9m SW of Station Entrance. Width 3.6m outside ticket machine. Width 3.1m SE adjacent to access to platform 2. Blocks 215mm x 50mm to station, 6mm coloured asphalt outside Station entrance. Width 2.7m at Ped Crossing point, narrows to 2.15 due to signal post.</p>
Multi Photo

<p>Lat: 50.953936 Long: -0.127515</p>
<p>Notes:</p>	<p>Downpipe to left of Station Entrance (looking at station) appears to have no drainage. Rainwater will run across Entrance. Could make area hazardous during wet weather and freezing temperatures. Corduroy Slabs on exit of Station? Blocks require sanding in areas.</p>

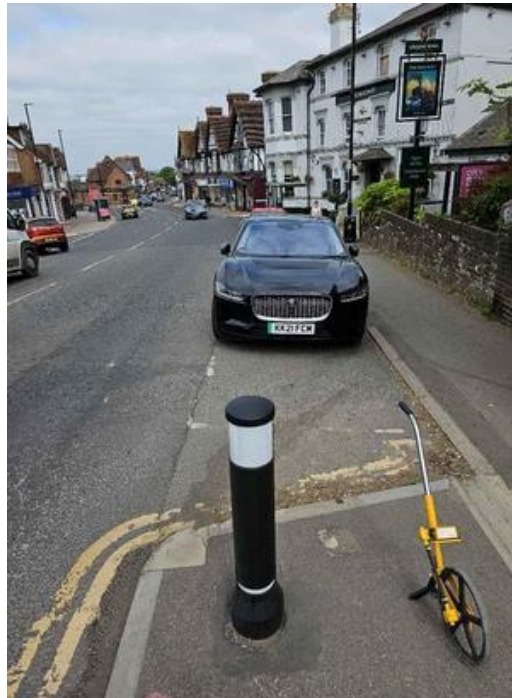
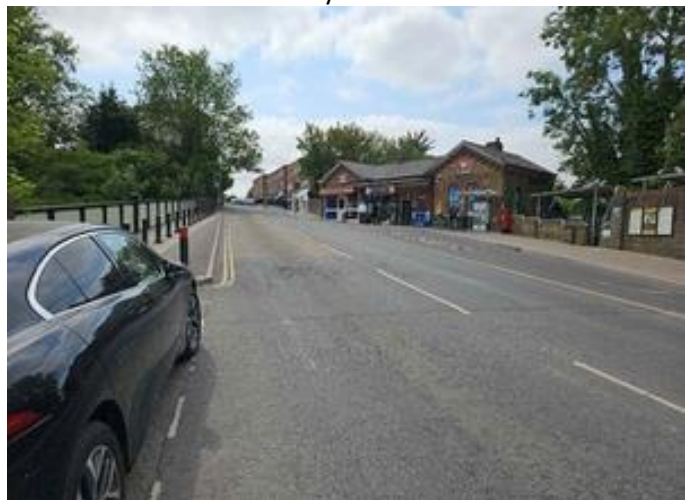
1hr no return. Width to bay 2m.

<p>Lat: 50.953873 Long: -0.127404</p>
<p>Notes:</p>	<p>Lining not as per design. Lining required. Surface Course on main carriageway reasonable. Although one area on east bound carriageway has a pothole. Anti-skid on approach to Ped Crossing. Temporary ped asphalt ramp requires removing ASAP as may cause a loss of control. Existing build out has been struck several times.</p>

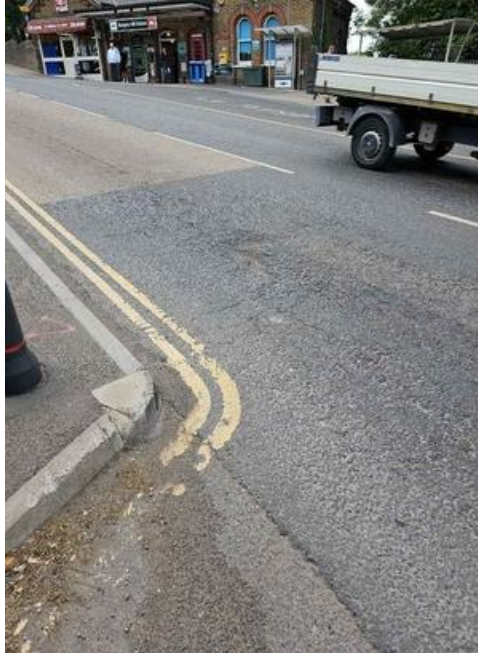
Evidence of quadrant kerb being struck.

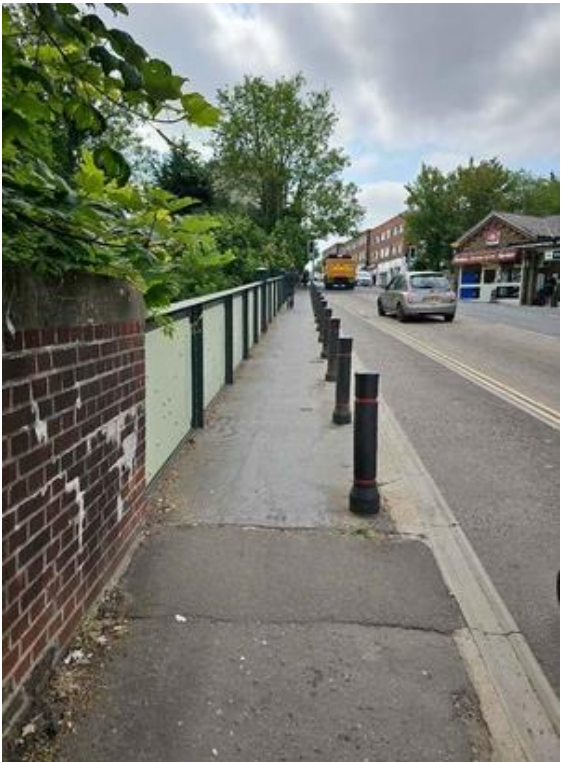
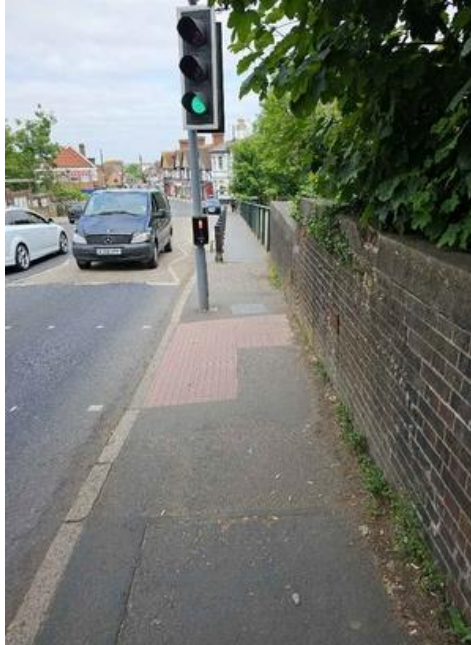
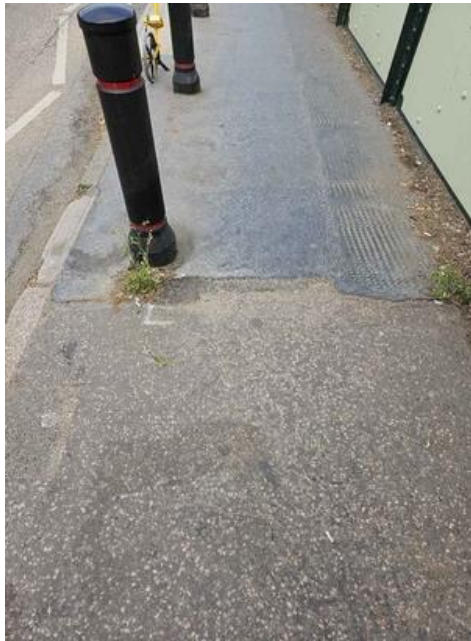
Area – 12c

Location	Northern footway
Description	Width 1.6 but narrows to 1.2m due to bollards and bridge revetment. Same both ends. Width Ped Crossing 1.74m. Surface not in a great condition. Particularly slippery over rail bridge. No proposed works.
Multi Photo

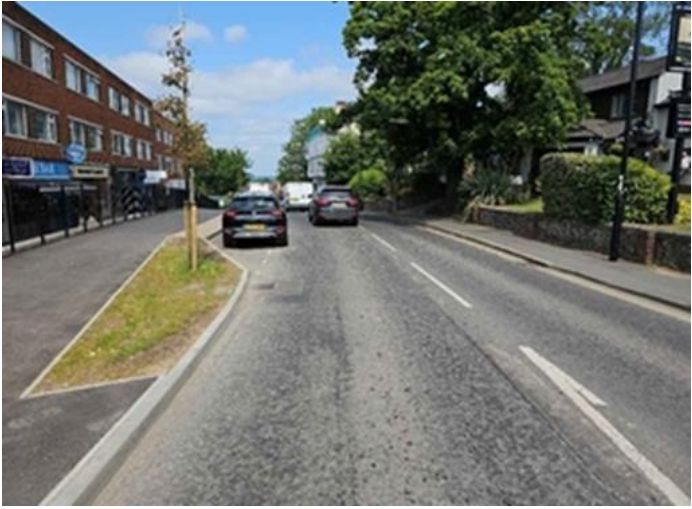
Area - 13a

<p>Poor Parking encroaching on Carriageway.</p>

<p>Lat: 50.953347 Long: -0.126445</p>
<p>Notes:</p>	<p>Poor tie repair to surface course (in front of kerbs) within Layby. Road width appears to be too narrow to allow for parking and HGVs to pass. HGV's crossing white line. HGVs unable to pass each other.</p>

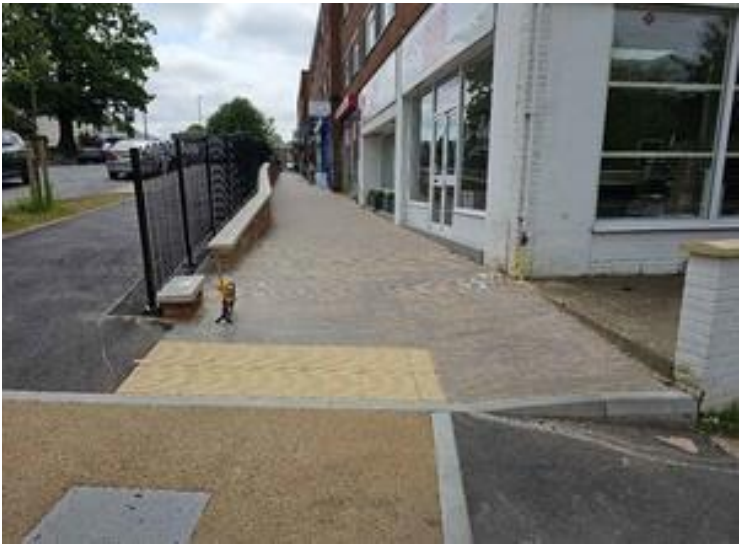
Area – 13b

Location	Footpath southern side.
Description	O/S no.9 width 3.8m. O/S no.7 width 3.6m. Adj. no. 1 width 1.4m 67.5m in length.
Multi Photo

<p>Lat: 50.953395 Long: -0.126665</p>
<p>Notes:</p>	<p>Corduroys used for footpath to shops. Presumably shared footway/cycleway continues pass shops. No signing or lining to confirm. Concerns for blind users where there is steep gradient, change levels. 215mm x 50mm Blocks. Sand required. No signs but post in verge. Lack of Drainage one small gully outside no. 9. Presumably in low spot to serve approx. 198m². Workmanship appears to be good.</p>

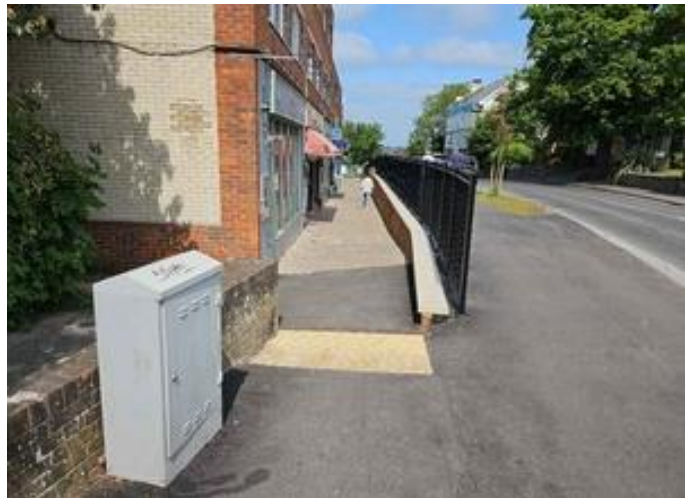
Steep gradient where footpath and foot/cycleway join.

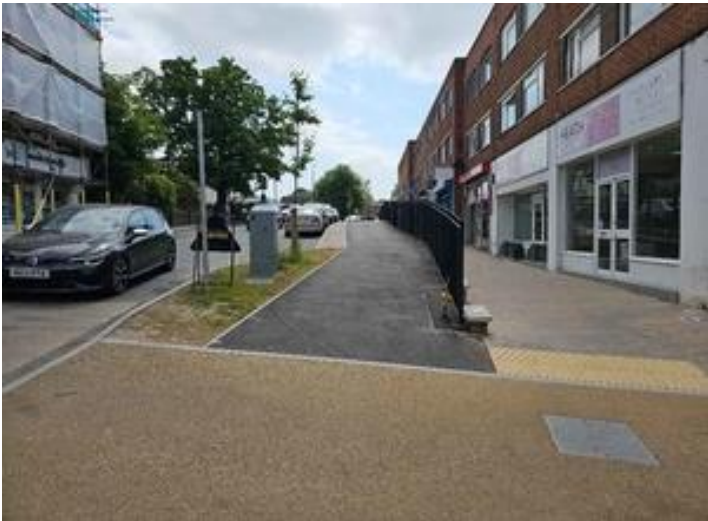
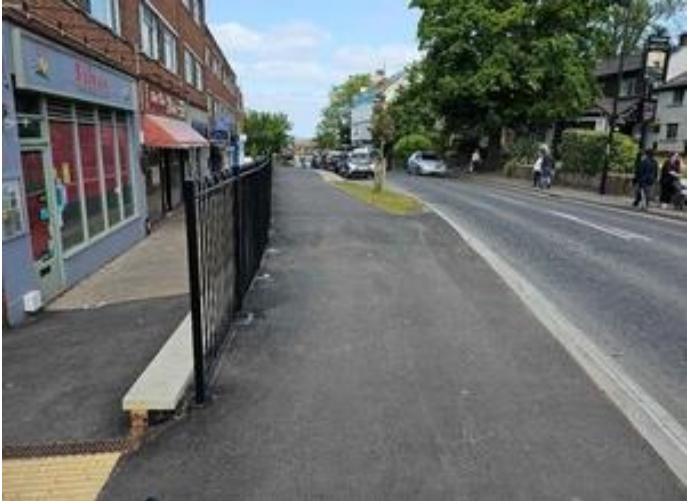
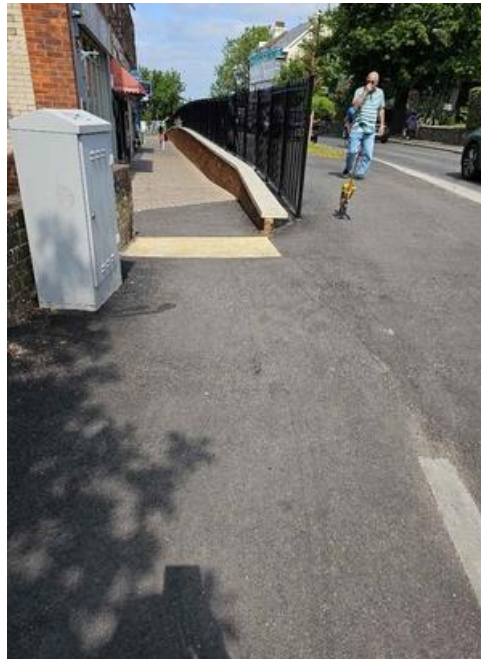
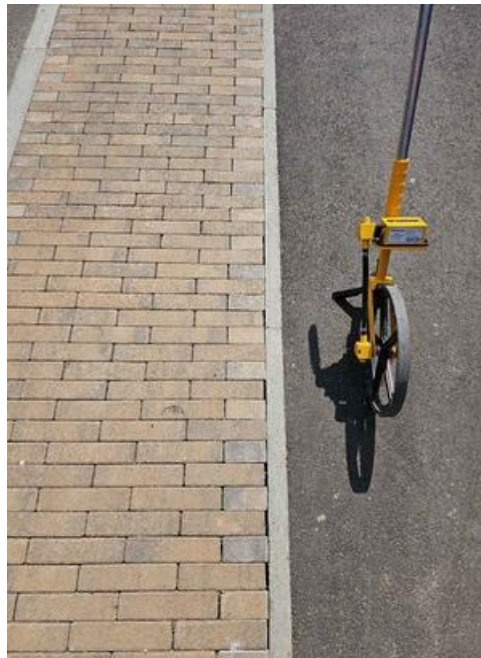
Area – 13c

<p>Lat: 50.953263 Long: -0.126453</p>
<p>Notes:</p>	<p>Signpost in verge but no signage. No lining. As per previous, cycleway surface no so good outside no.1. Level difference between Cycleway and footway wall should have continued along until level. Possible due to cabinet located against wall would reduce the width. Relocate cabinet. If railings were located on top of wall cycle width would increase by 160mm. Would also remove the temptation for children to walk along wall. Quite significant drop would cause serious injury.1.37m height. Sand required between blocks. Lack of understanding for segregated route. Sand required between blocks</p>

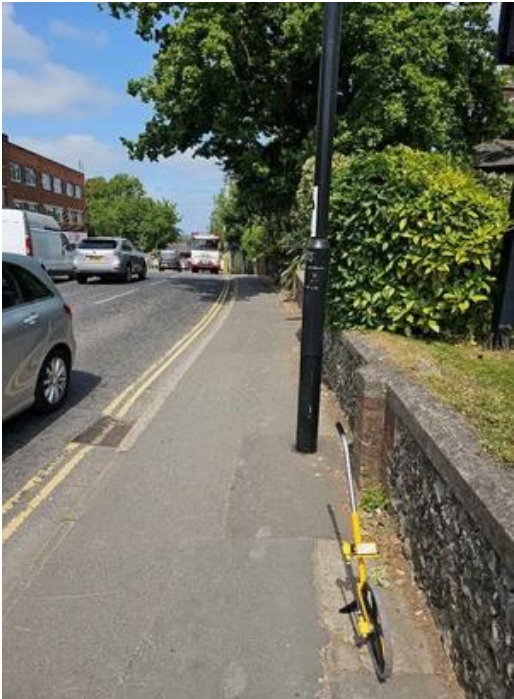
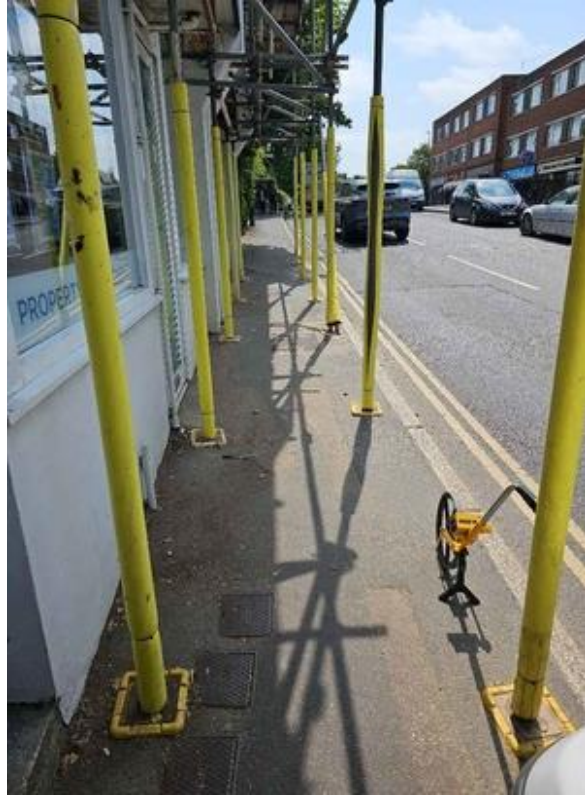
Area – 13d

Location	Northern Footway dims
Description	Opp. no.8 width 1.7m. O/S Tophouse PH width 1.46m Opp. No.2 width 1.74m narrows to 1.37m due to LC.
Multi Photo

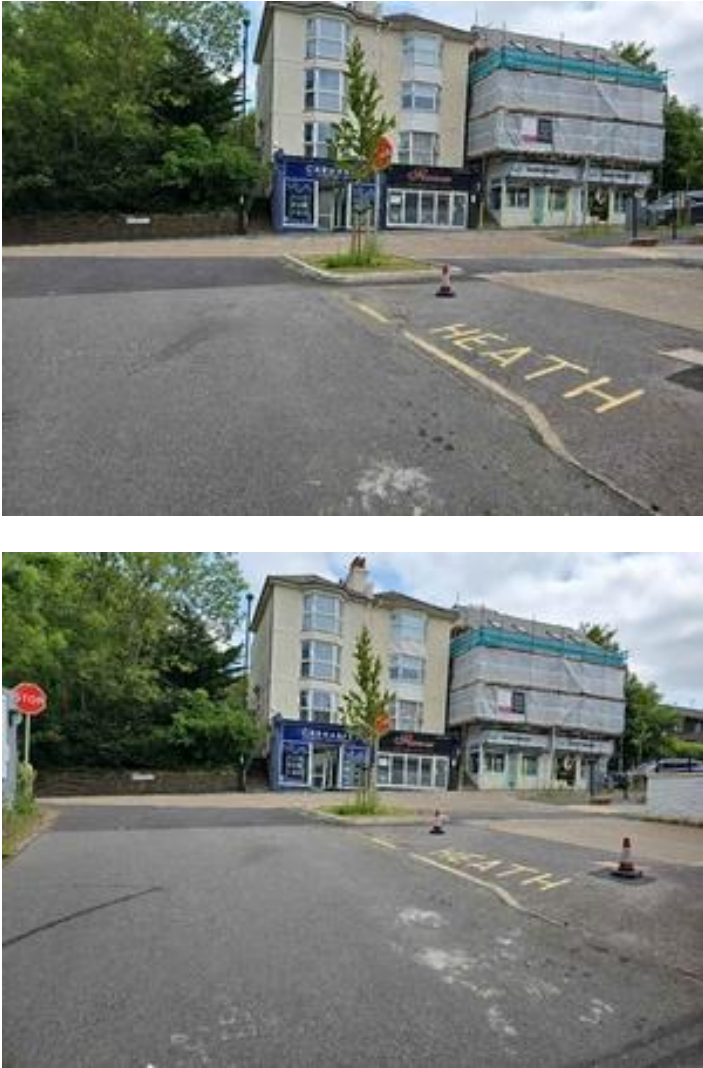
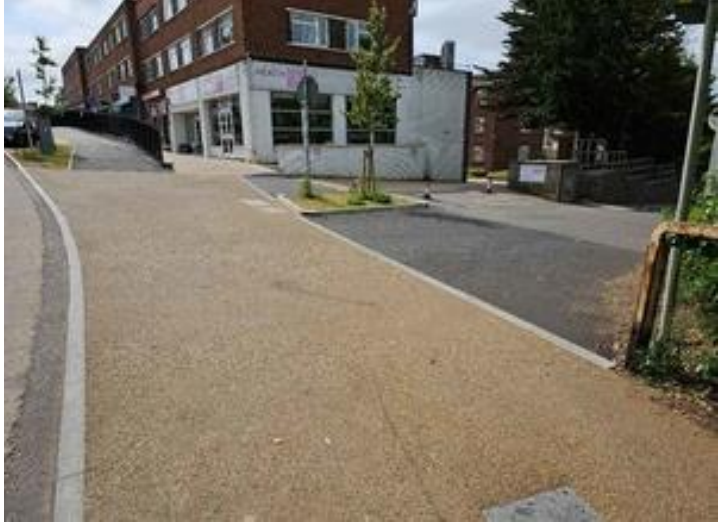
Area – 13e

Location	Access to carpark and flats
Description	Width is 6.6m narrowing down to 3.4m. 10mm buff coloured Asphalt surface.
Multi Photo

<p>Lat: 50.953544 Long: -0.126984</p>
<p>Notes:</p>	<p>No stop lines. Stop signs mounted at different heights. 2.36 and 215m no end caps.</p>

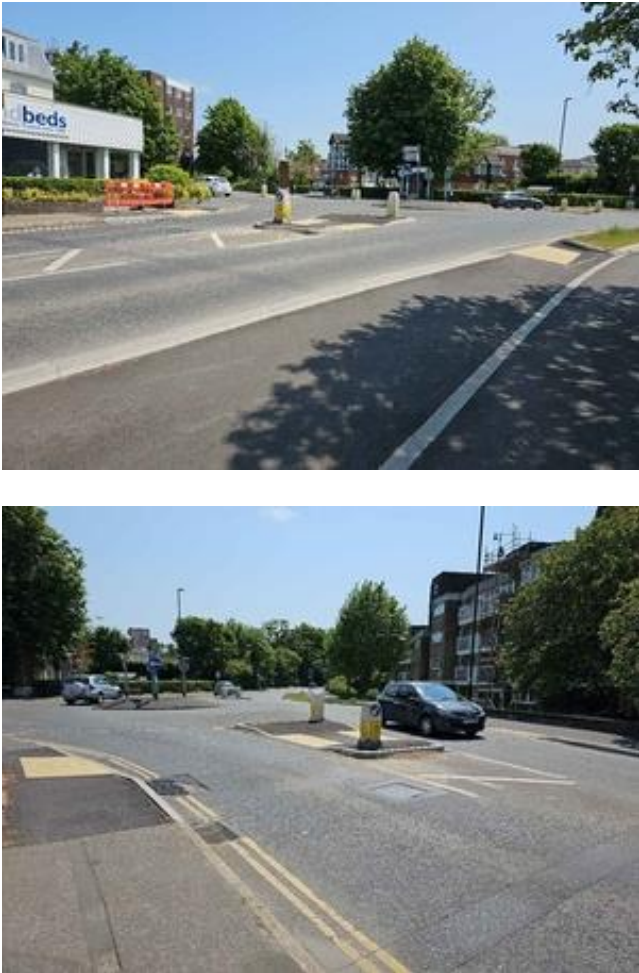
Area – 14a

Location	Keymer Road West Arm
Description	Width of foot/cycleway 3.9m southern. Westbound CW width 4.4m. Island width at its narrowest 2.7m. Eastbound CW width 4.1m.
Multi Photo

<p>Lat: 50.953006 Long: -0.125988</p>
<p>Notes:</p>	<p>Unfinished surface course. No idea on what is shared or unsegregated. Corduroys required for entering shared space. cycles crossing? No signs or lines. Poor repair around gully.</p>

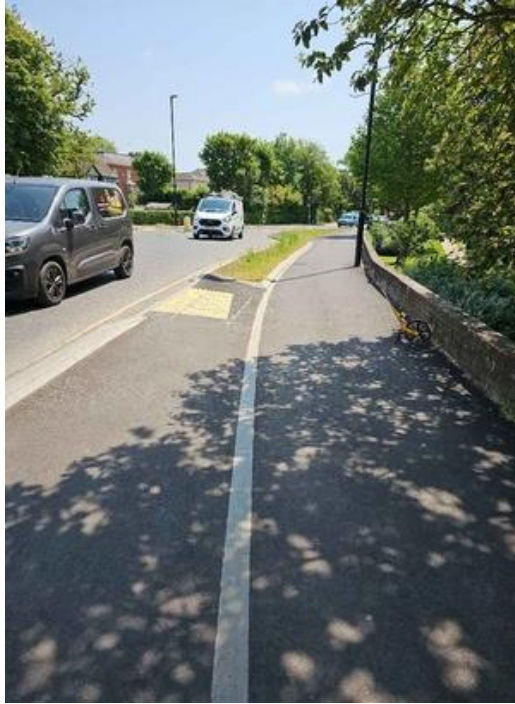
Shared route?

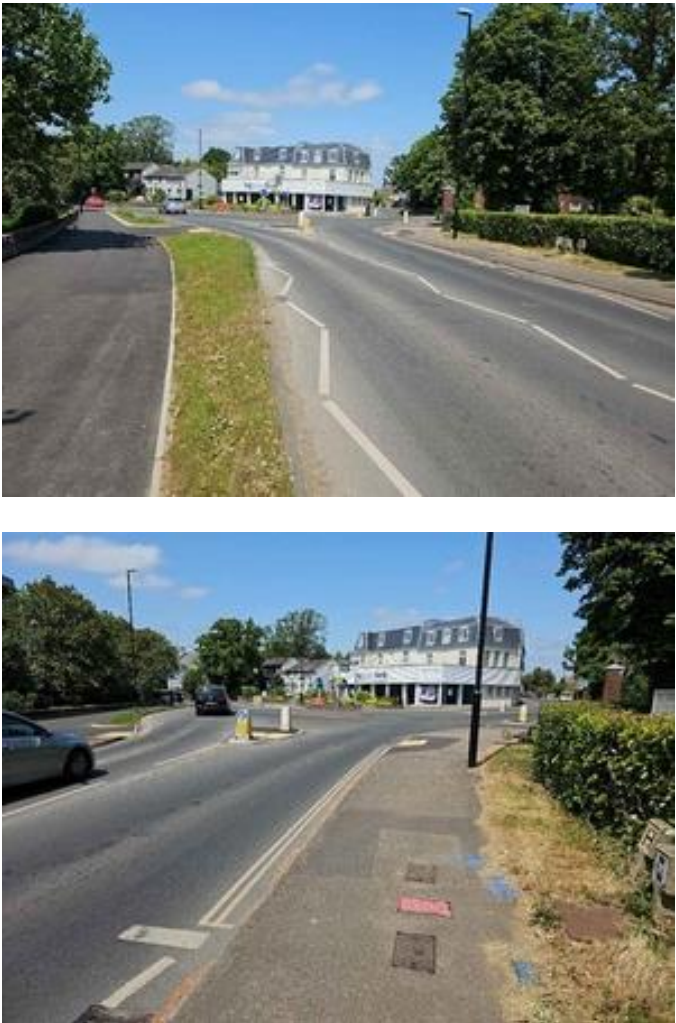
Area – 14b

Location	Keymer Road SW arm
Description	<p>Width to western foot/cycleway 3.8m. CW width northbound 3.6m. Island 1.6m at narrowest. CW width southbound 4.2m. Width to eastern footway width 3.6m.</p>
Multi Photo

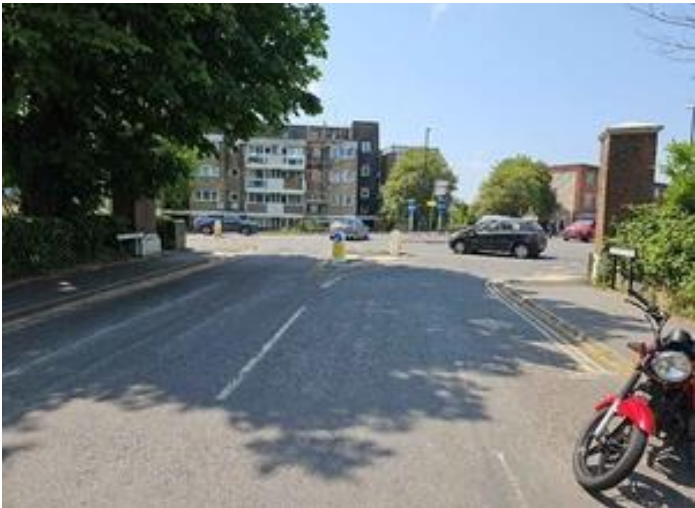
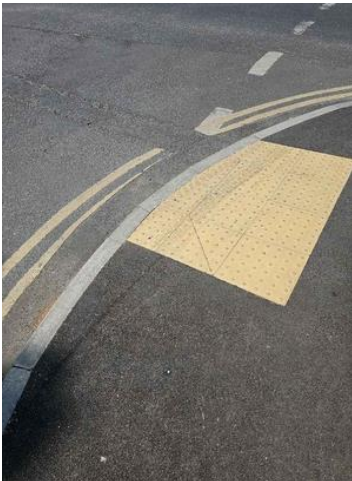
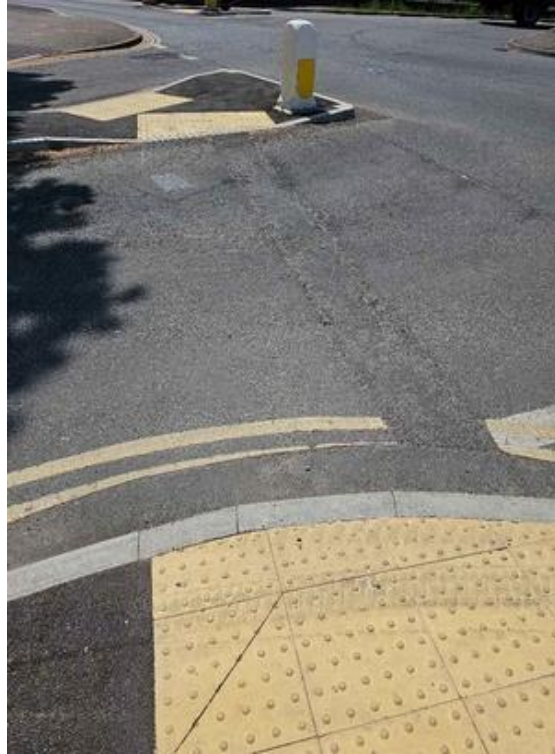
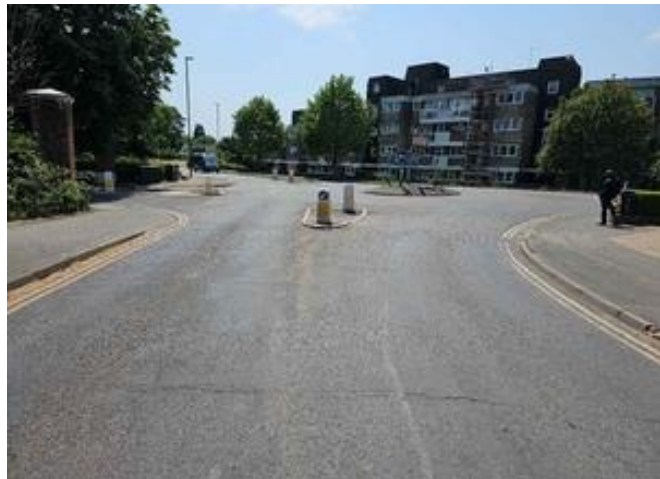
Area – 14c

Defect Location	Silverdale Road Arm
Defect Description	Width to south footway 2m. CW width westbound 3.8m. Island width 2m at its narrowest. CW width eastbound 4.8m. Width to north footway 1.55m.
Multi Photo

<p>Lat: 50.952864 Long: -0.125704</p>
Notes:	Yellow lines require refreshing around junction. Poor trench repair to surface course.

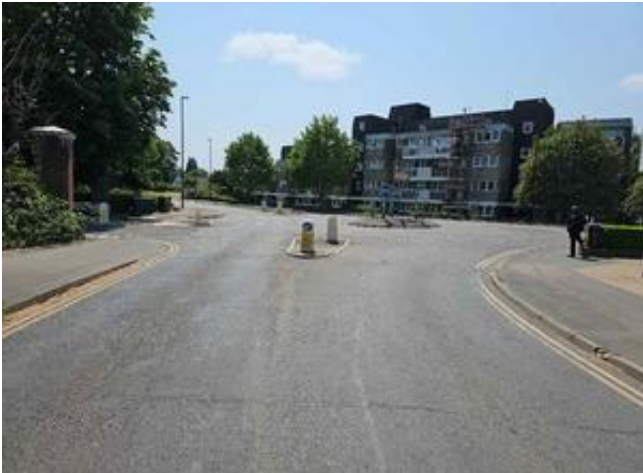
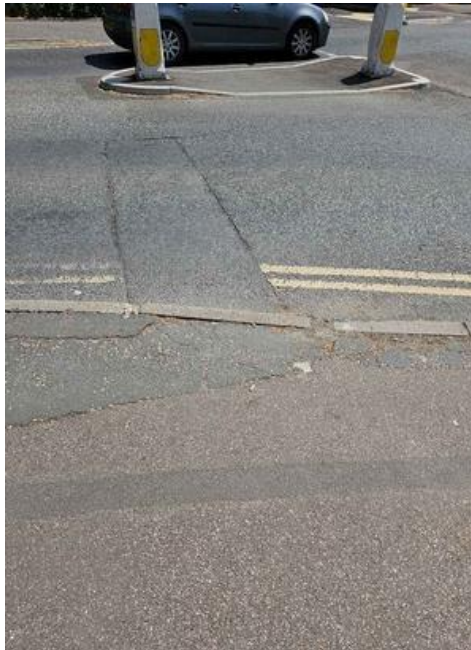
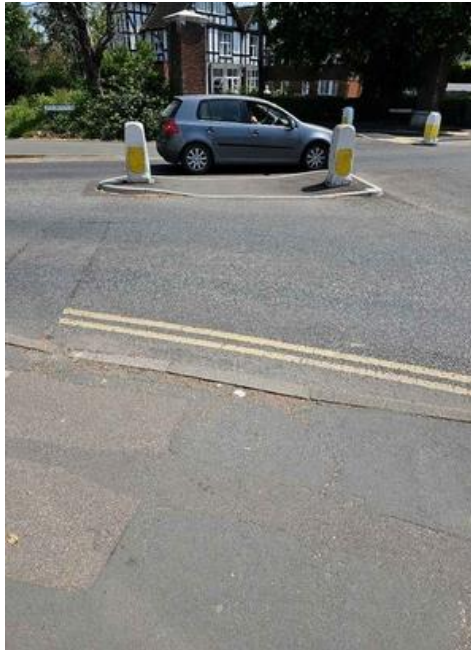
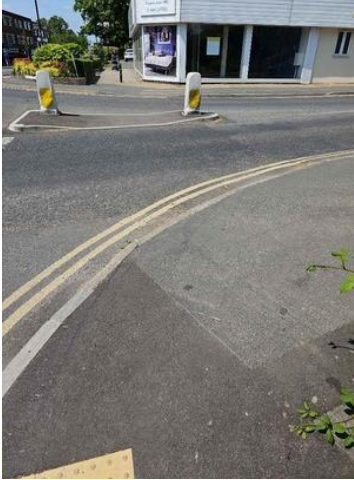
Area – 14d

Location	Junction Road Arm
Description	Width to western footway 2.9m. CW width southbound 3.8m. Island 1.5m at its narrowest. CW width northbound 4.8m. Width to eastern footway 1.8m.
Multi Photo

No tactiles

<p>Lat: 50.952911 Long: -0.125690</p>
<p>Notes:</p>	<p>No tactiles. Yellow lines require refreshing.</p>

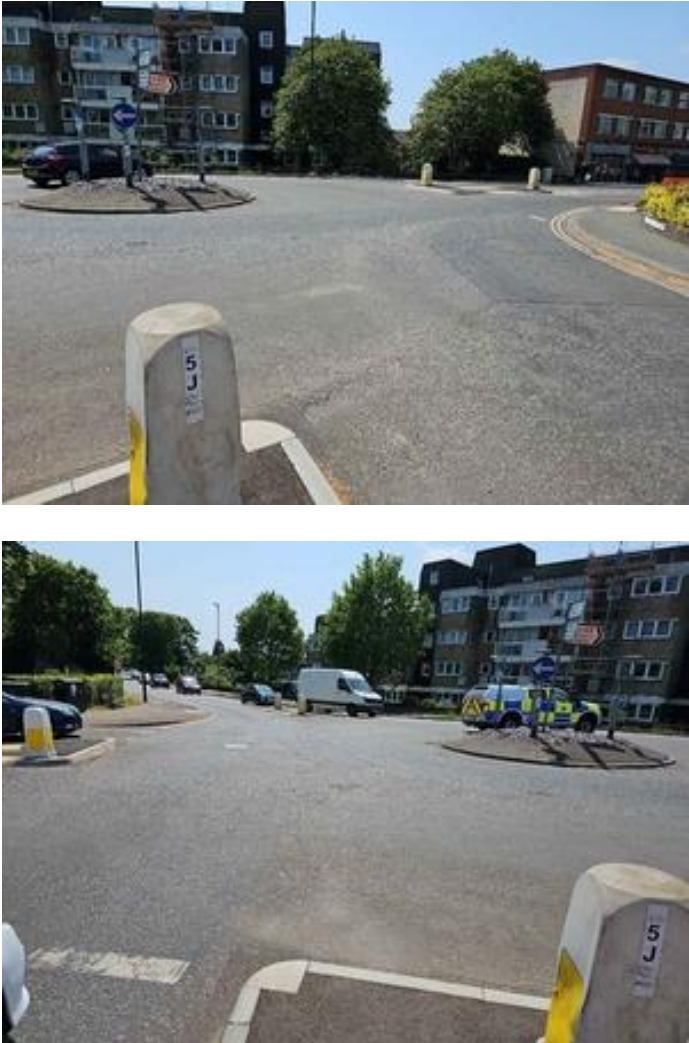
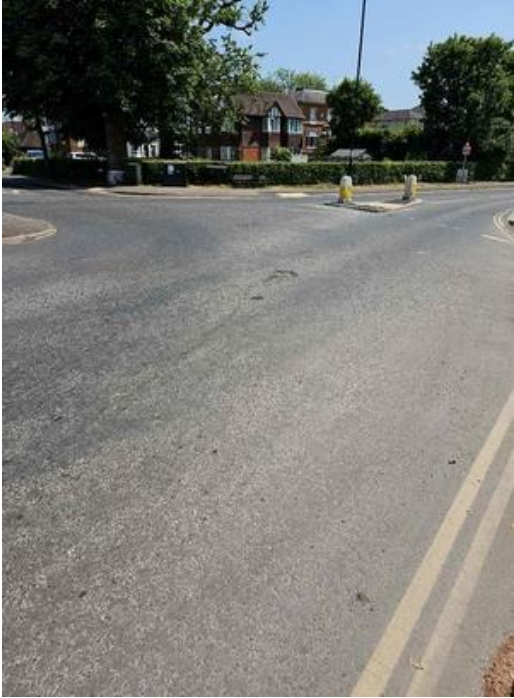
Area – 14e

Location	Circulatory to RAB
Description	Unable to measure but appears to be as existing.
Multi Photo

A photograph showing a road junction. The road surface is asphalt. A pothole is visible in the center of the junction. There are trees and buildings in the background.
Location / GPS

A map showing the location of the pothole. The map is a street view map with a red pin indicating the location. The map shows a residential area with streets like Burgess Hill, Flavour, The Top House, Asian Rose, Wynnstay, Keymer Rd, Silverdale Rd, and Oak Lodge Nursing Home. A red pin is located on Keymer Rd. The map is credited to mapbox and OpenStreetMap. <p>Lat: 50.952753 Long: -0.125958</p>
Notes:	Pothole appearing on circulatory.

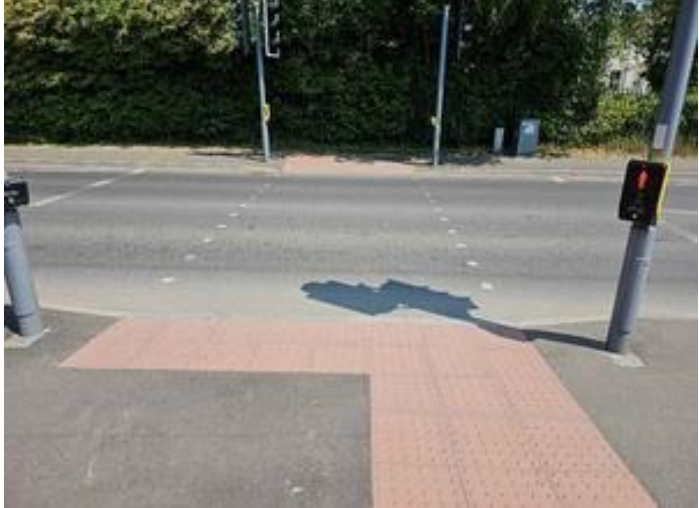
Area - 15a

Defect Location	Foot/Cycleway Western side.
Defect Description	Corduroys required for entering shared space. Width of crossing 3.2m.
Multi Photo

<p>Lat: 50.952455 Long: -0.125903</p>
<p>Notes:</p>	<p>Distance from studs to stop line 3.2m, should be max 3m.</p>
