ICENI CONSULTING SURVEY REPORT

Client:	Burgess Hill Town Council
Site:	Place & Connectivity Programme Phase 1, Burgess Hill
S38/S278/UU/LHA/Private/	Local Highway Authority
Highway Authority	West Sussex County Council
Date/Time	05/06/2023
Iceni Representative:	Robert Lee

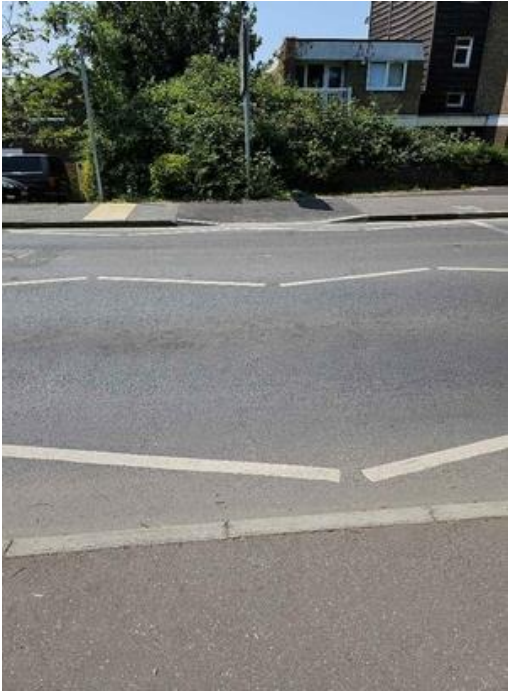
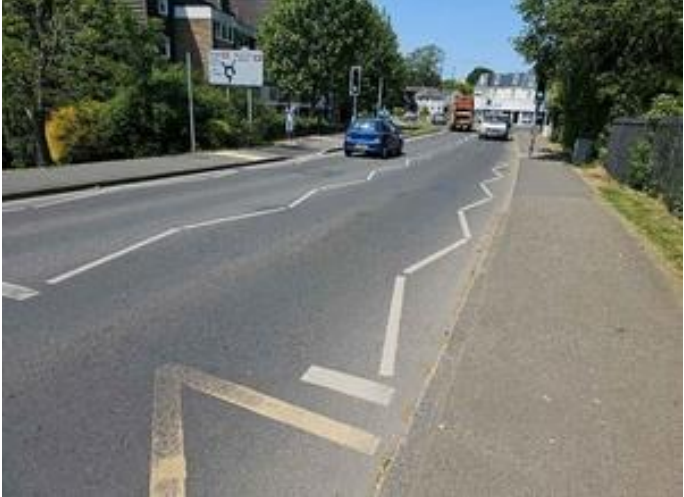
Area – 15b

Location	Keymer Road Carriageway
Description	Carriageway width 7.45m.
Multi Photo

<p>Lat: 50.952449 Long: -0.125913</p>
<p>Notes:</p>	<p>Surface course appears to be a 10mm Thin surface course. Looking polished but presumably as existing. Sign missing from post. Lining required to cycle connection to carriageway. It's not clear what's its purpose is.</p>

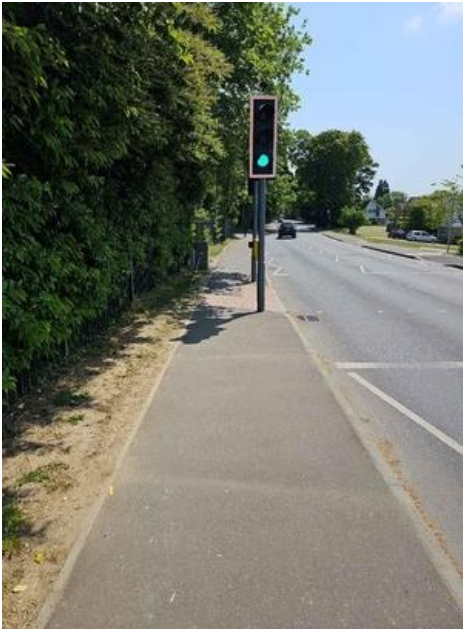
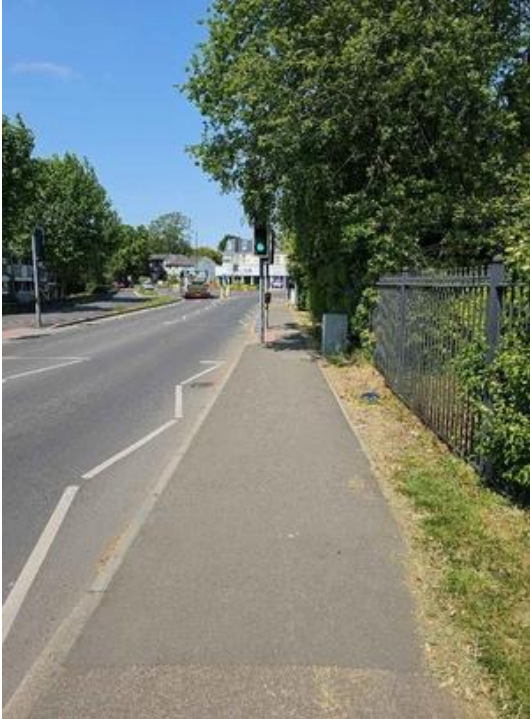
Area – 15c

Location	Footway Eastern side
Description	Footway width 1.8m. 1m verge. 2.8m total available. Cycle currently travelling Southbound are unable to join carriageway correct side. Possibly could have installed Toucan crossing and allowed cycles to cross over and enter carriageway on correct side.
Multi Photo

<p>Lat: 50.952418 Long: -0.125843</p>
Notes:	Trees obscuring lighting head. All OK other than that.
