BUILDING INSPECTION REPORT

BURGESS HILL PARK CENTRE

60 PARK ROAD

AUGUST 2022

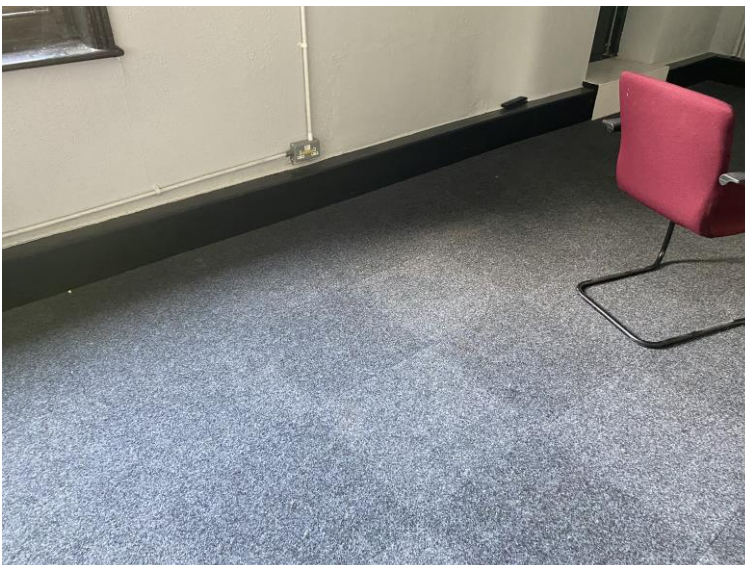
67.

Bowing to the rear of recreation room 2 floor.
